State of Ohio Environmental Protection Agency

**Re:** Belmont County  
Tri-State Asphalt Flyash Landfill  
Tri-State Group, Inc. & Glenn Straub  
Compliance Evaluation Inspection  
NPDES Permit 01N00107\*AD  
Correspondence (IWW)

**NPDES**  
Compliance Inspection Report

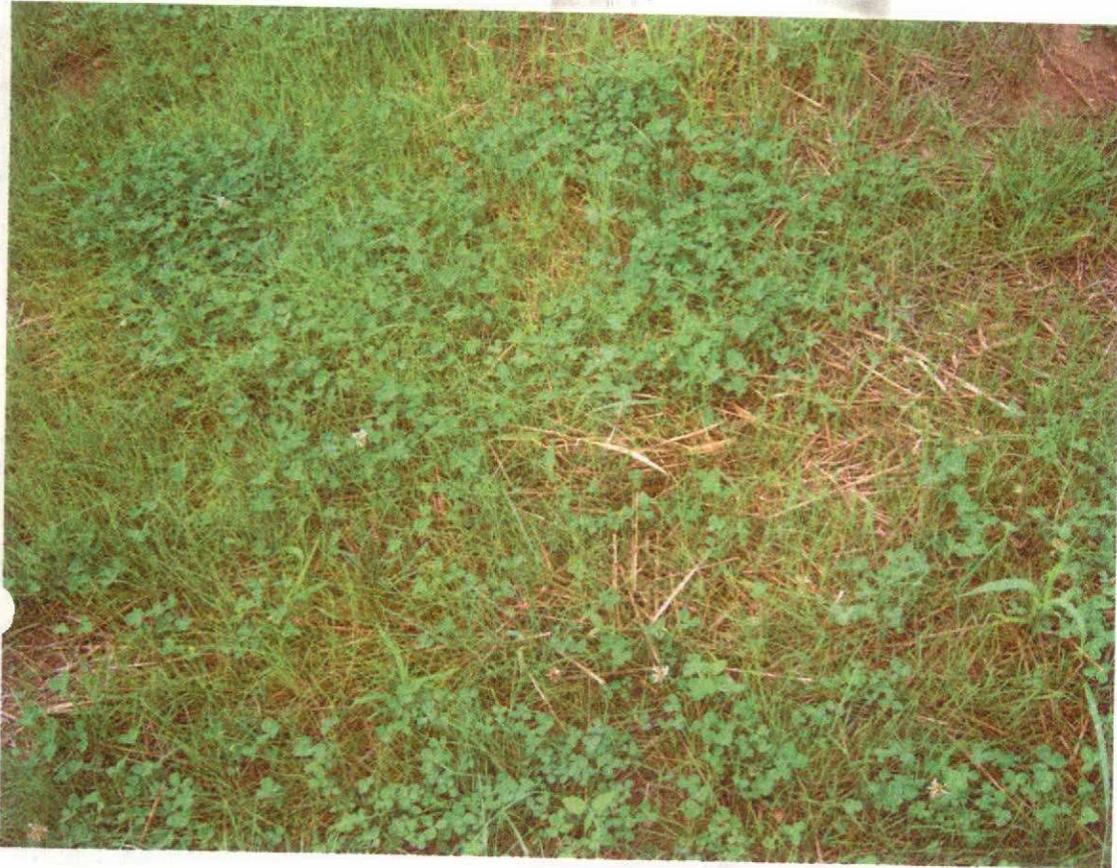
Photo 1

1. The vegetation on the majority of the site is good (see photos 1 and 15 attached). However, there are several areas where the vegetation is sparse (see photos 9, 10, 21 and 22 attached). Maintenance of the vegetation is needed as required by the post closure maintenance plan. It is recommended that a soil evaluation be made by either the Ohio State University Belmont County Extension Office (Steve Schumacher, 740/695-1455) or a local fertilizer store (such as Landmark) for re-seeding, liming and fertilizer needs. Provide a plan with a time schedule for repairing these areas.
2. The access road from the office trailer has begun to erode away (see photos 28 and 29). Since this soil is highly erodible it is recommended that this be repaired right away before it gets worse. It appears that this is the only access for the company to this site. Provide a date when this will be accomplished.
