State of Ohio Environmental Protection Agency

Re: Seneca County  
Fostoria Mobile Estates  
Sewerage

July 13, 2009

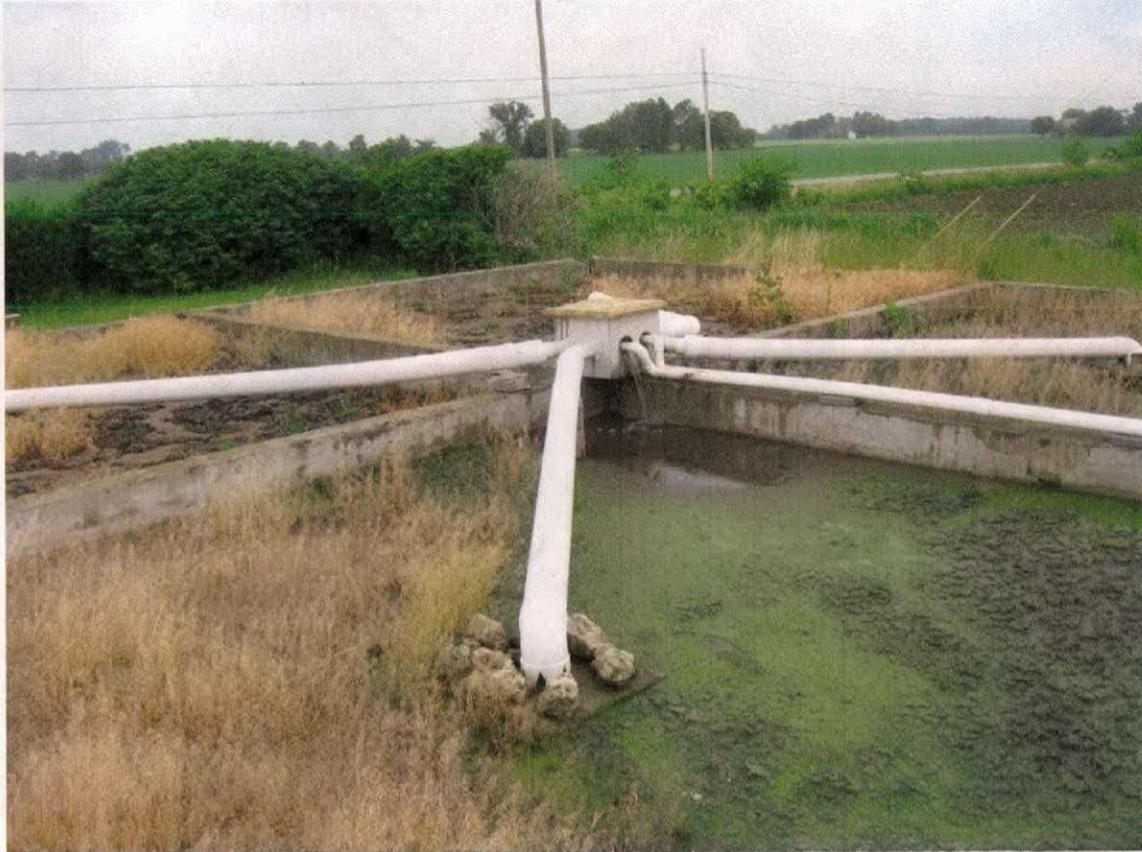
Fostoria Mobile Estates MHP, Seneca Co.  
Sand filters looking northeast – leaking distribution box  
taken by M.B.Cohen, 06/10/09

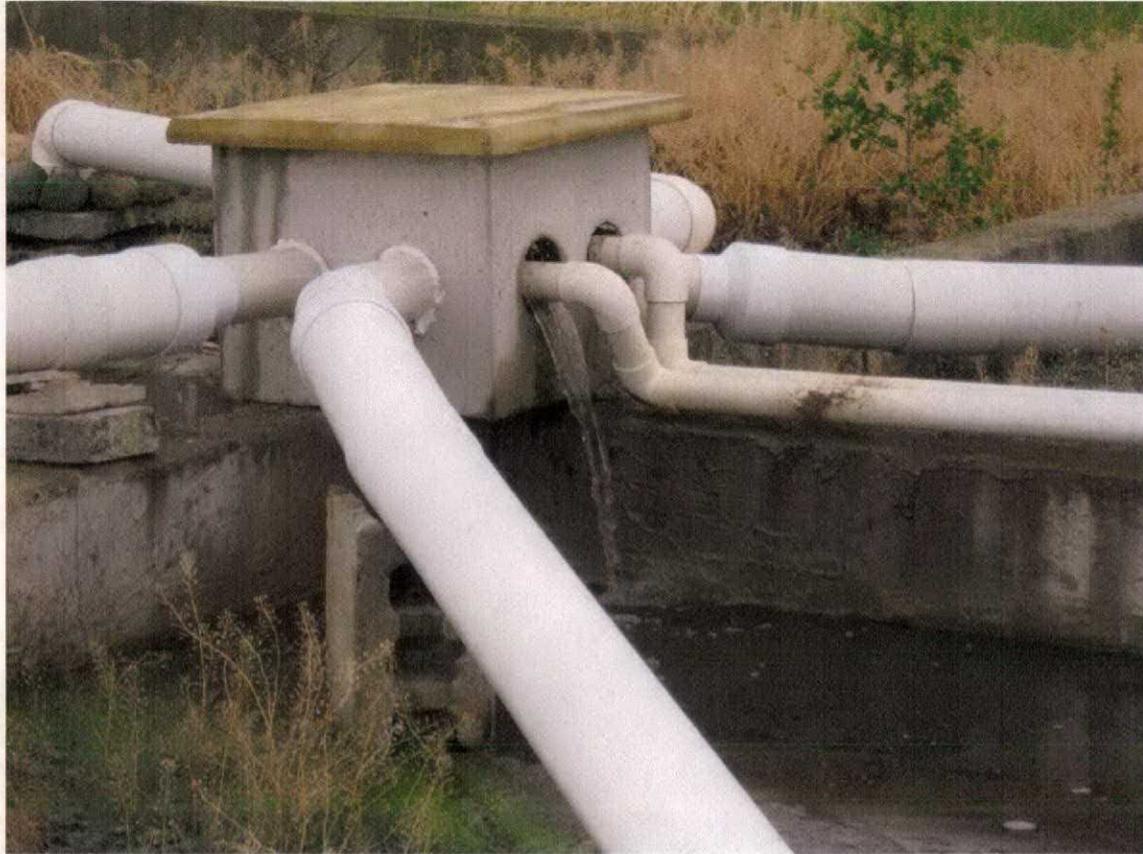
Looking northeast at sand filter distribution box leaking on S-W bed (S-E bed was in use)

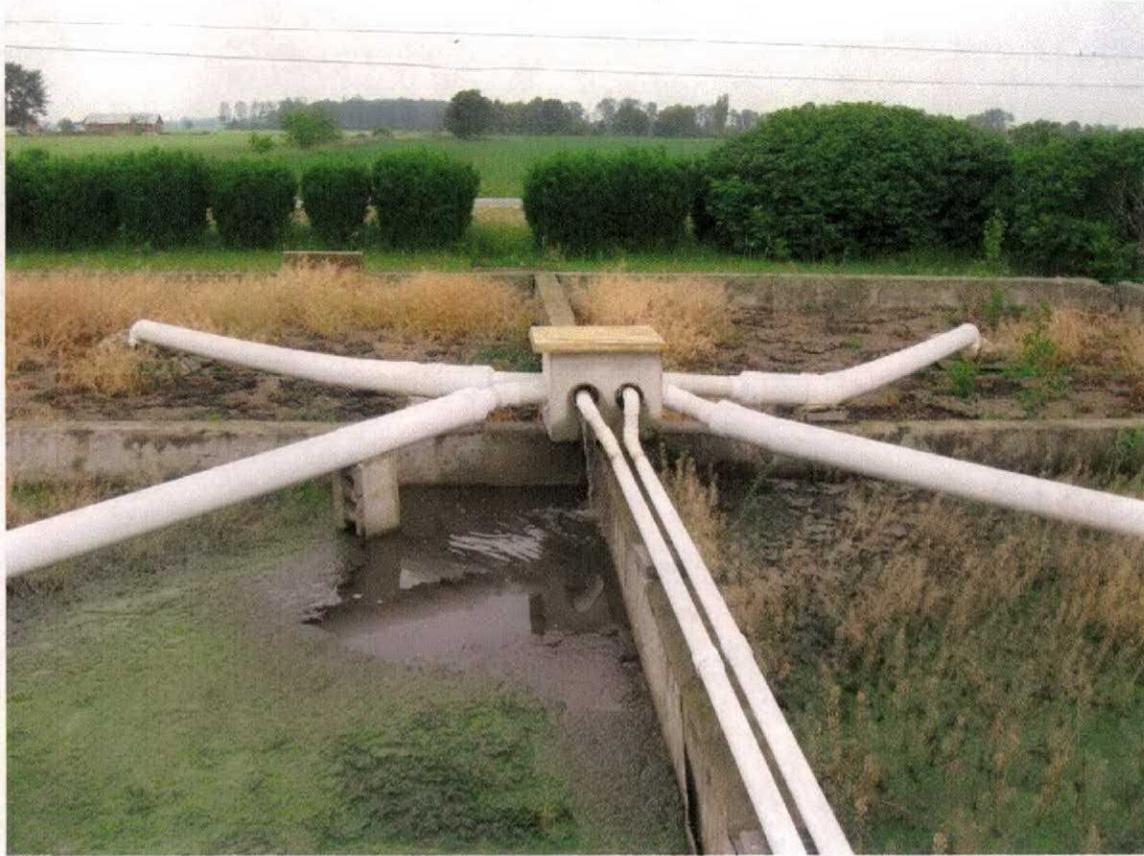
Fostoria Mobile Estates MHP, Seneca Co.  
Sand filters looking north – leaking distribution box  
taken by M.B.Cohen, 06/10/09

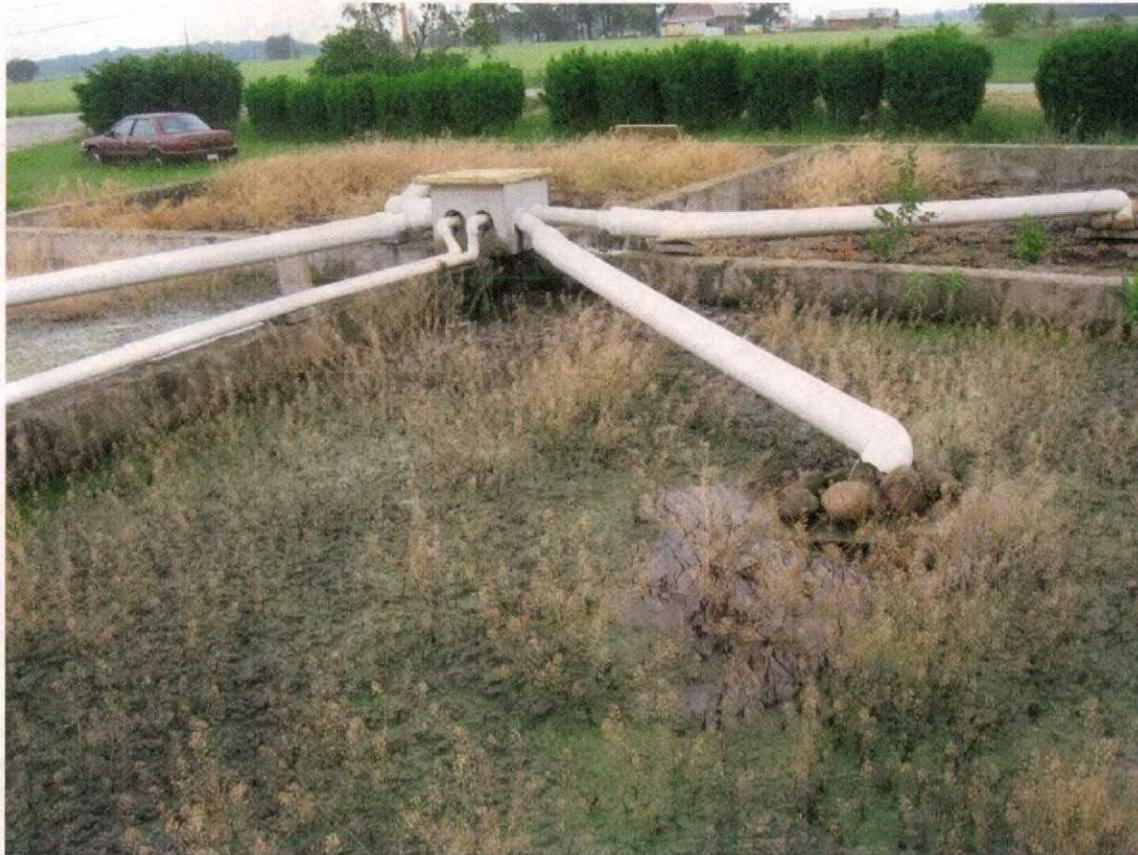
Fostoria Mobile Estates MHP, Seneca Co.  
Sand filters looking northwest (water visible on SE bed in use)  
taken by M.B.Cohen, 06/10/09

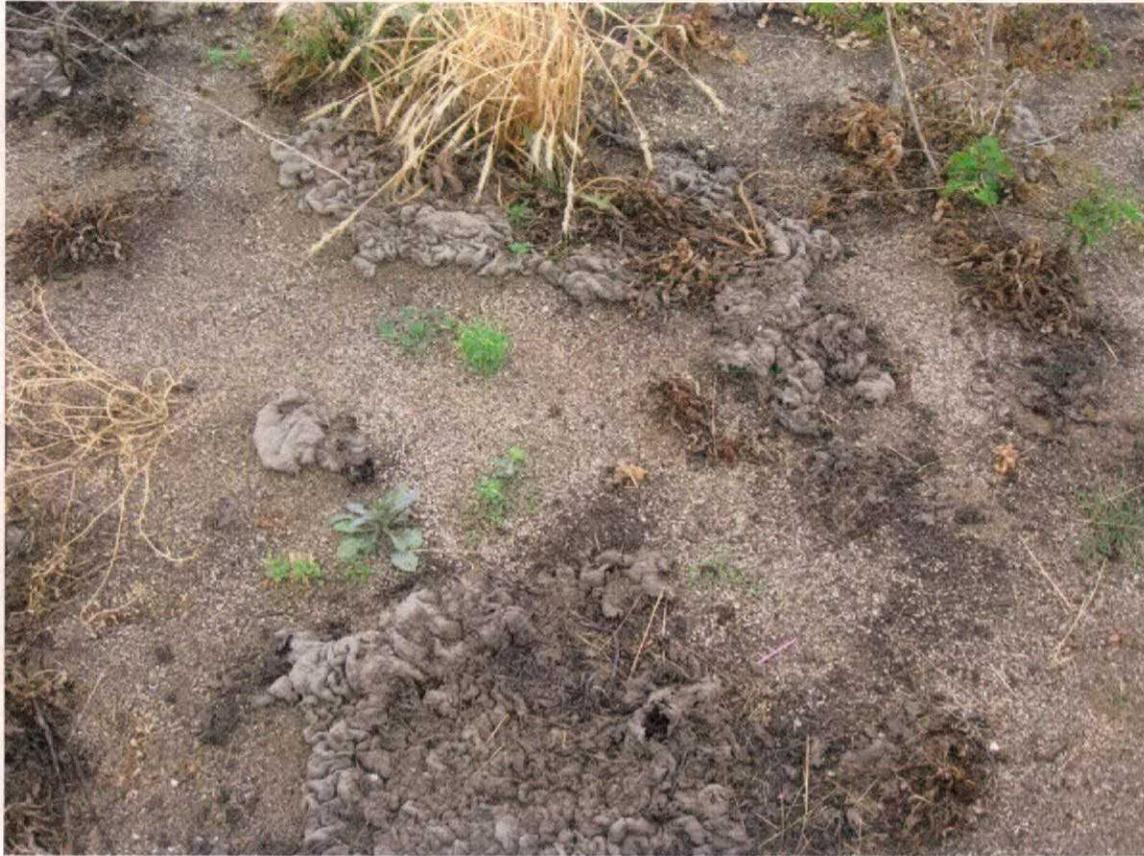
Fostoria Mobile Estates MHP, Seneca Co.  
Solids on northeast sand filters  
taken by M.B.Cohen, 06/10/09

14. The aeration tanks were operational and appeared to be receiving adequate aeration at the time of the inspection.
15. The east side of the clarifier was observed to still have a very thick layer of floating solids covering the surface of the tank. The skimmer was not operational.
16. The west half of the clarifier tank was observed to still have bulking sludge near the effluent discharge weir. The skimmer was in operation.
17. The two (2) sludge returns were operating, both observed to have a very low solids content.
18. The surface sand filter distribution box has been replaced, but was leaking where the pipes entered the box from the pump station. This needs to be repaired.
19. The sand filter beds (4) were observed to have an accumulation of old solids and weed growth. The filter beds need to be cleaned and sand surface leveled.

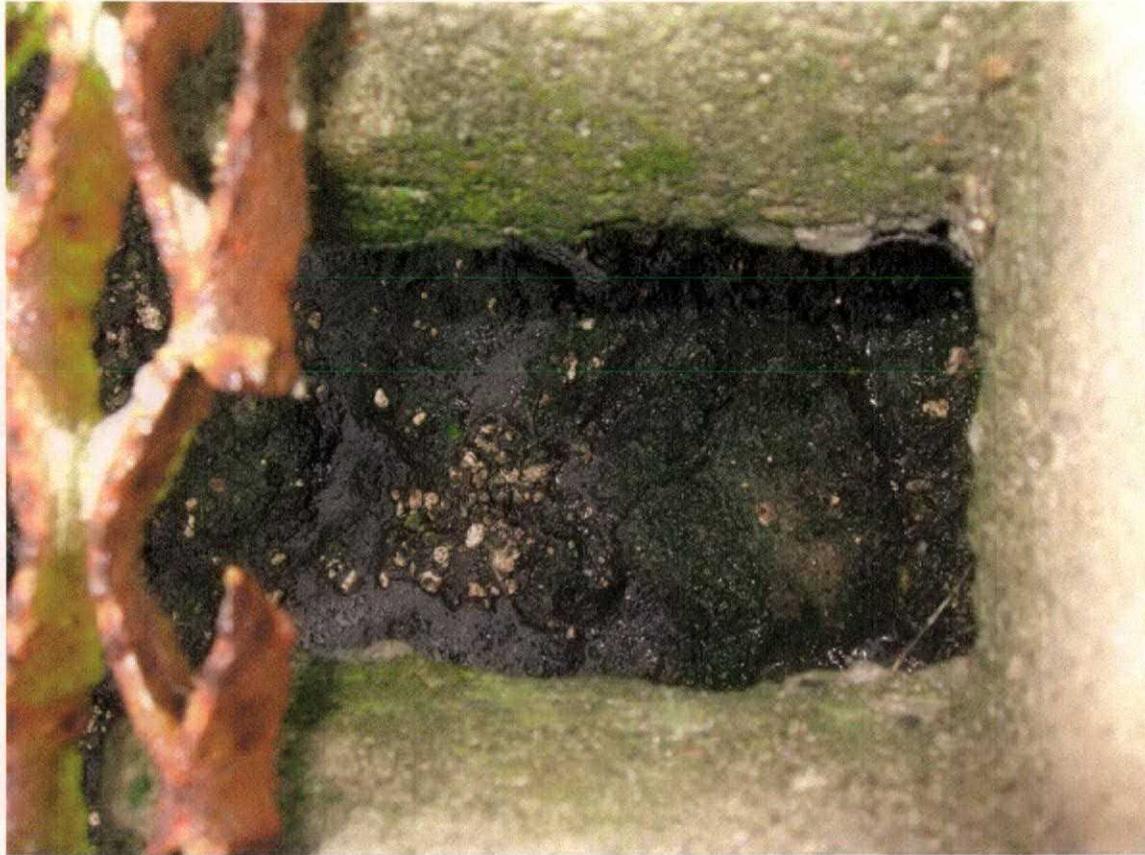
Fostoria Mobile Estates MHP, Seneca Co.  
Bulking solids in clarifier tank  
taken by M.B.Cohen, 06/10/09

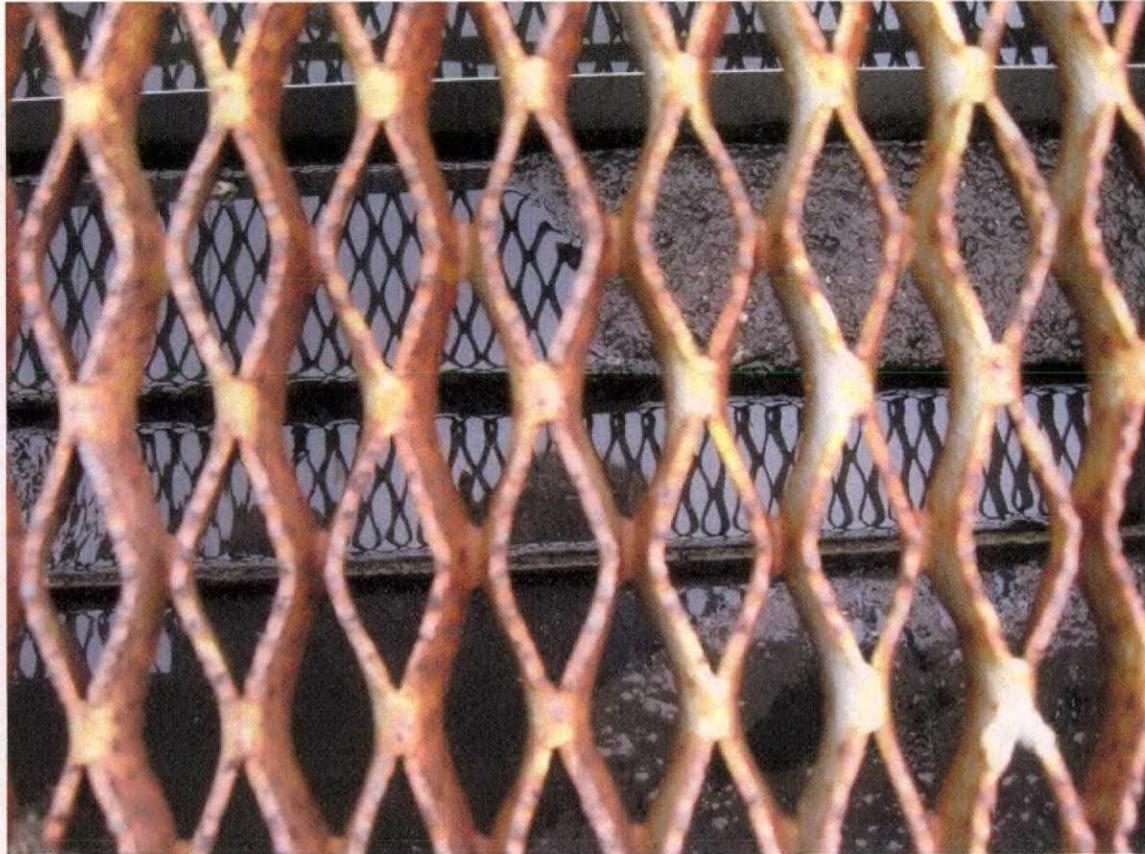
Fostoria Mobile Estates MHP, Seneca Co.  
Bulking sludge in clarifier tank / effluent weir  
taken by M.B.Cohen, 06/10/09

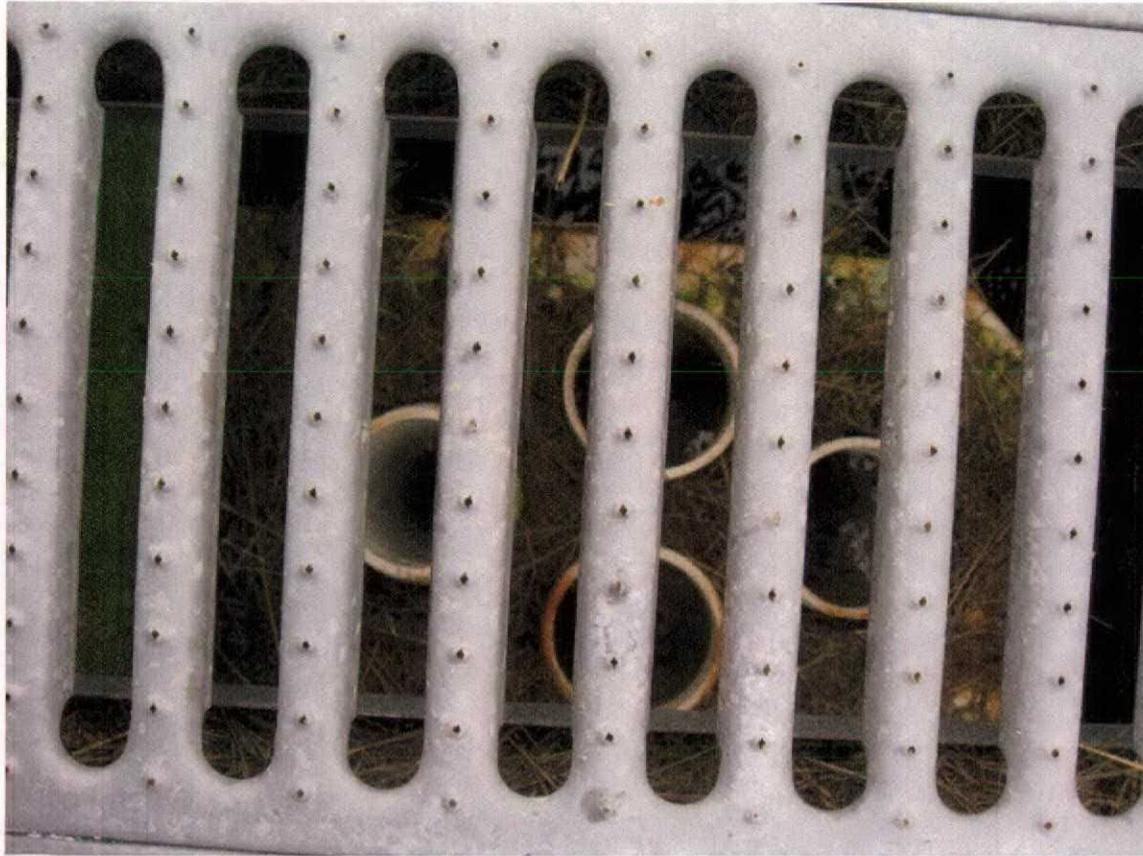
20. No chlorine was provided. Chlorination/disinfection must be provided from May through October.
21. Pictures taken during the June 10, 2009, inspection are enclosed.

Fostoria Mobile Estates MHP, Seneca Co.  
Chlorine tank – No chlorine provided.  
taken by M.B.Cohen, 06/10/09

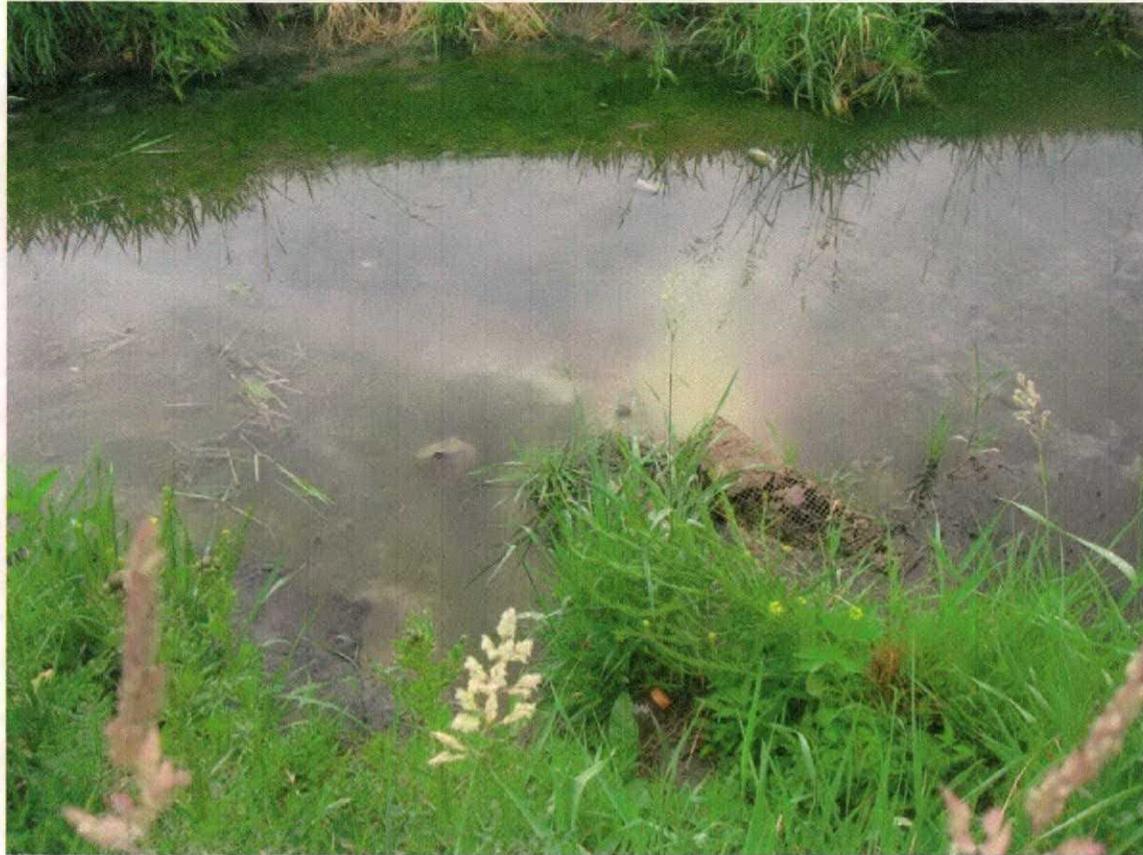
Fostoria Mobile Estates MHP, Seneca Co.  
Looking north/northeast at treatment plant discharge into ditch  
taken by M.B.Cohen, 06/10/09

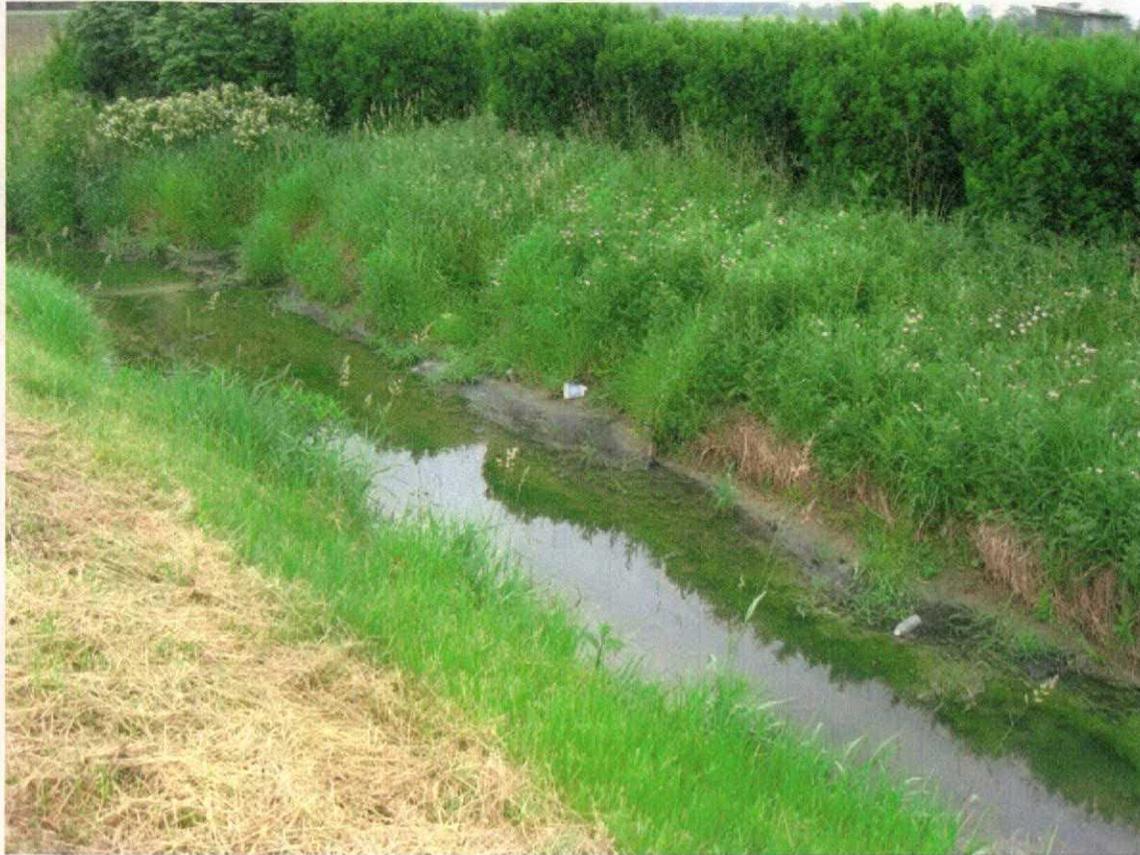
Looking southeast towards plant discharge – solids and algae growth along ditch

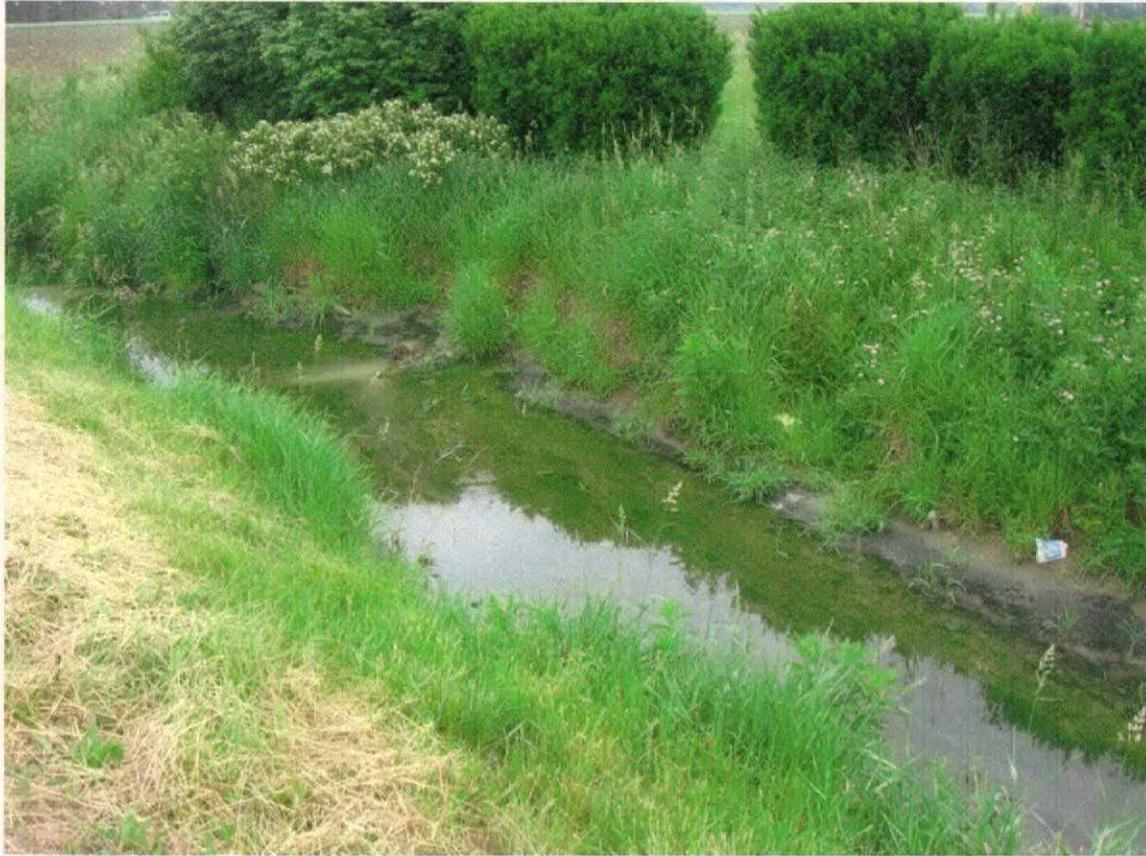
Looking southeast towards plant discharge – solids and algae growth along ditch  
taken by M.B.Cohen, 06/10/09

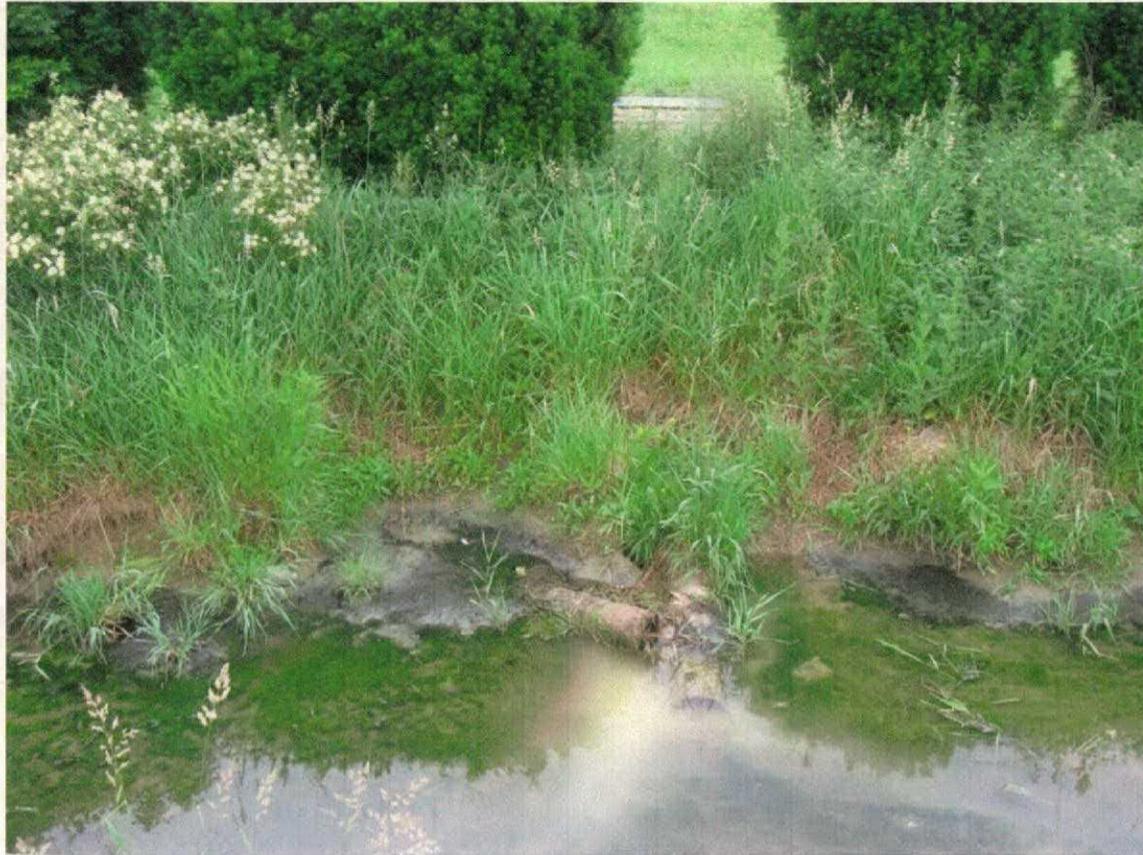
Fostoria Mobile Estates MHP, Seneca Co.  
Looking south at plant discharge – solids and algae growth along ditch  
taken by M.B.Cohen, 06/10/09

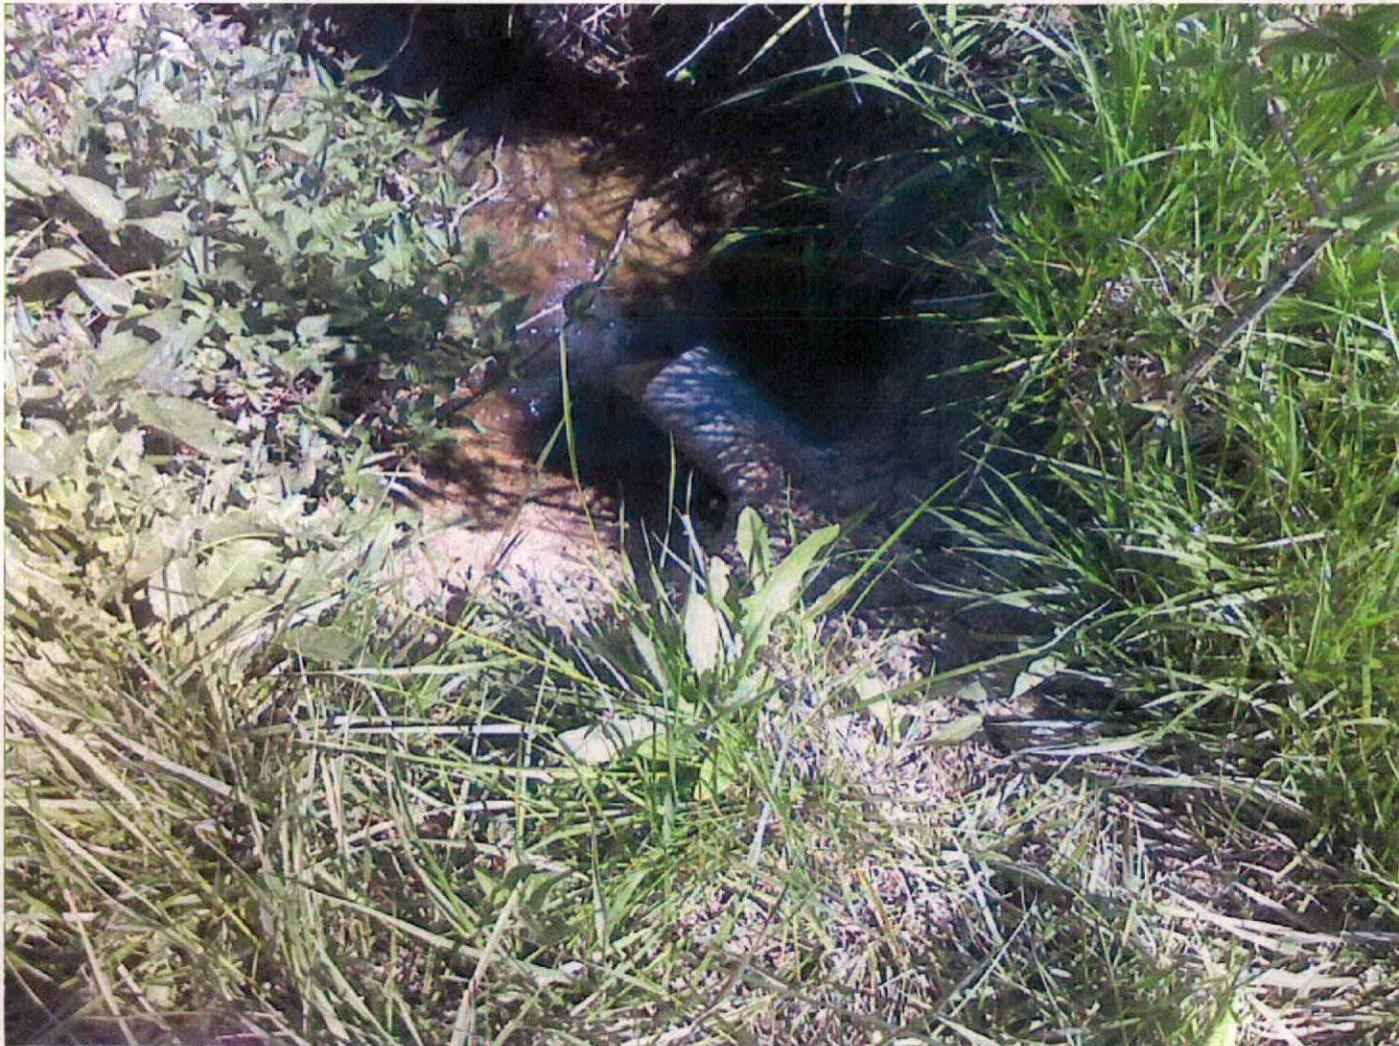
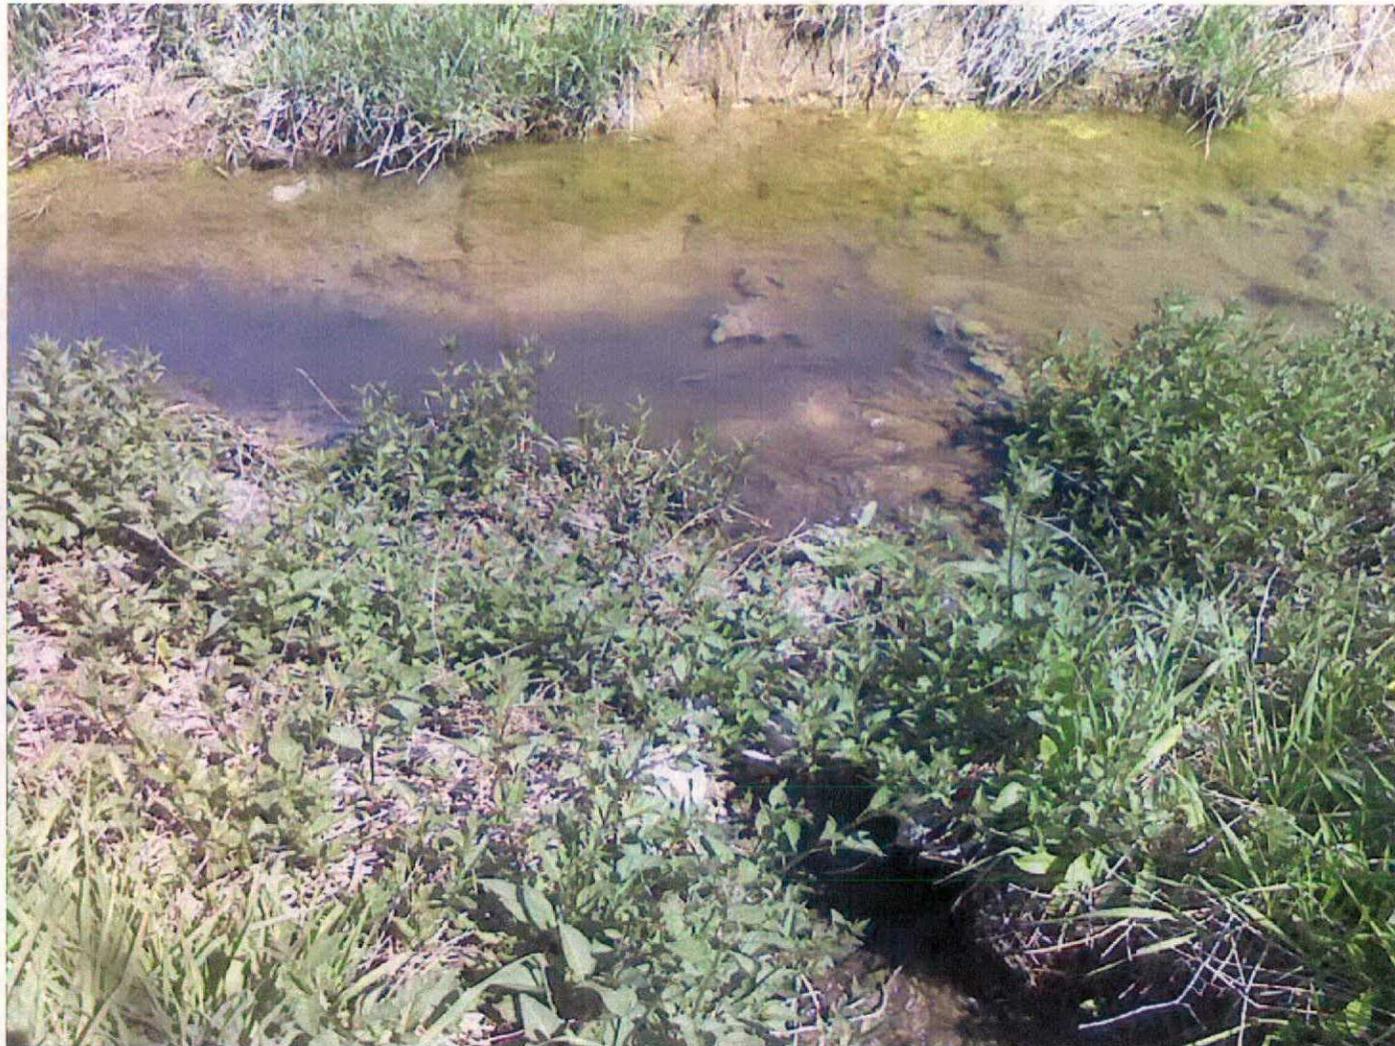
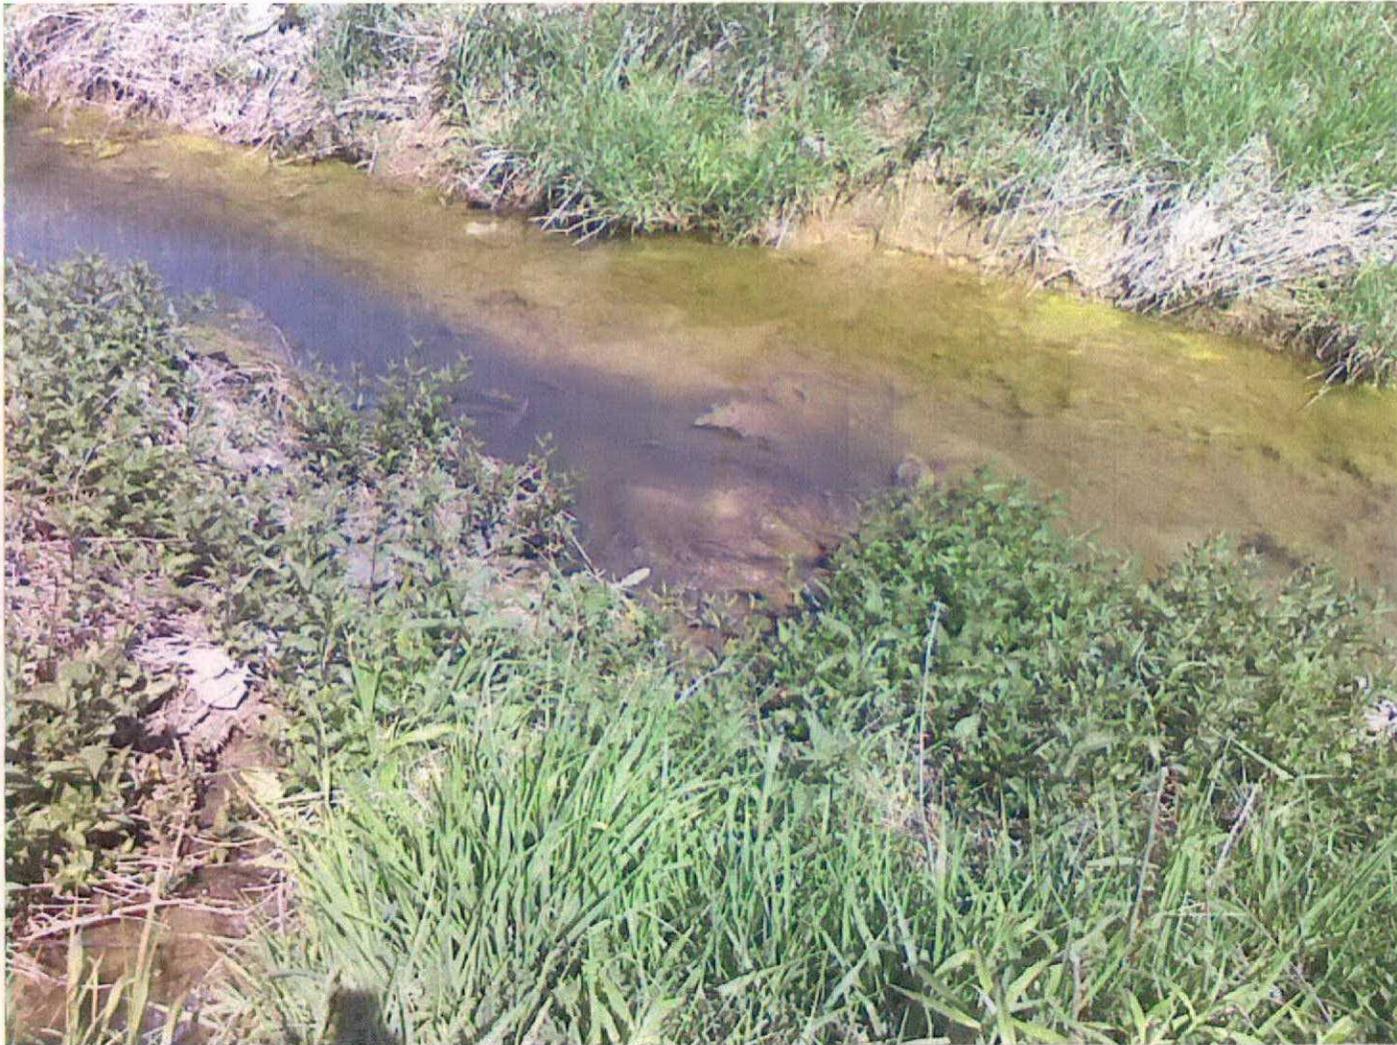
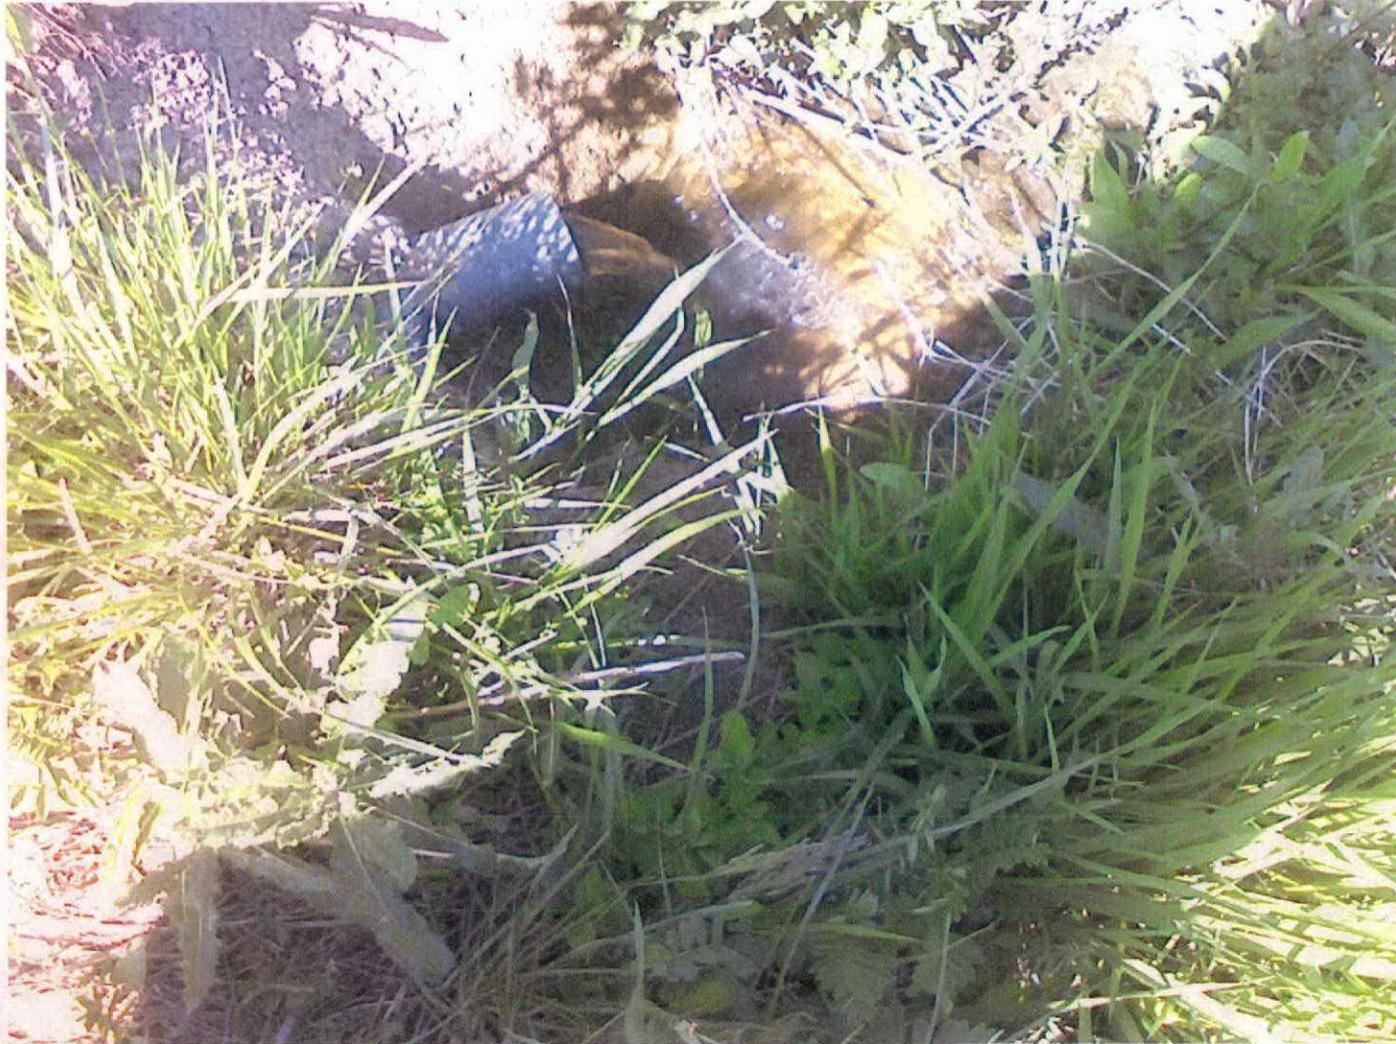
8. The effluent from the clarifier discharge had a turbid grey color, with visible solids carry over at the time of the inspection.
9. The partially treated wastewater was observed to be flowing out of the lift station tank through a bypass pipe outlet on the east side of the tank. This pipe was observed discharging to the ditch located just east of the WWTP. The grey septic wastewater was observed in the ditch.

Fostoria Mobile Estates MHP, Seneca Co.  
Bypass discharge from sand filter dosing lift station into ditch east side of plant  
taken by M.B.Cohen, 5/12/09

Fostoria Mobile Estates MHP, Seneca Co.  
Bypass from sand filter dosing lift station – discharging into ditch east side of plant  
taken by M.B.Cohen, 5/12/09

10. The bypass and/or overflow pipes located within the sand filter dosing lift station must be physically eliminated at this time. As indicated in our previous letter (dated September 16, 2008 ), documentation of the elimination of this bypass line is to be submitted to this office. Please provide documentation of the elimination as soon as possible, but no later than July 30, 2009.

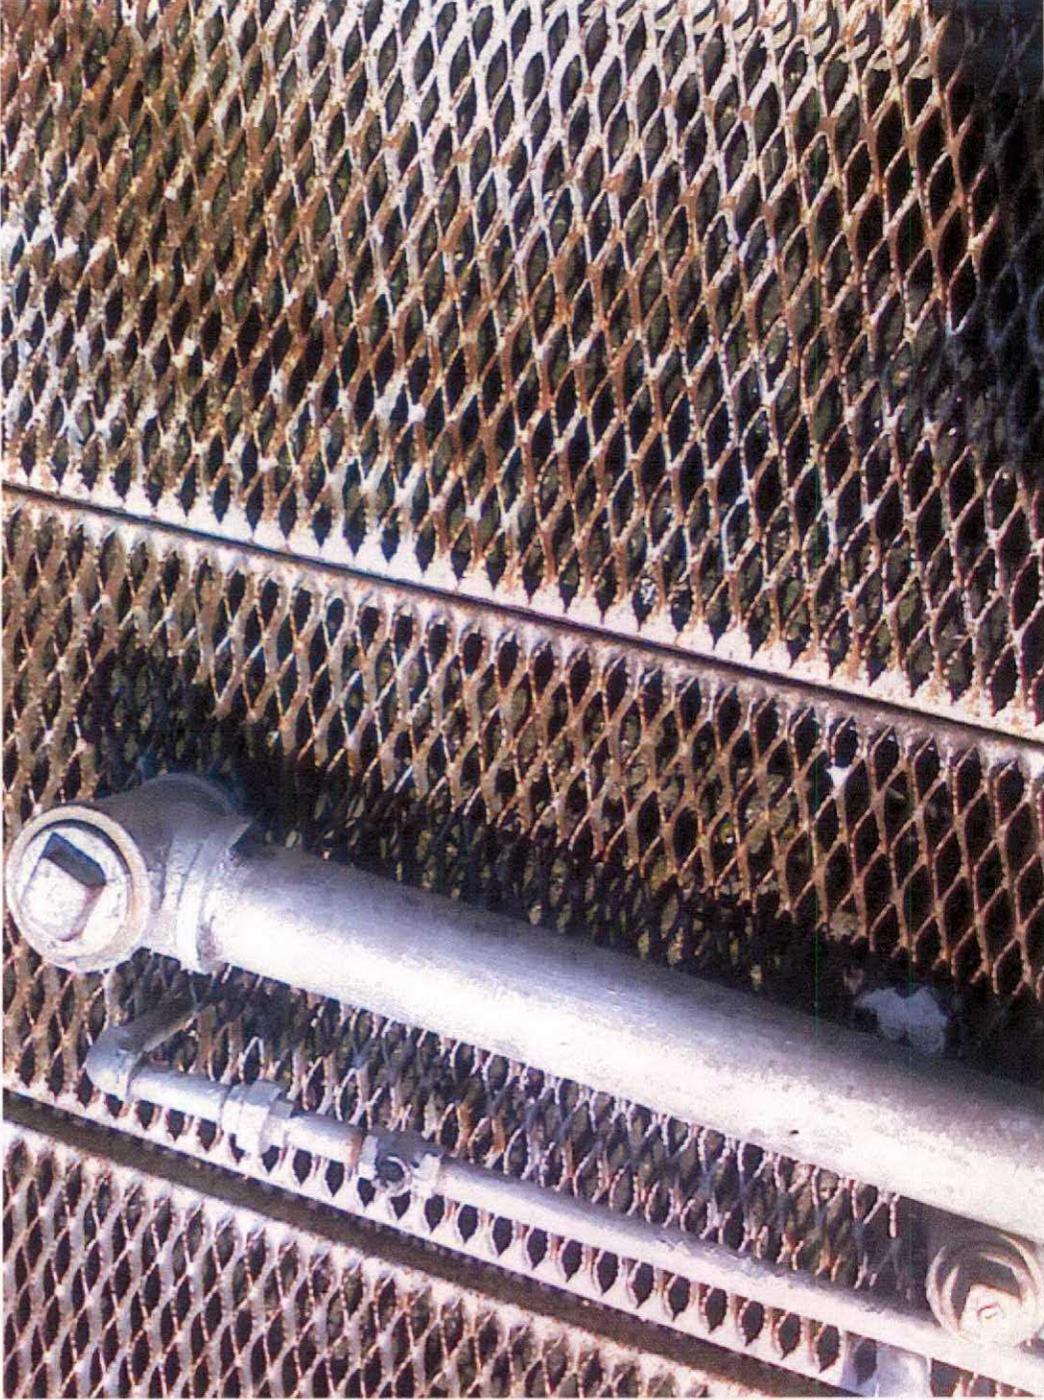
Fostoria Mobile Estates MHP, Seneca Co.  
Clarifier

4. The two (2) sludge returns were operating. The return liquid had a very low solids content.
5. The east side of the clarifier was observed to have a very thick layer of floating solids covering the surface of the tank.

6. The west half of the clarifier tank was observed to have bulking sludge near the effluent discharge weir.
7. The clarifier hopper walls need to be scraped down once per day to increase the solids returned and prevent sludge from bulking and floating to the surface of the tank.

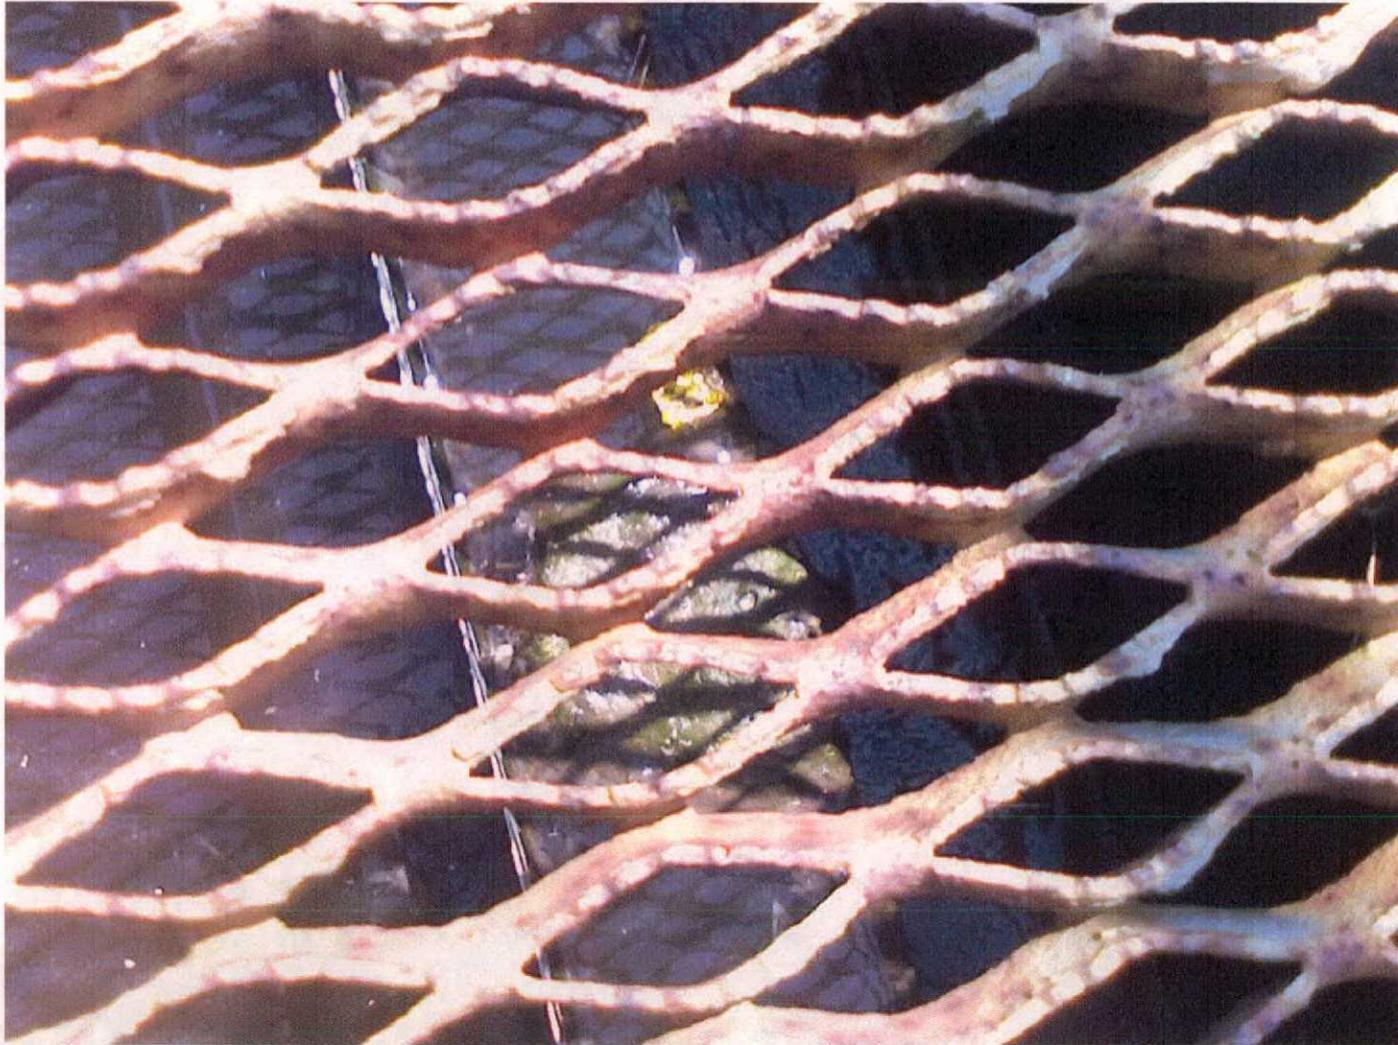
Fostoria Mobile Estates MHP, Seneca Co.  
Bulking sludge in clarifier tank / effluent weir  
taken by M.B.Cohen, 5/12/09

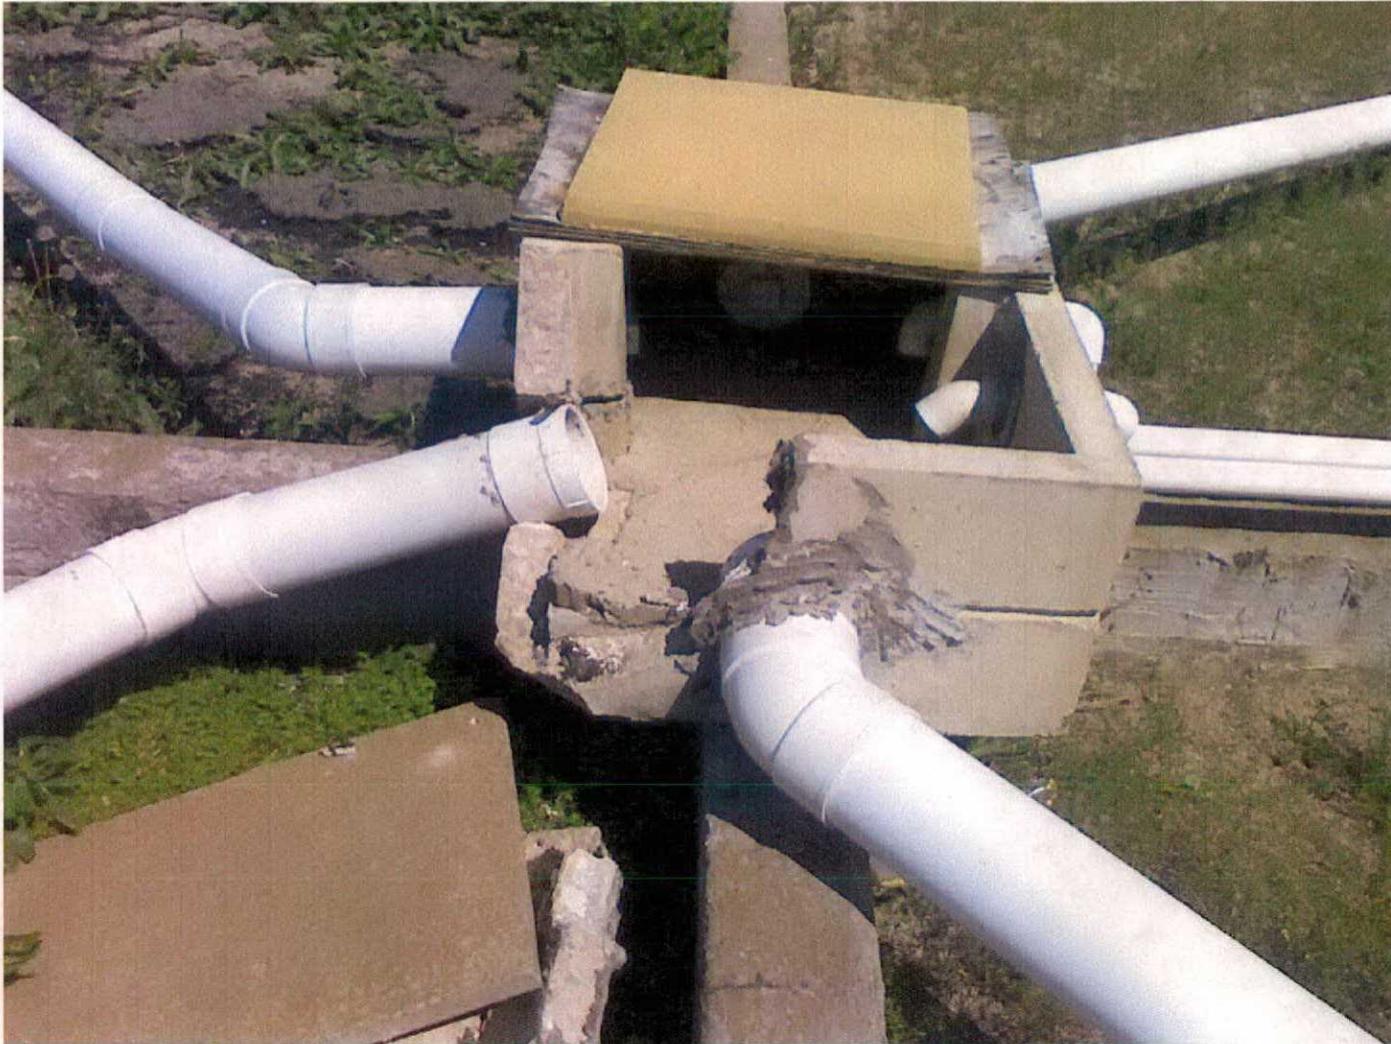
11. The surface sand filter distribution box has fallen apart. Mr. Stahl indicated that Mack, Inc., had been contacted and were scheduled to replace the distribution box the next day.

Fostoria Mobile Estates MHP, Seneca Co.  
Sand filter distribution box in need of repair  
taken by M.B.Cohen, 5/12/09
