State of Ohio Environmental Protection Agency

Re: Seneca County  
Fostoria Mobile Estates  
Sewerage

July 13, 2009

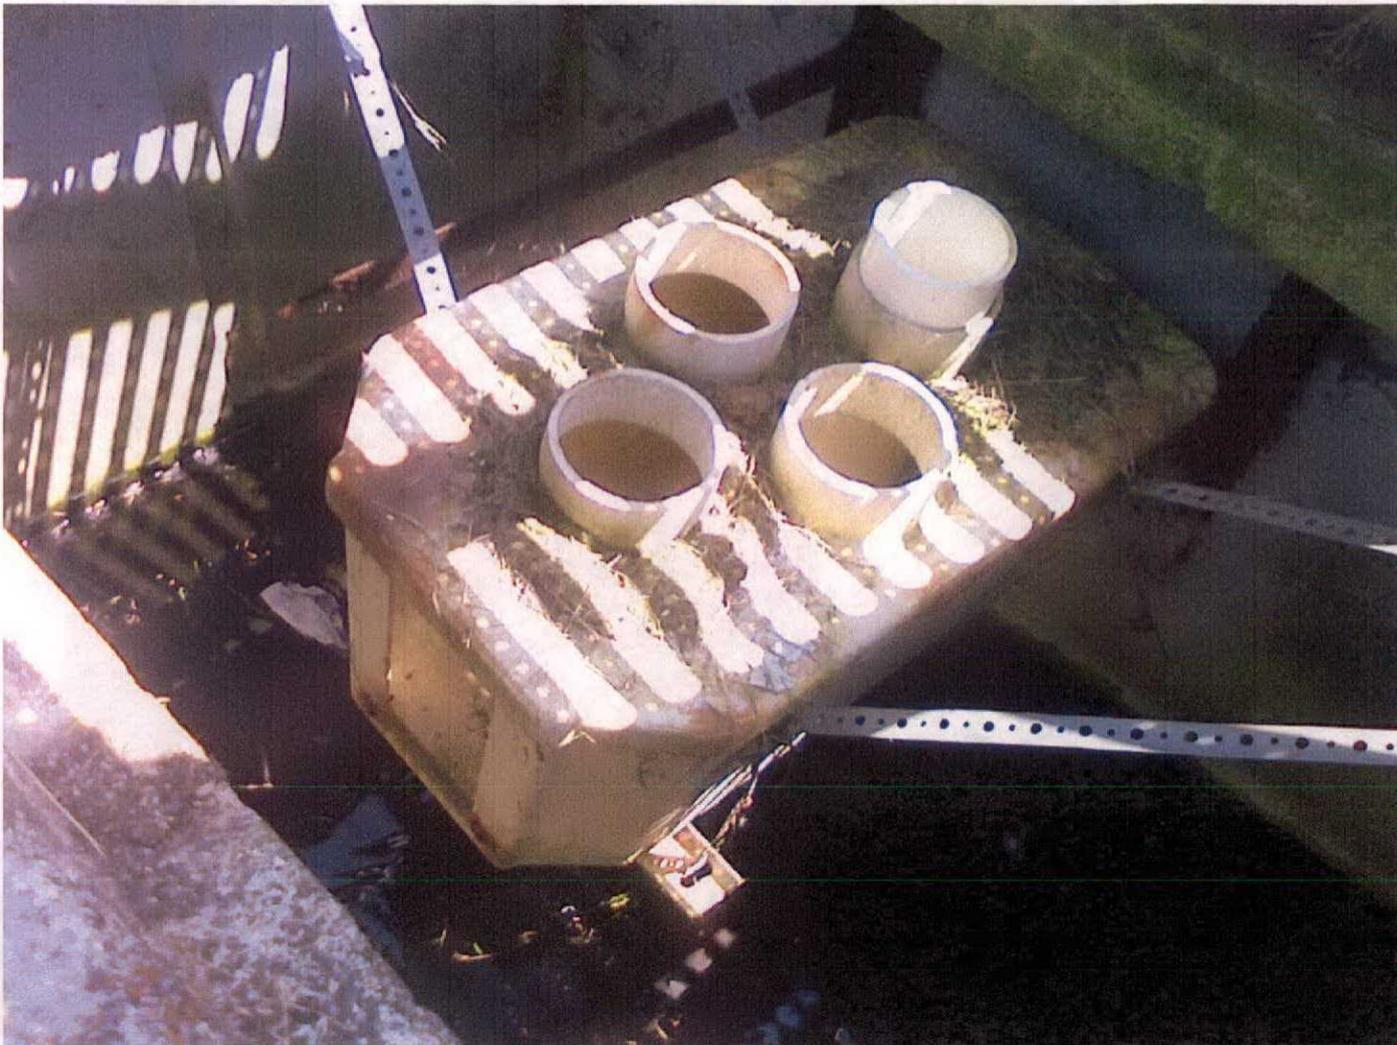
12. No disinfection was being provided as the surface sand filters and chlorine contact tank were being bypassed and the chlorination unit was dry.
13. Pictures taken during the May 12, 2009, inspection are enclosed.

Fostoria Mobile Estates MHP, Seneca Co.  
Chlorine tank and chlination unit – not in use due to bypass  
taken by M.B.Cohen, 5/12/09

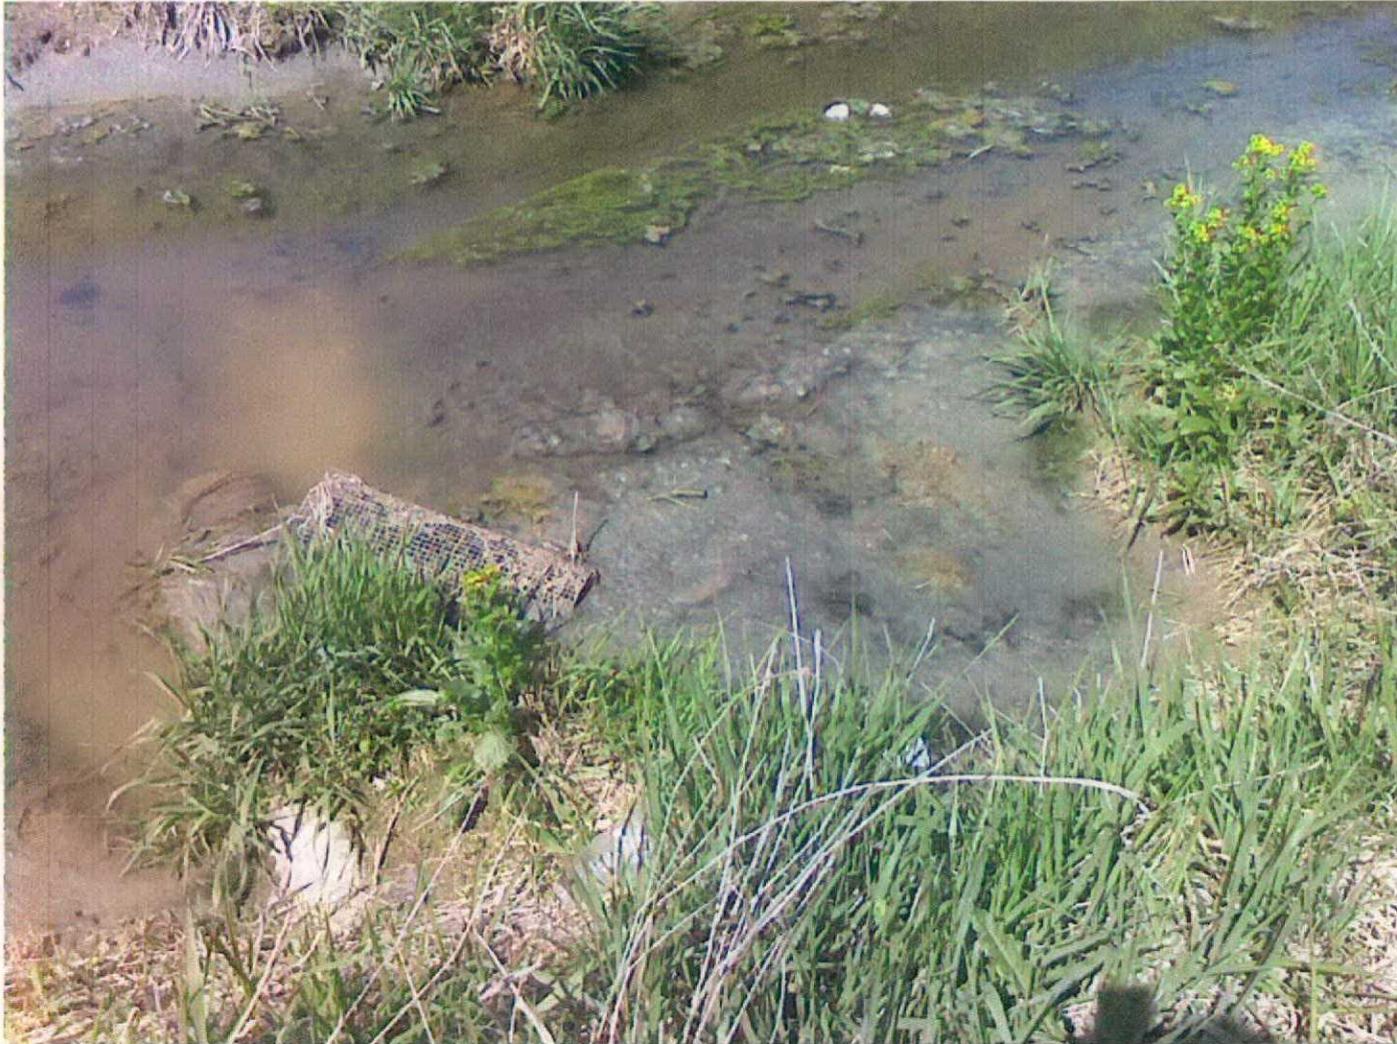
Fostoria Mobile Estates MHP, Seneca Co.  
Ditch north of chlorine contact tank – downstream of plants bypassed discharge  
taken by M.B.Cohen, 5/12/09
