Re: Seneca County
Fostoria Mobile Estates
Sewerage

June 23, 2010

On May 25, 2010, an inspection was made at the wastewater treatment plant (WWTP) serving Fostoria Mobile Estates. Observations and recommendations noted during the inspection are as follows:

Fostoria Mobile Estates MHP, Seneca Co.

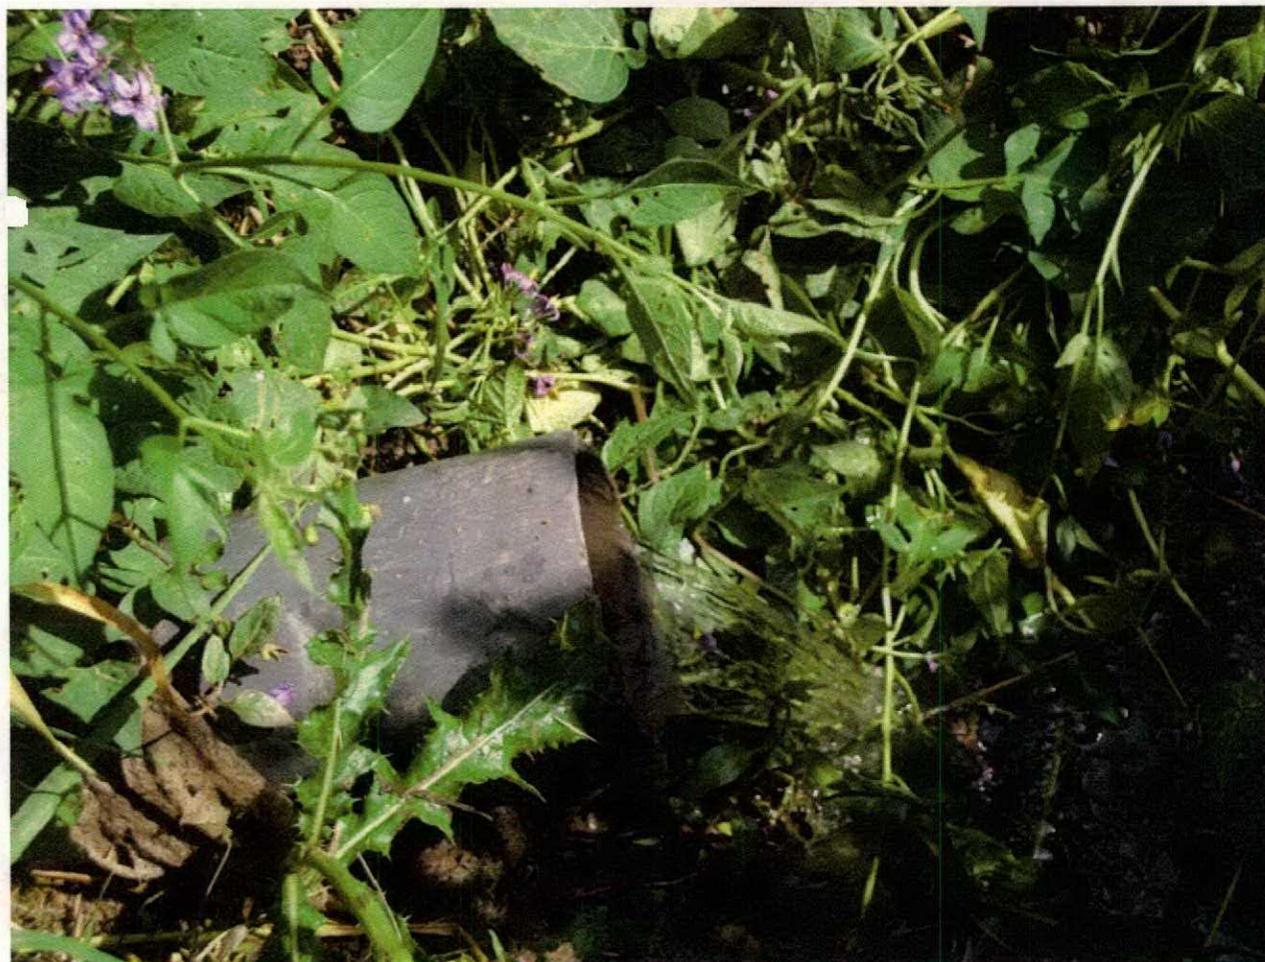
5. The clarifier effluent was discharging to the lift station (dosing tank). The lift station pumps were not in use (turned off) and the partially treated wastewater was observed discharging through a bypass pipe on the east side of the tank. Dye placed into the lift station tank was observed discharging immediately, at the ditch to the east of the WWTP

Dosing tank bypass pipe discharging into ditch on the east side of the WWTP

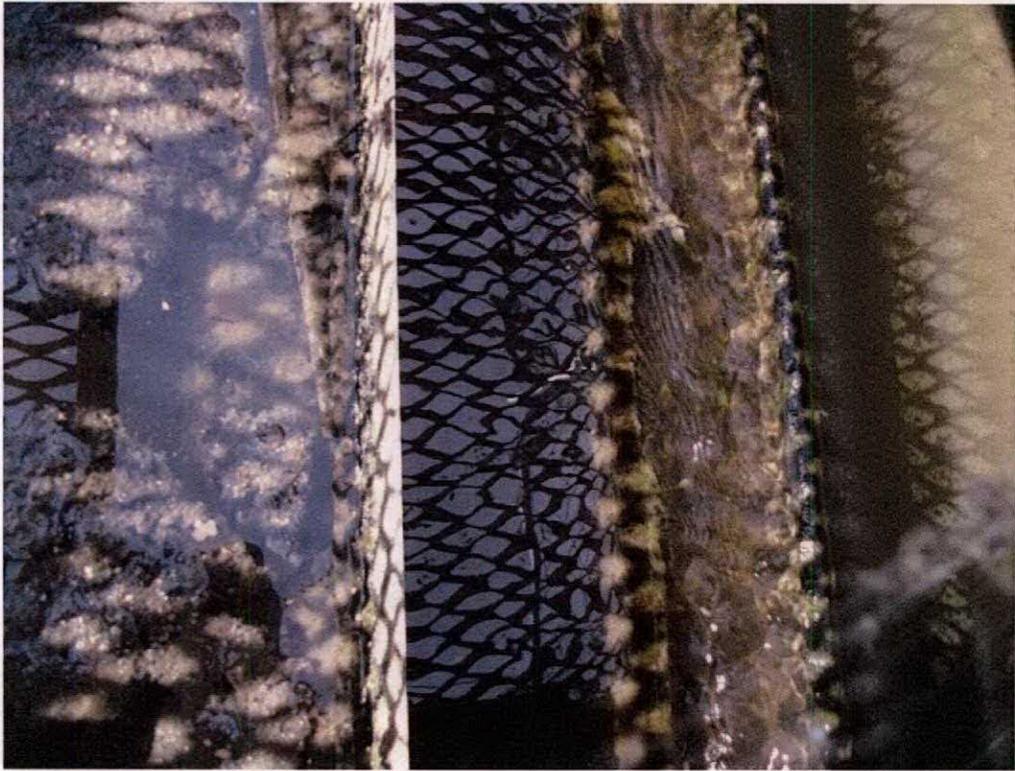
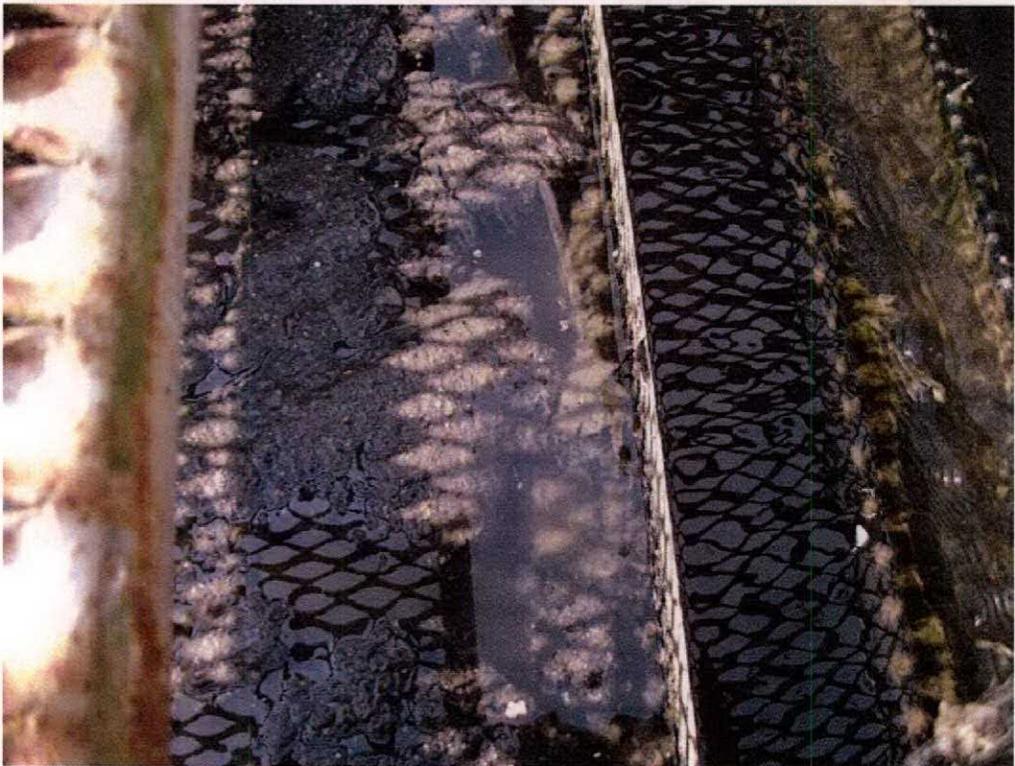
3. Bulking sludge and floating solids near the effluent discharge weir were observed in the west half of the clarifier tank.
4. The two (2) sludge returns were operating, but the contents being returned were clear with little to no solids.

Bulking sludge in clarifier tank / effluent weir

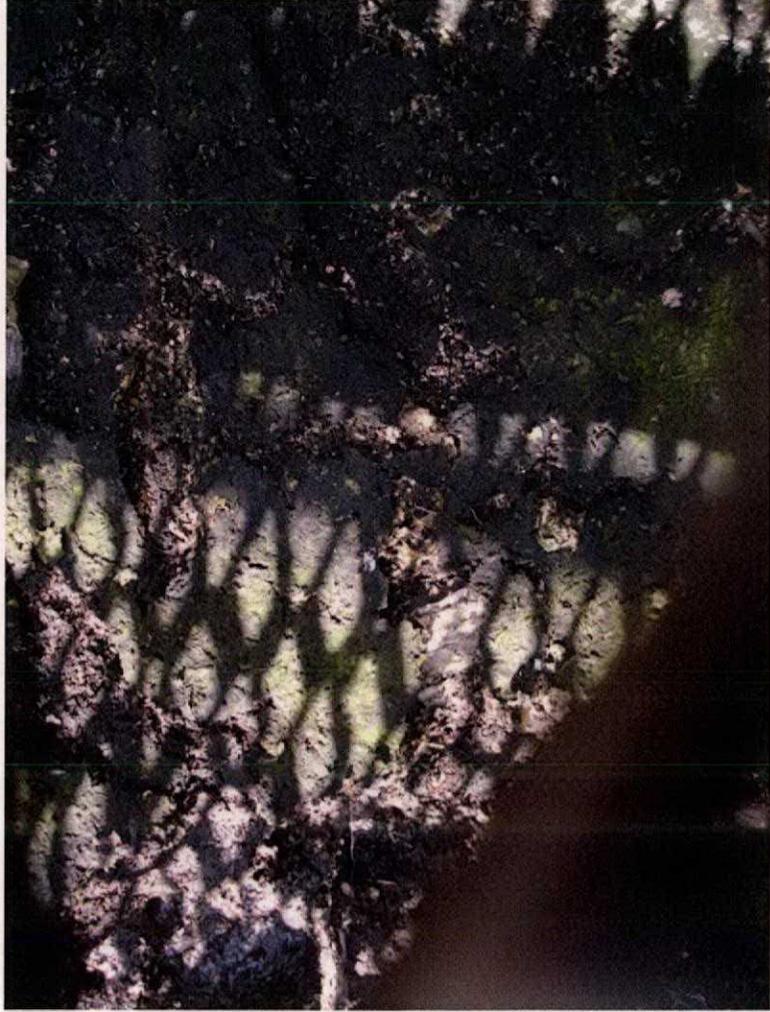
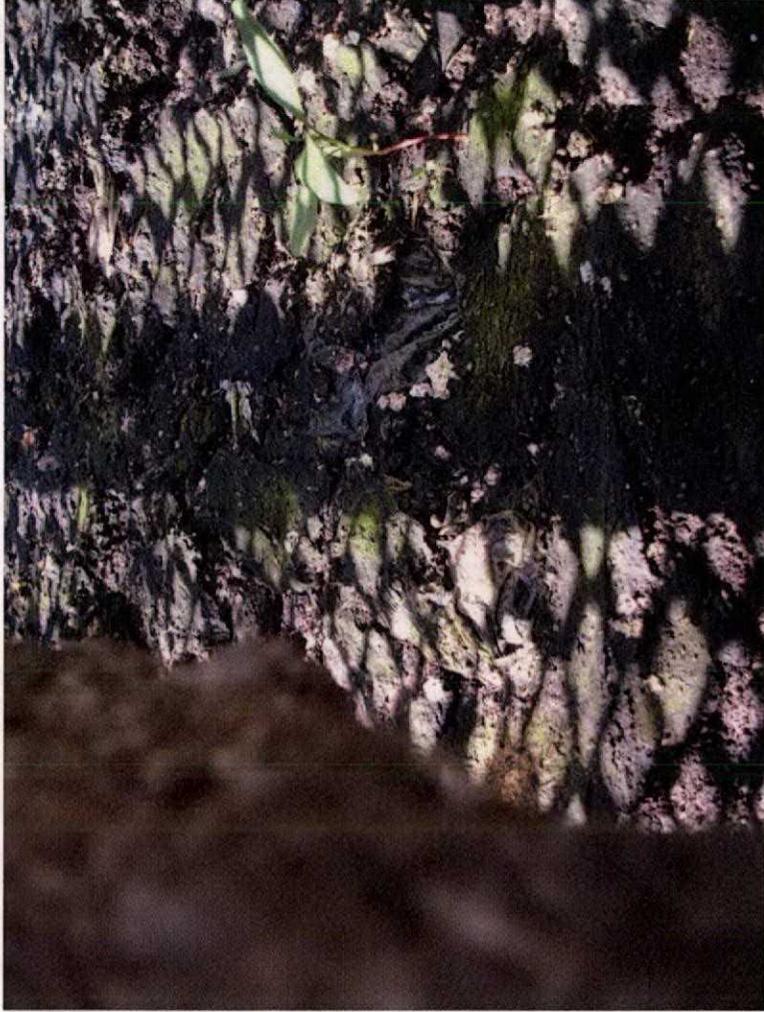
Bulking sludge in clarifier tank

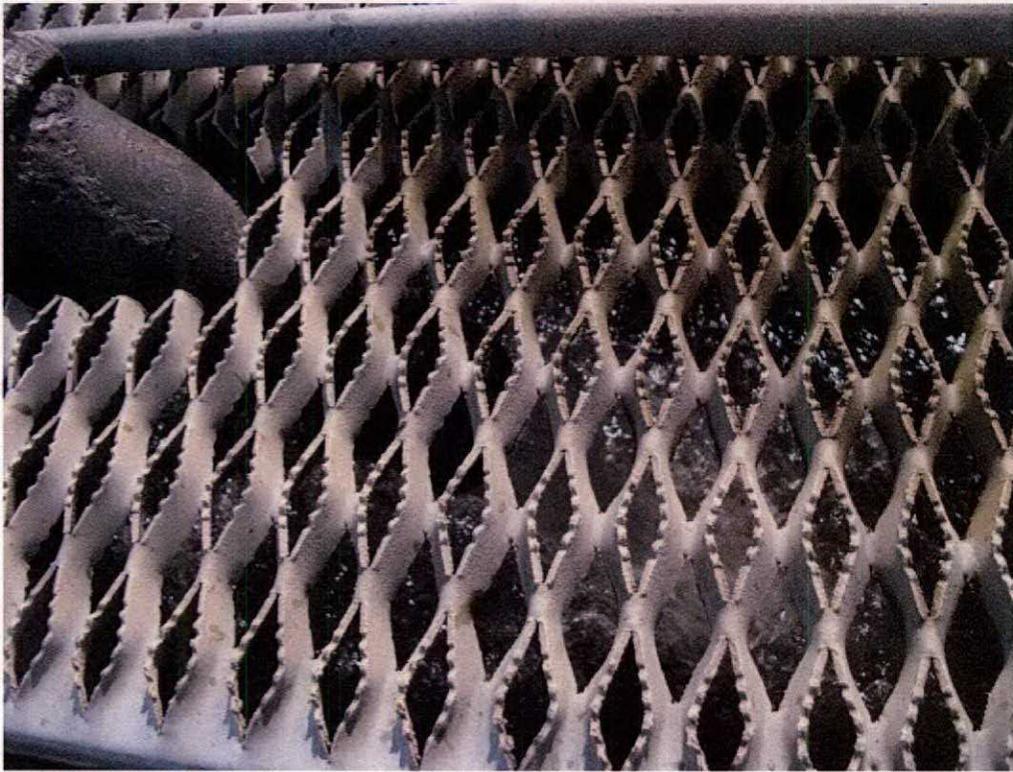
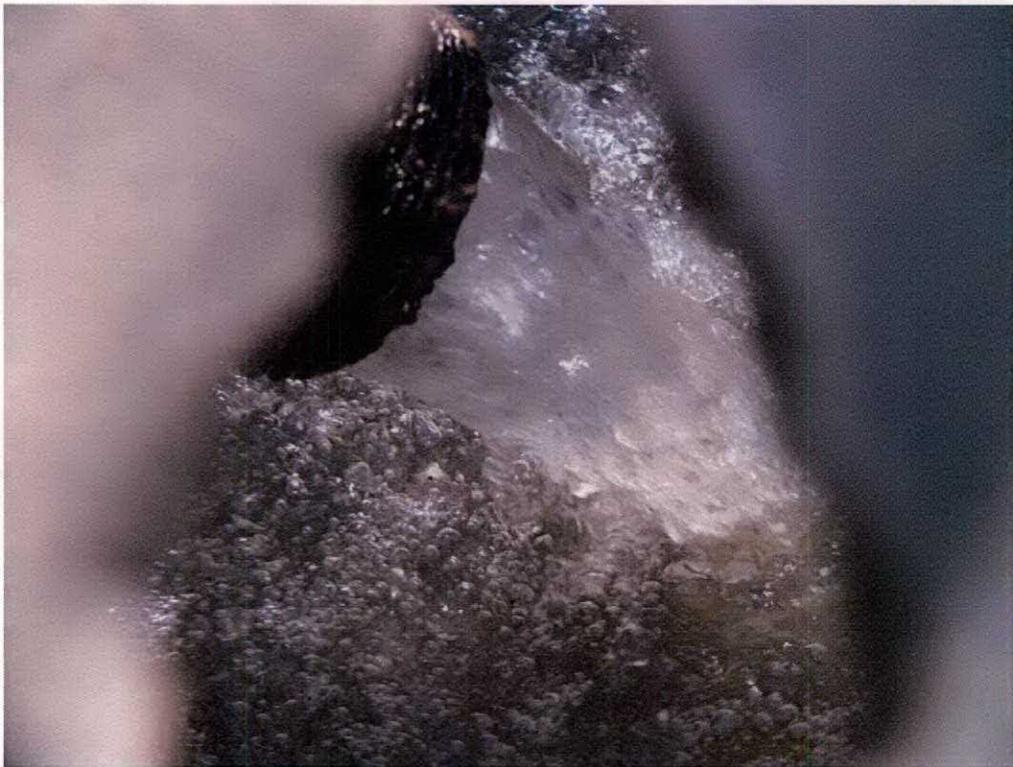
1. Aeration was being provided to the contents of the aeration tanks at the time of the inspection.
2. A thick layer of solids was covering the surface of the east side of the clarifier tank.

Sludge return from clarifier into aeration tank (running clear)

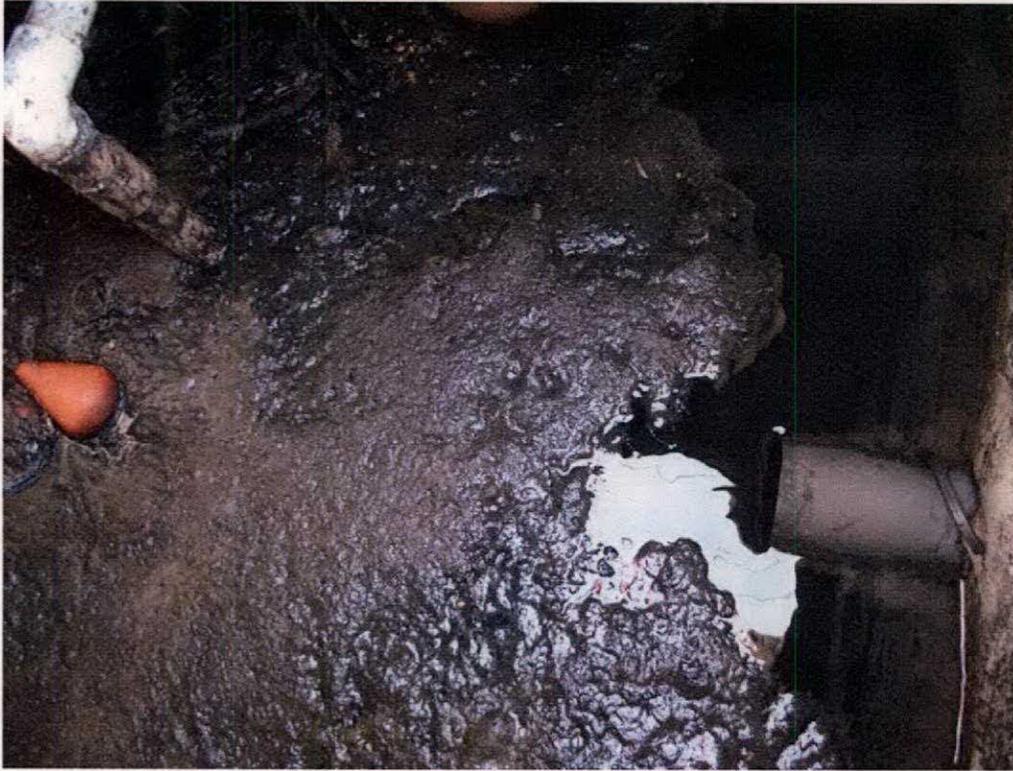
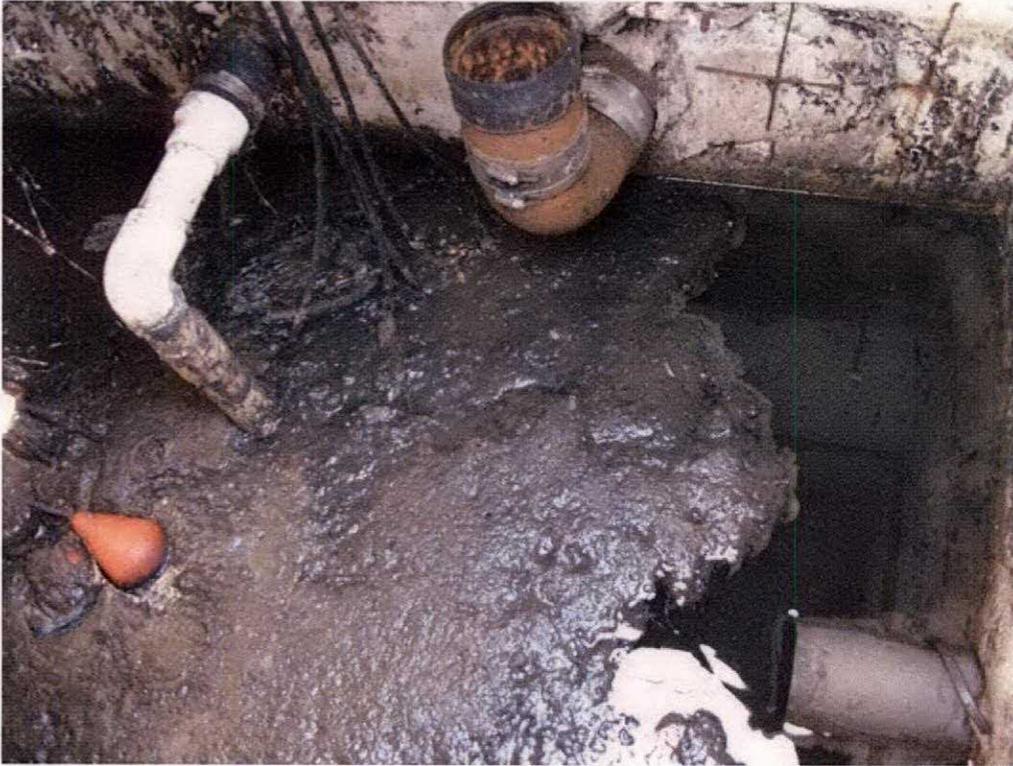
Dosing tank bypass pipe (on right) discharging into ditch on the east side of the WWTP

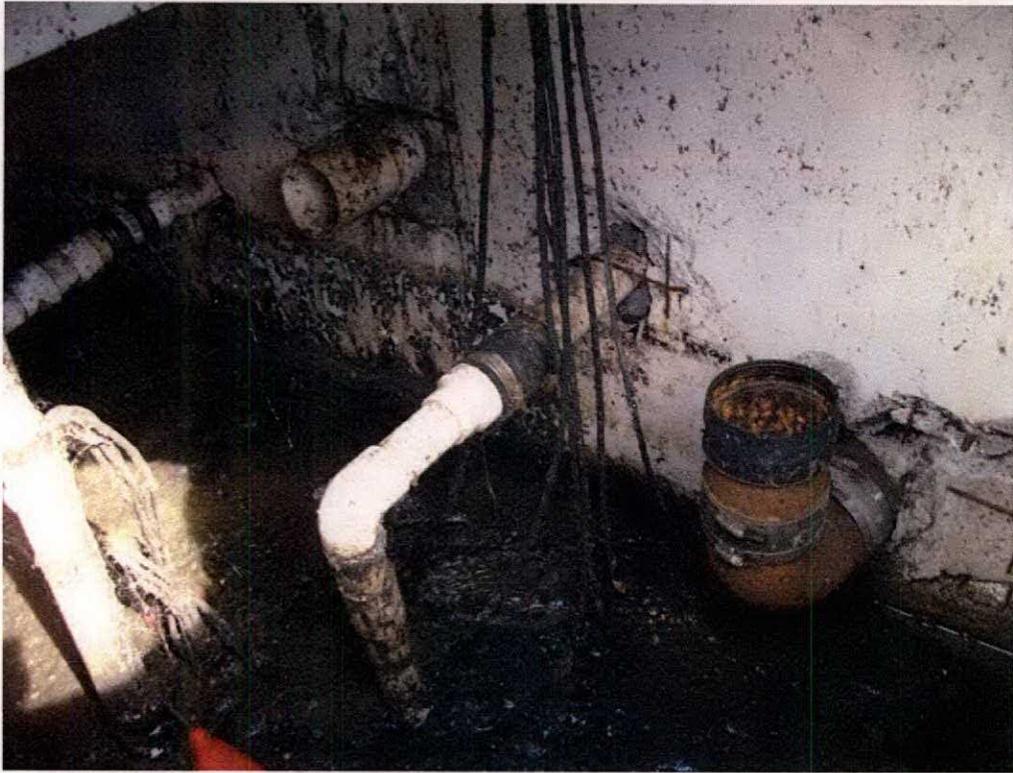
Dosing tank pipes and bypass pipes on north side of tank

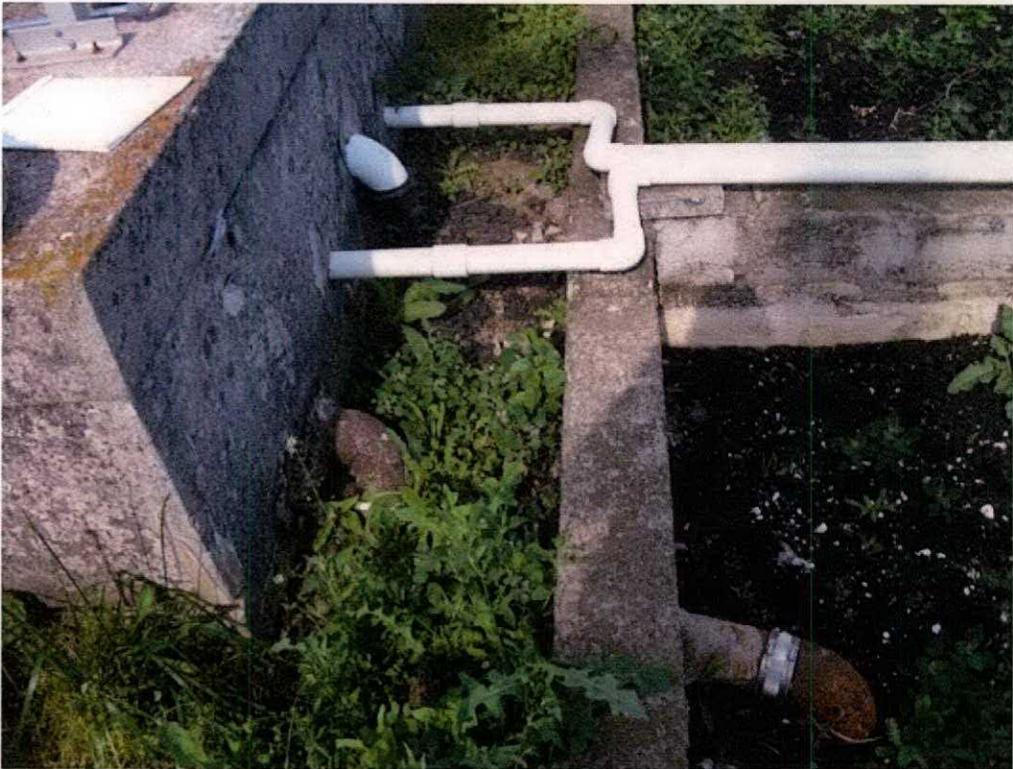
Outlets of (north) dosing tank and bypass pipes between tank and sand filters

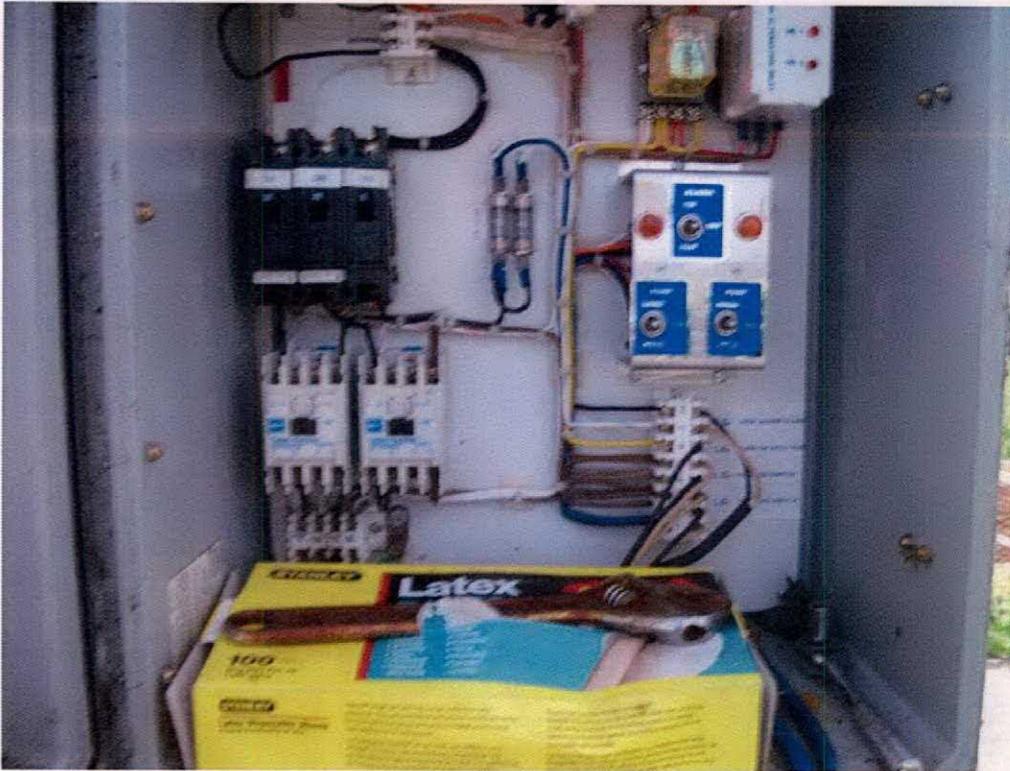
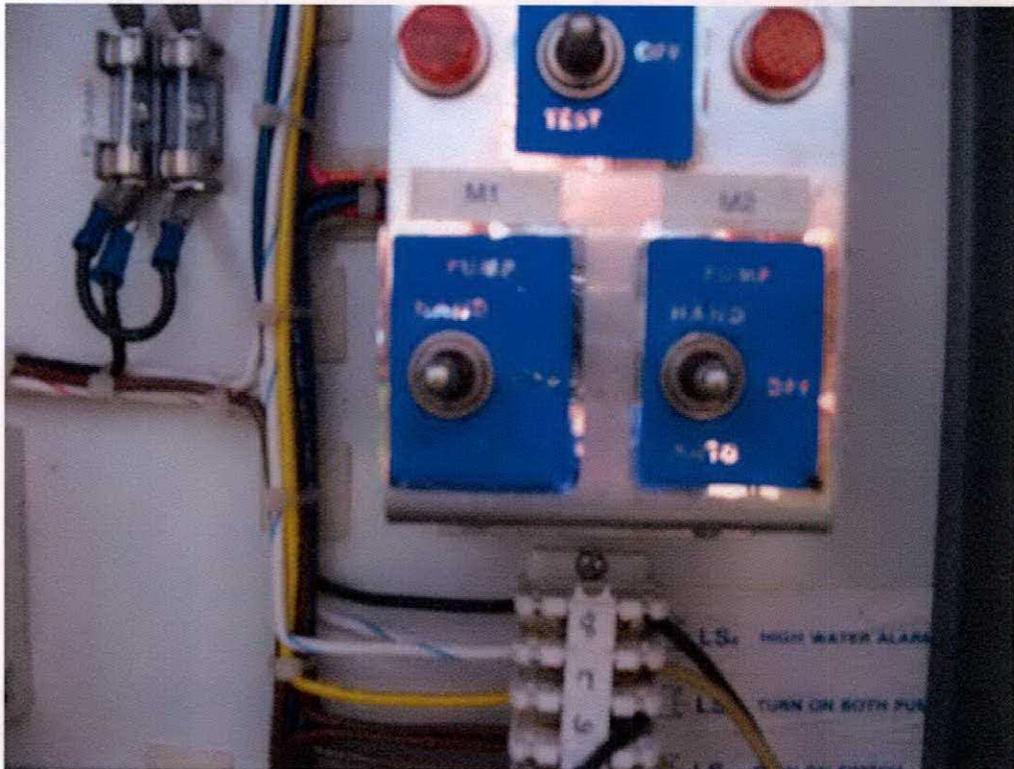
Sand filter dosing tank lift station control panel (pumps off)

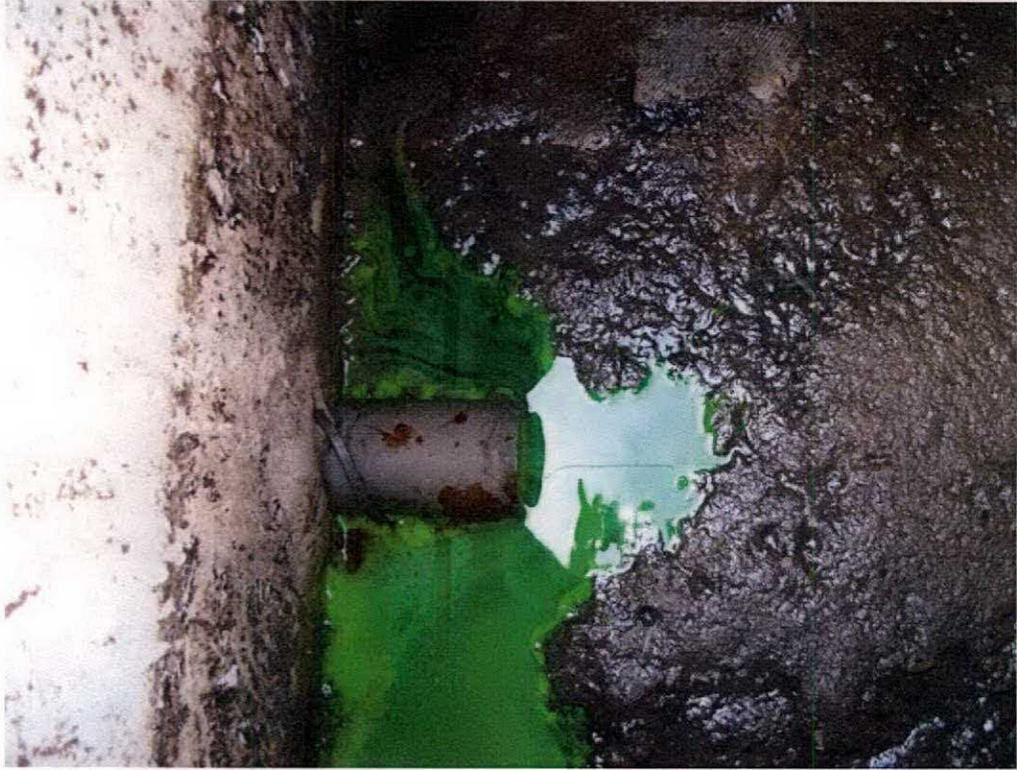
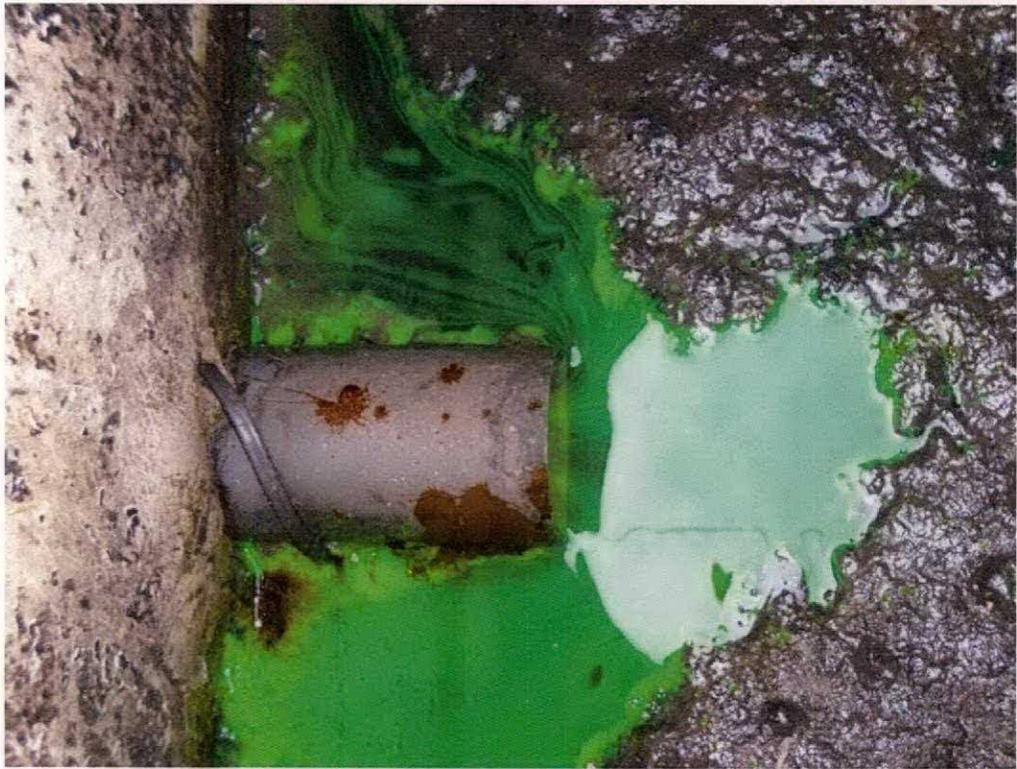
Dye in dosing tank discharging through bypass pipe (east to ditch)

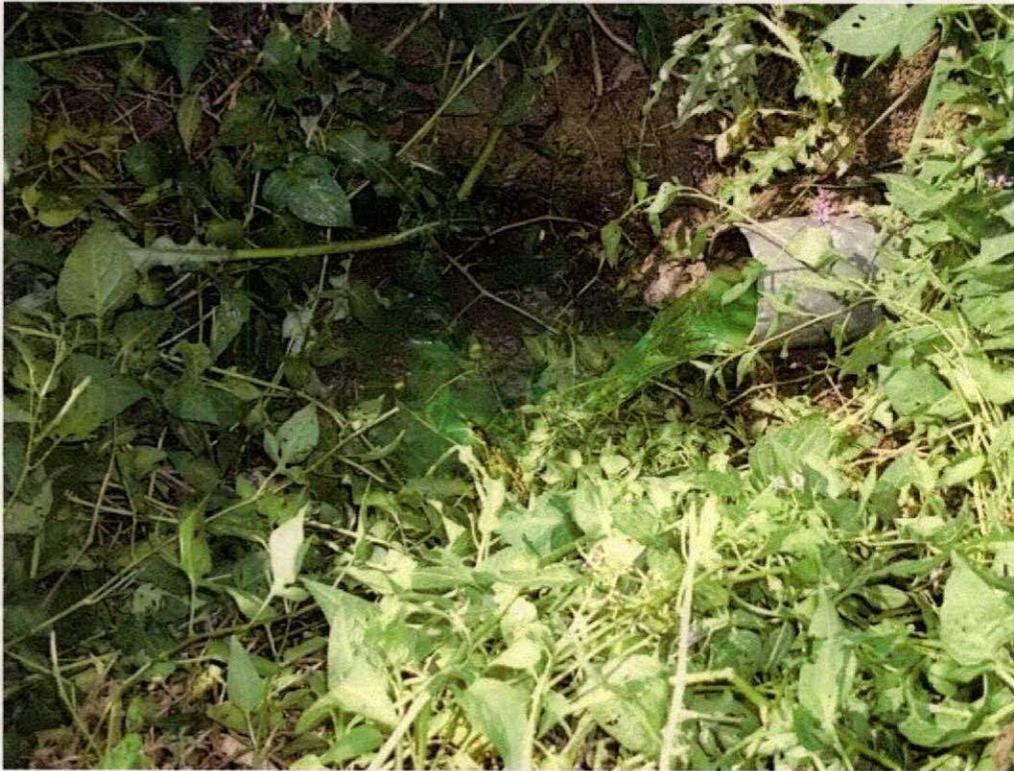
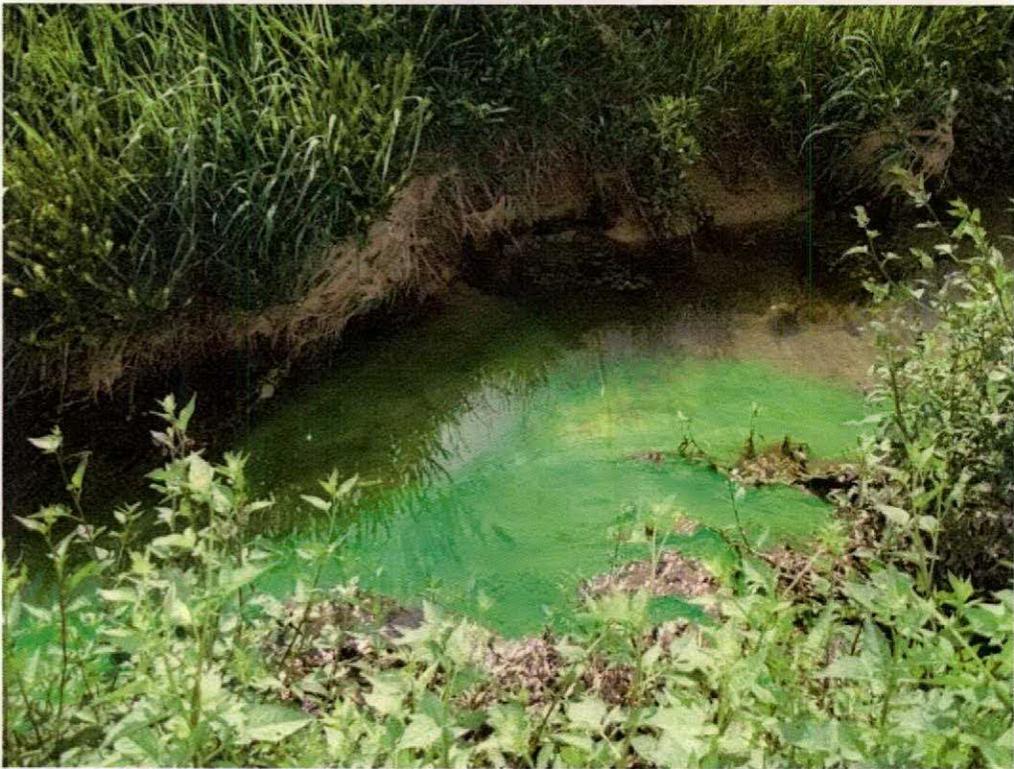
Dye from dosing tank discharging east into the ditch

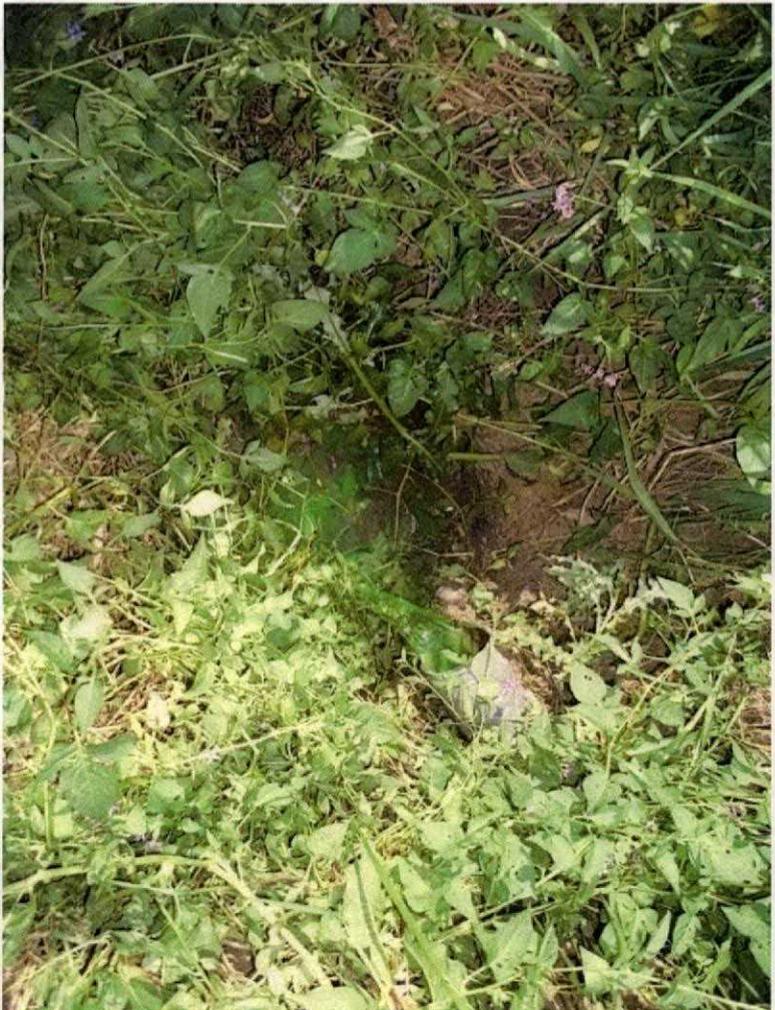
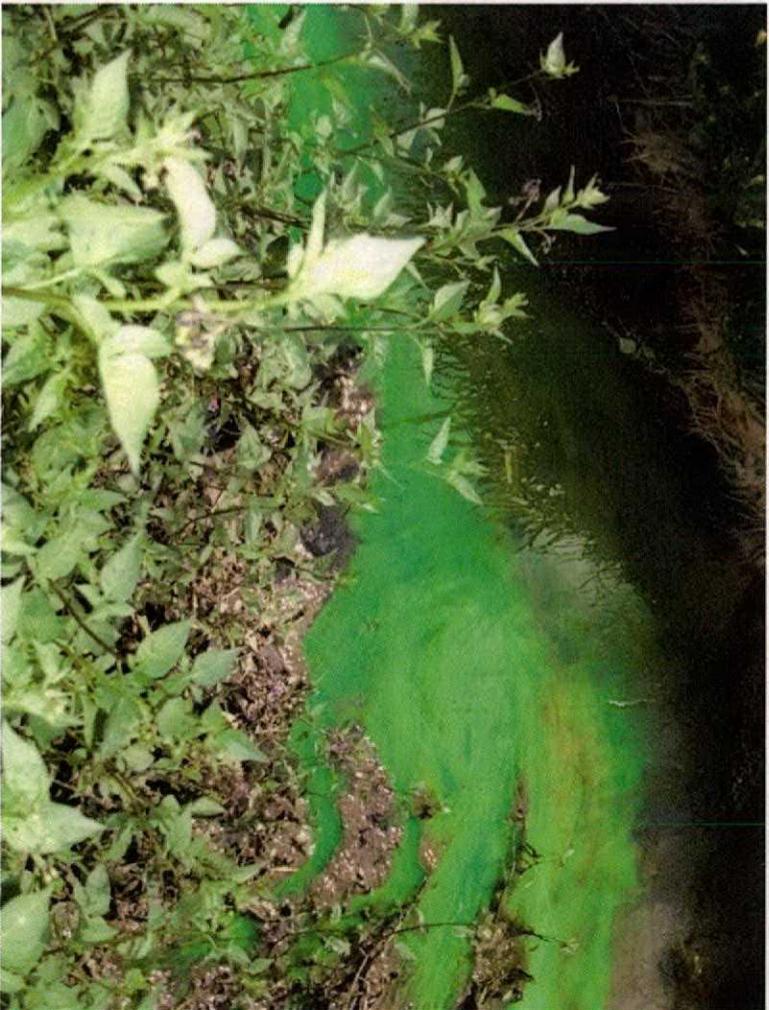
Dye from dosing tank discharging east into the ditch

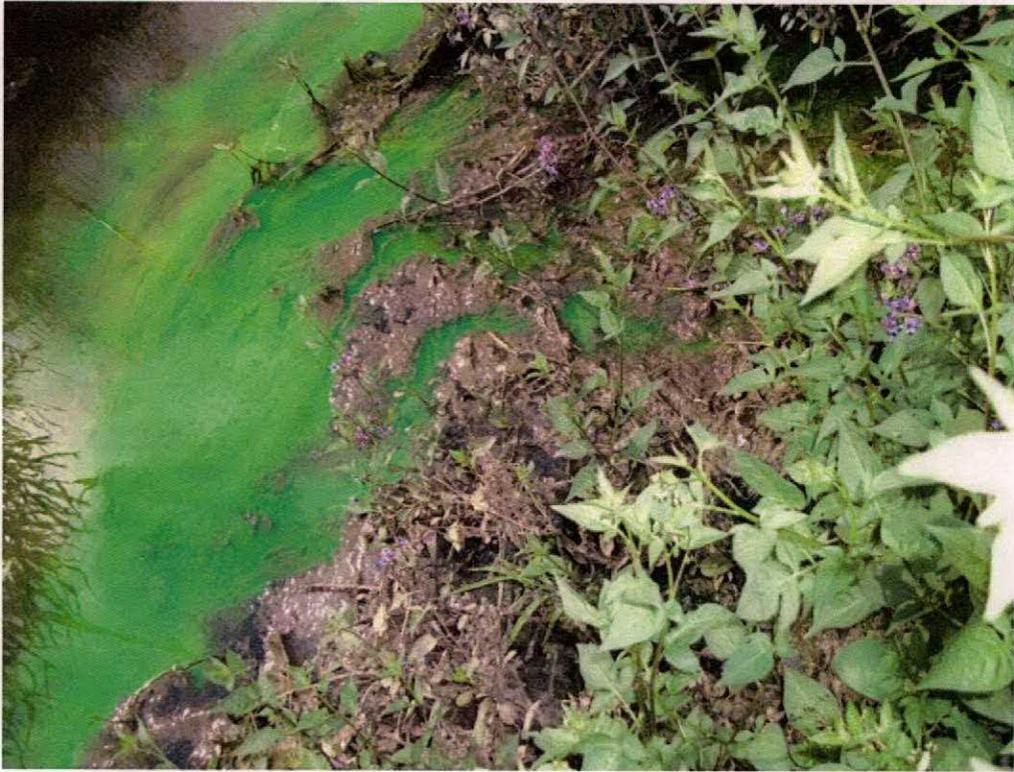
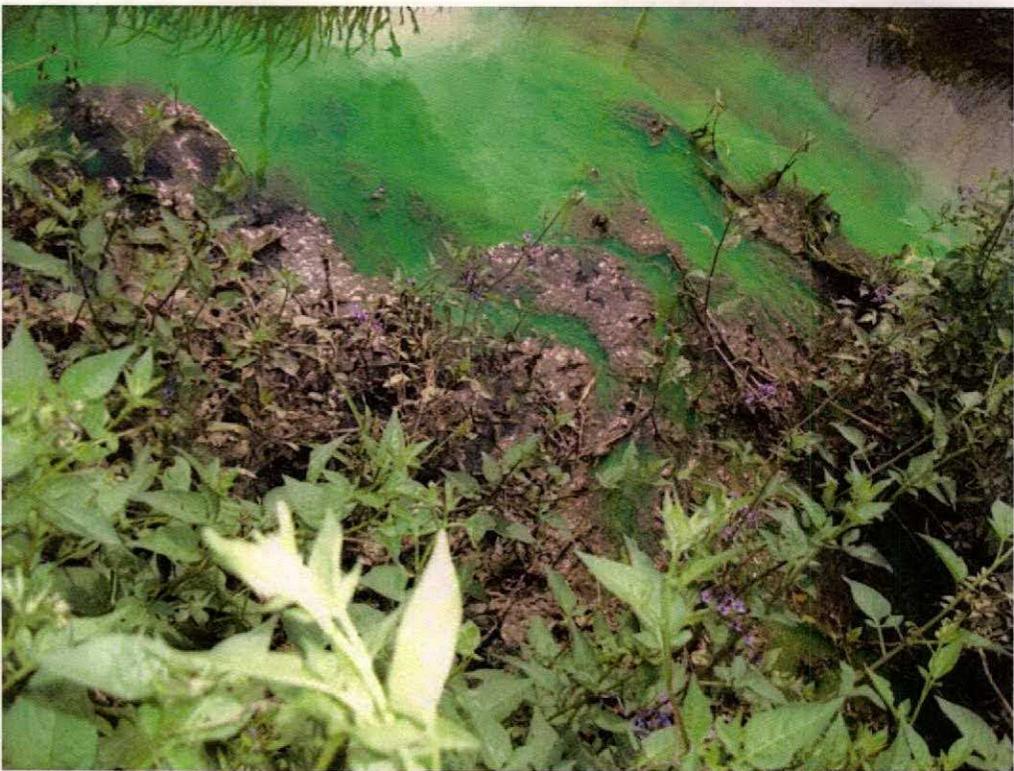
Dye from dosing tank / Sludge and solids deposits observed in ditch at the bypass discharge location

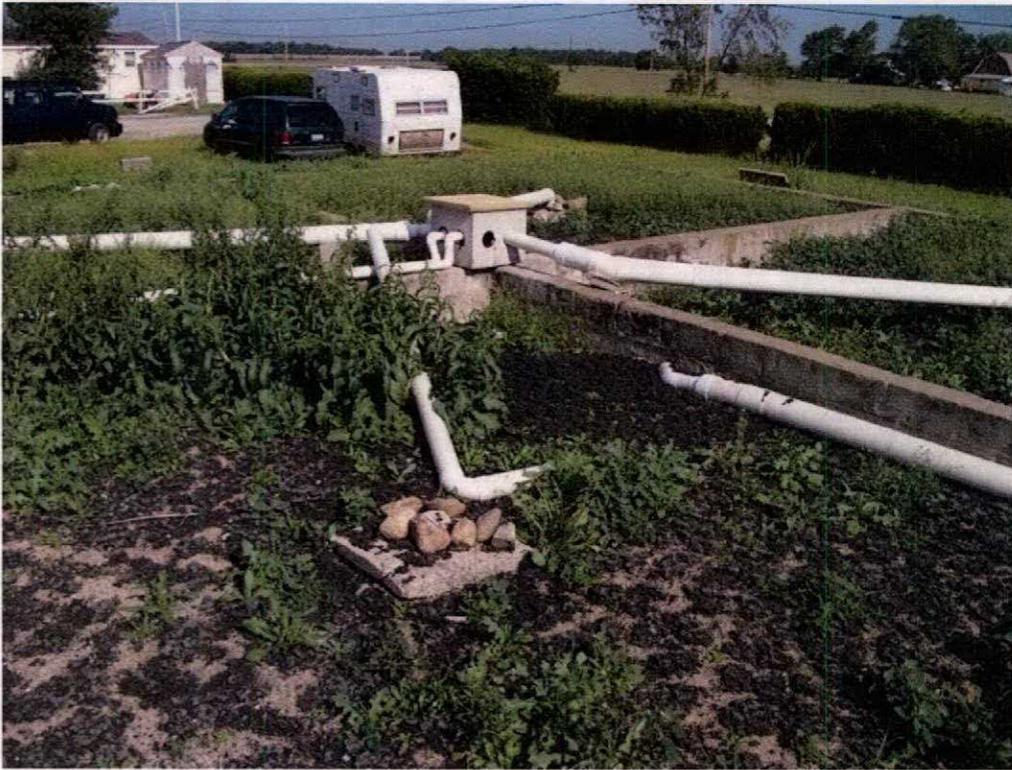
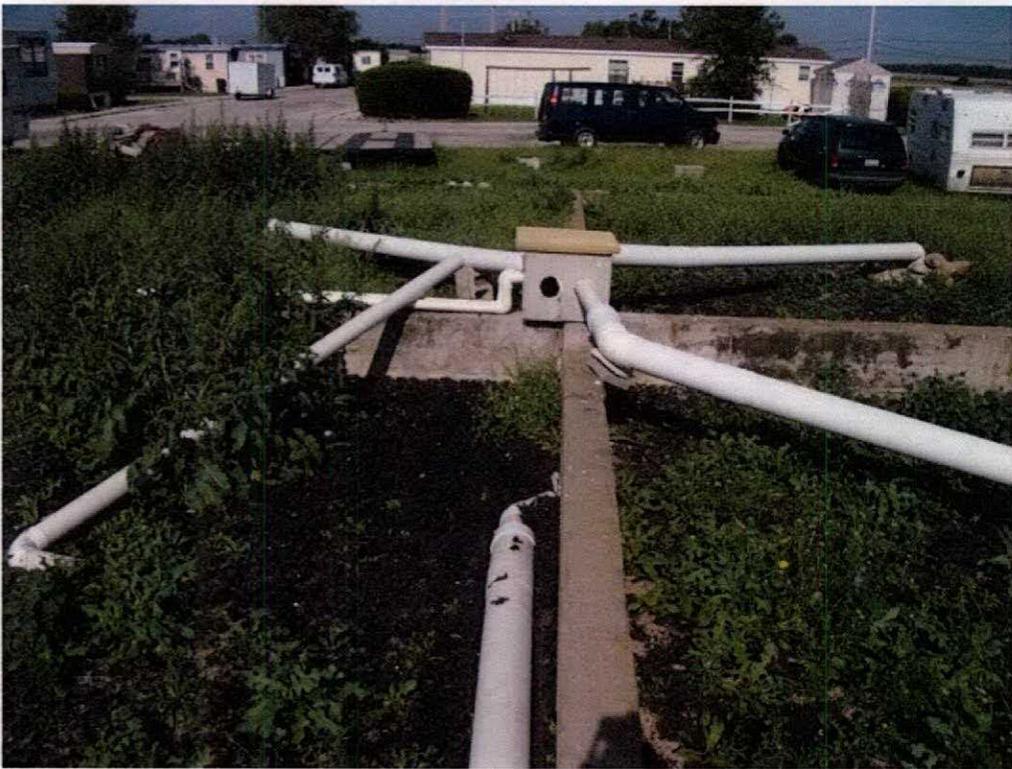
6. There was no flow to the sand filters and all four (4) of the sand filter beds were observed to be dry with an accumulation of dried solids.
7. There was no flow to the chlorine contact tank as this was also being bypassed.

Sand filters with dried sludge (being bypassed at time of inspection)

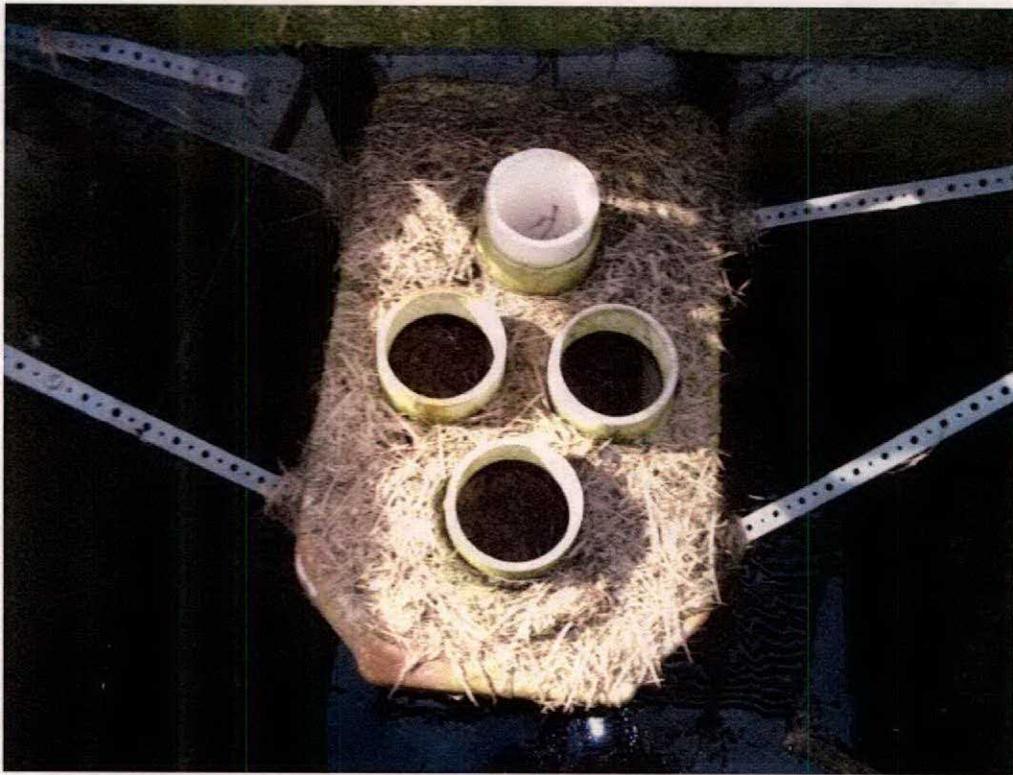
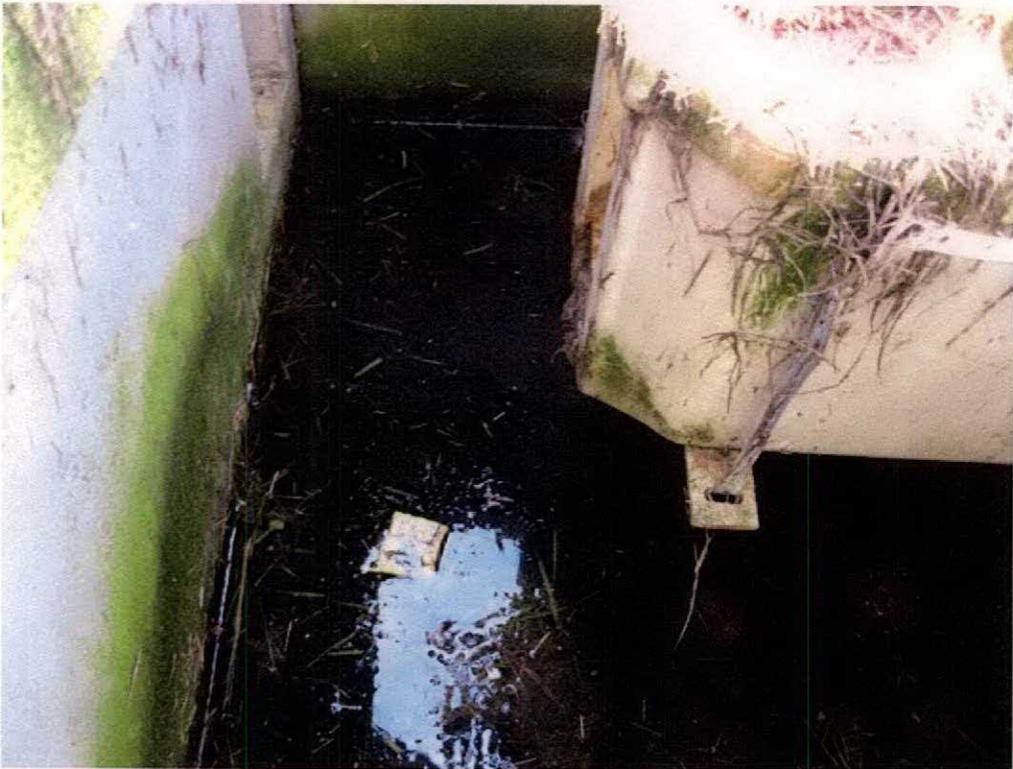
No flow through chlorine contact tank, no disinfection / water level in tank below chlorination unit.

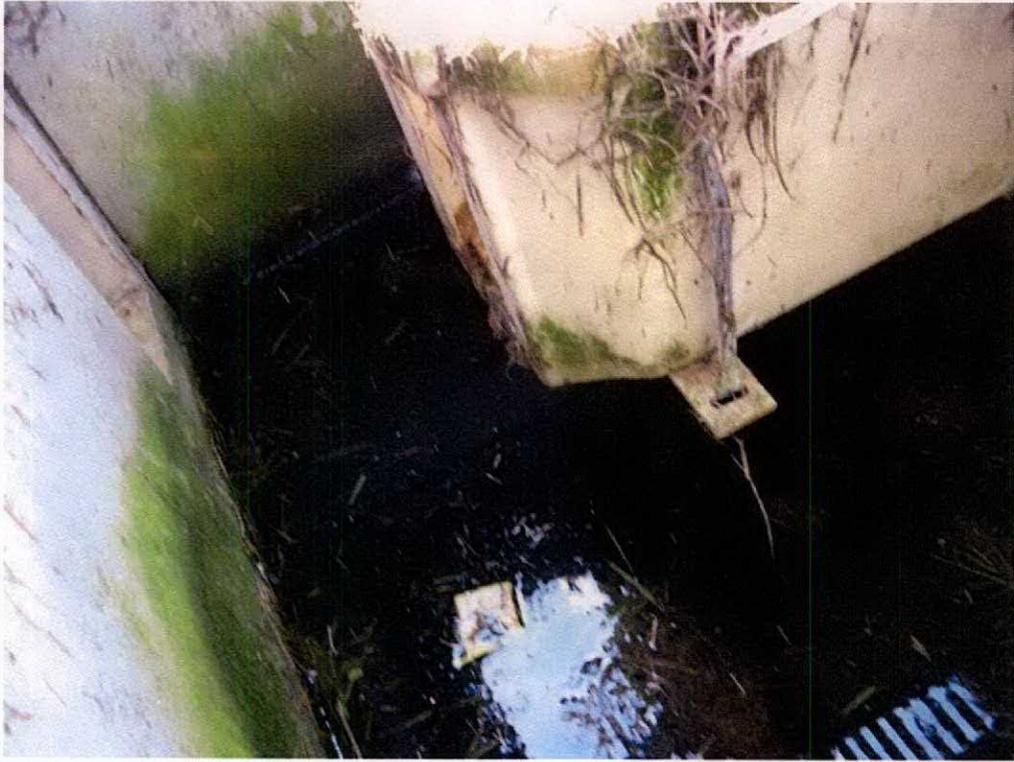
Dry chlorine contact tank

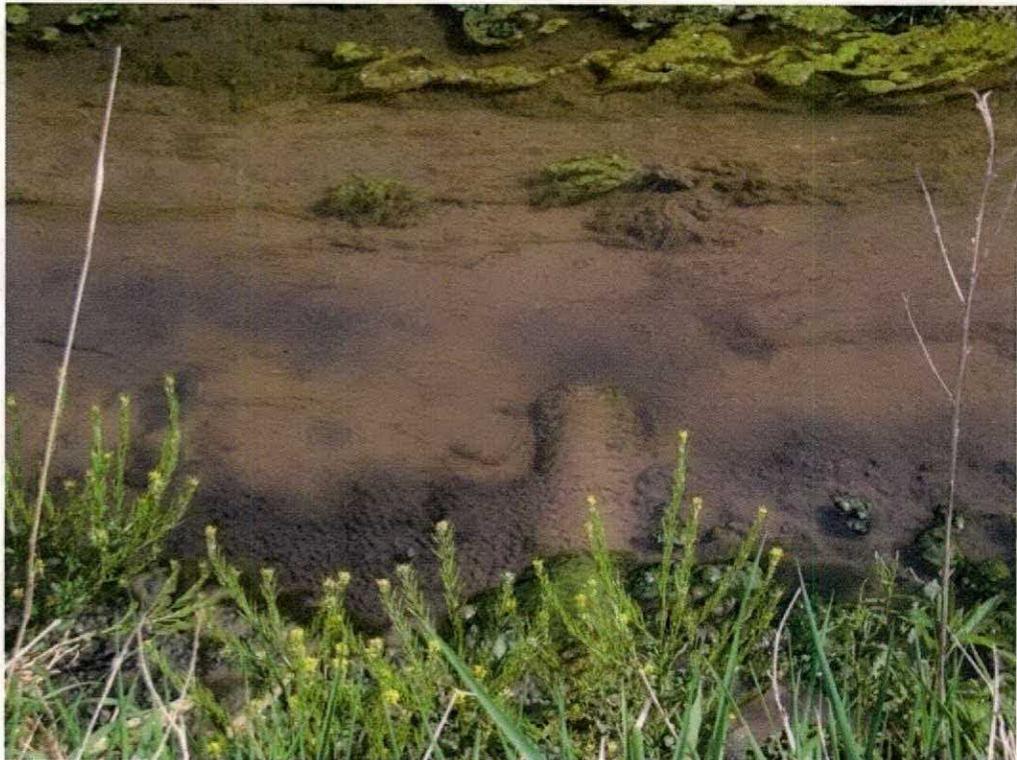
No discharge through outlet tile at time of inspection
