Re: Seneca County
Fostoria Mobile Estates
Sewerage

June 23, 2010

On May 25, 2010, an inspection was made at the wastewater treatment plant (WWTP) serving Fostoria Mobile Estates. Observations and recommendations noted during the inspection are as follows:

Fostoria Mobile Estates MHP, Seneca Co.

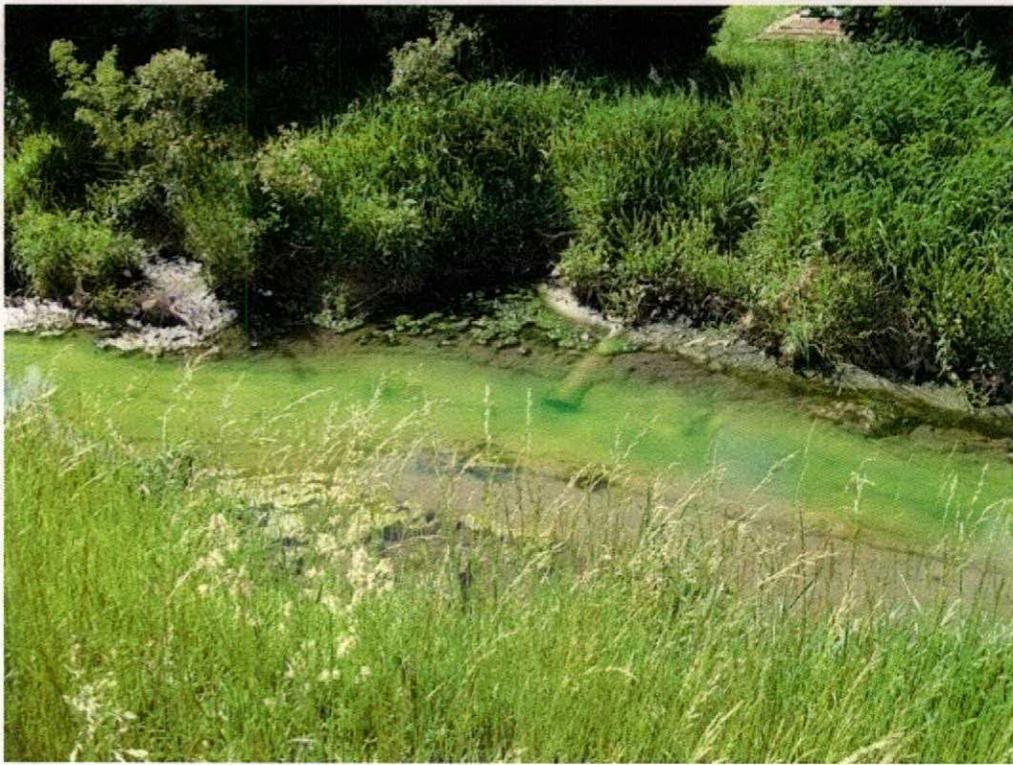
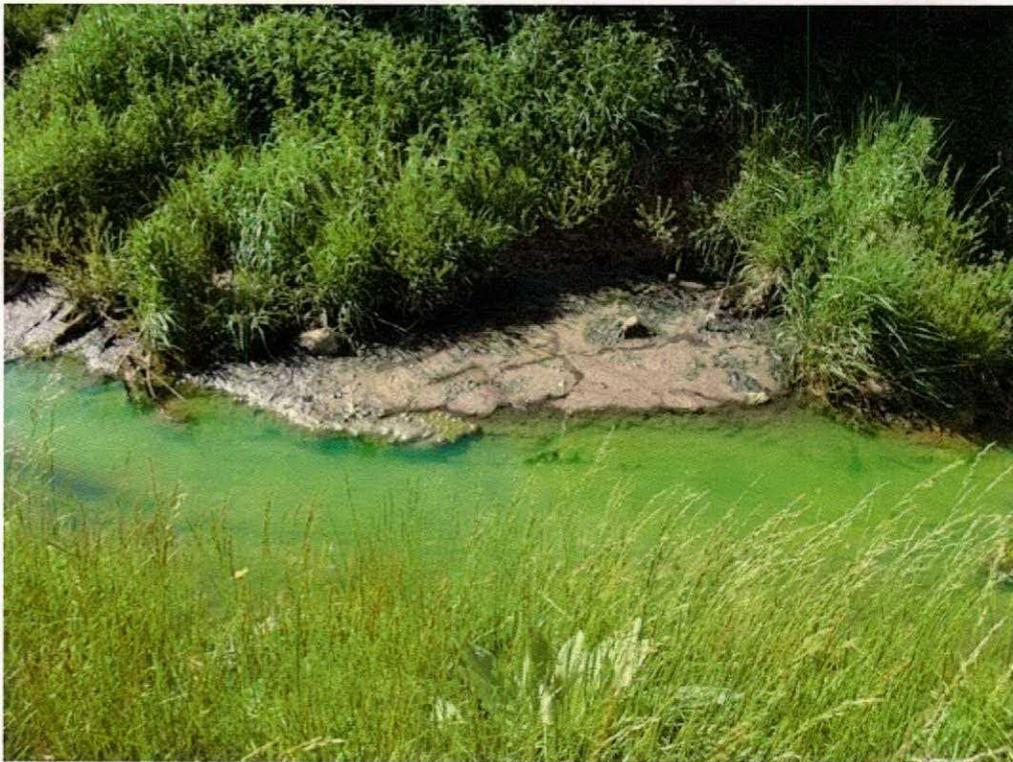
Looking south at ditch on TR 33 (E. of MHP east access drive) – Dye present from upstream discharge from bypass pipe. page 16 of 17

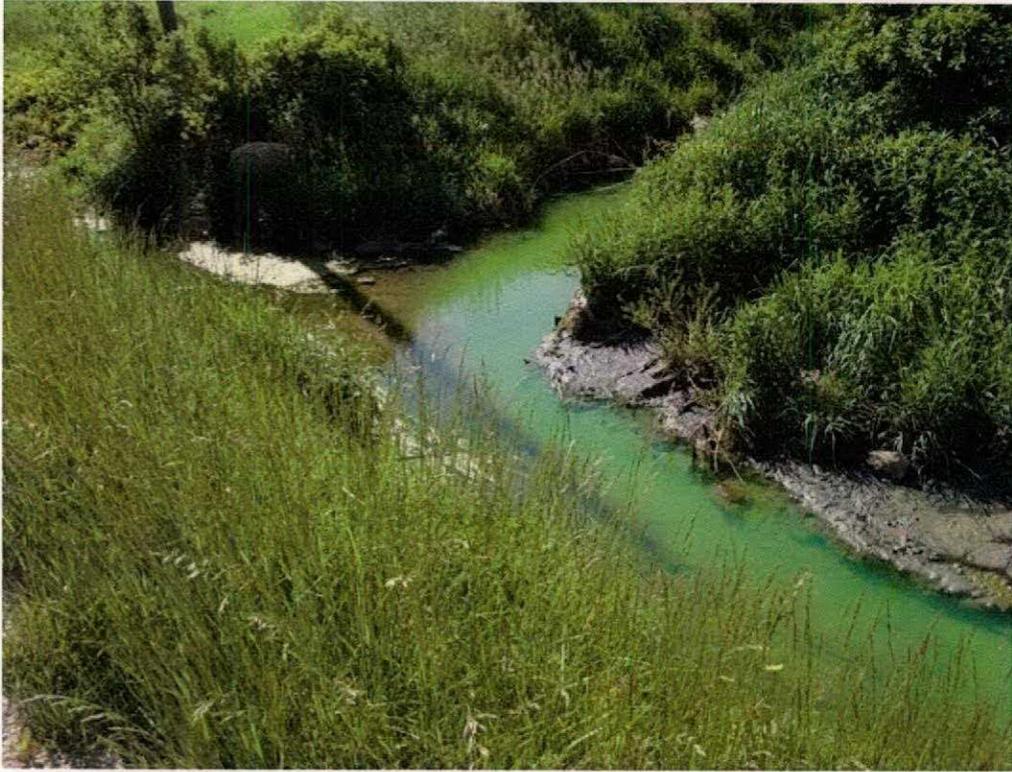
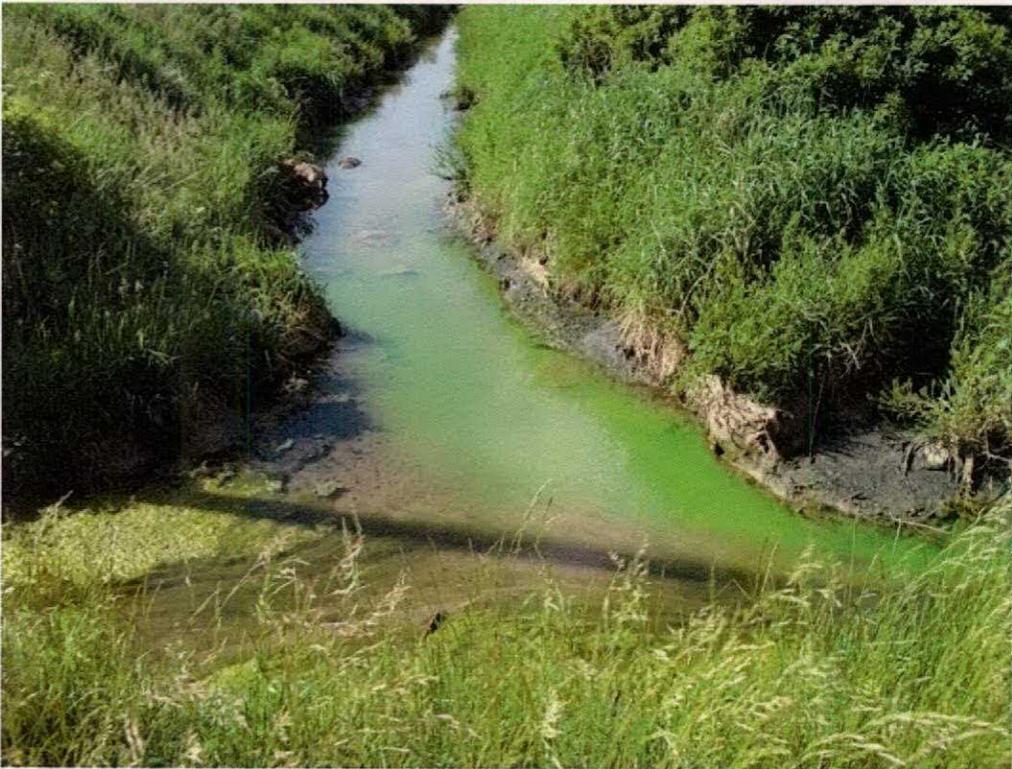
Looking S/SE, where ditch on east side of WWTP connects with TR 33 ditch
- Dye present from upstream discharge from bypass pipe. .
