State of Ohio Environmental Protection Agency

August 21, 2008

Re: Schlichter C&DD Facility, Butler County
Ground water monitoring well repair issues

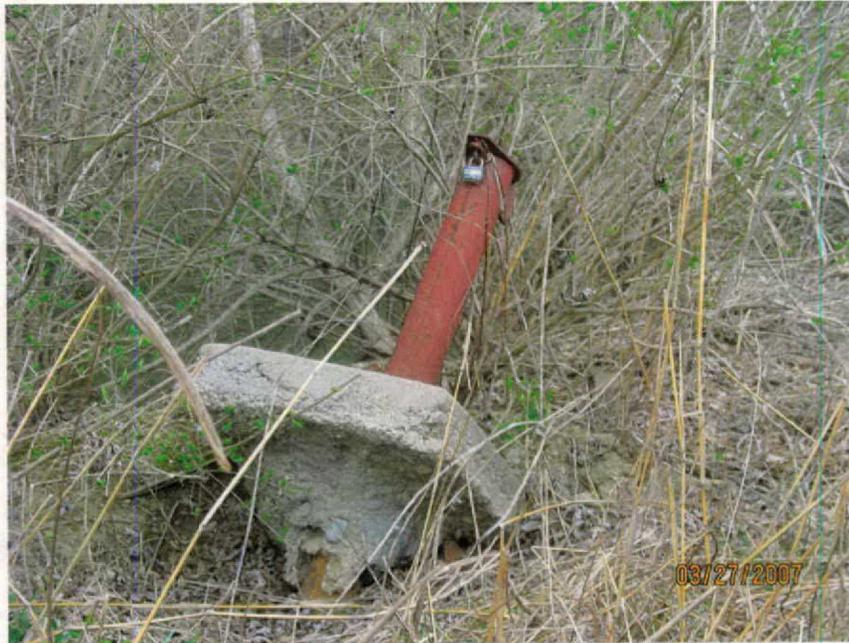
1. Inspections conducted on March 27, 2007 and May 14, 2008, revealed heavy damage to ground water monitoring well MW-5 (See Figure 1). The well seal no longer prevents contamination of the ground water and any samples taken from this well which is a violation of OAC Rule 3745-400-10(A)(2)(b). **The owner/operator needs to make repairs to the well to prevent contamination of samples and the ground water. The owner/operator needs to have a well contractor or equivalent professional inspect and repair well MW-5.** If well MW-5 is beyond repair then abandonment and replacement options need to be investigated with OEPA knowledge, consensus, and approval of those option(s) undertaken.

Figure 1: Ground water monitoring well MW-5

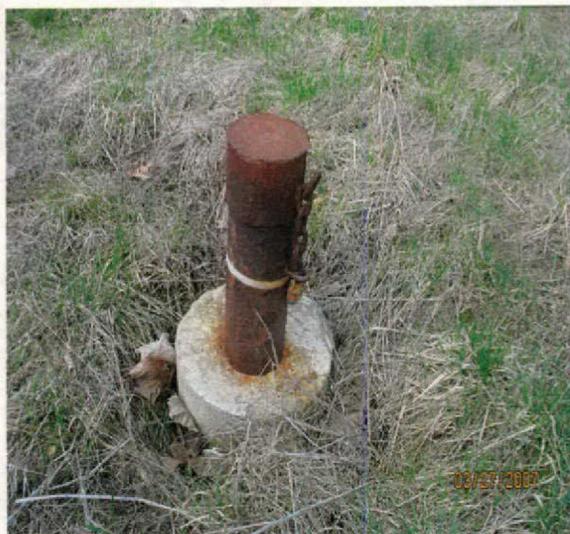
Damage to the surface seals was also noted on wells MW-3 and MW-4 which has been caused by erosion (see Figures 2 and 3), this is also a violation of OAC Rule 3745-400-10(A)(2)(b). **The owner/operator needs to make repairs to the wells to prevent contamination of samples and the ground water.** The well pad around well MW-3 needs additional soil added to prevent water from ponding and graded so that water will drain away from the well. Erosion control around well MW-4 will require more effort. The surface seal needs to be repaired by the addition of concrete beneath the current seal or a new seal needs to be constructed. Care should be used to prevent changing the inner well casing top of casing elevation; otherwise, a new survey of this elevation will be needed. Once the surface seal is again intact, erosion control is necessary to prevent the same problem from recurring. Re-grading the area so that surface water drains away from the well may be required.

Figure 2: MW-3 erosion around well pad

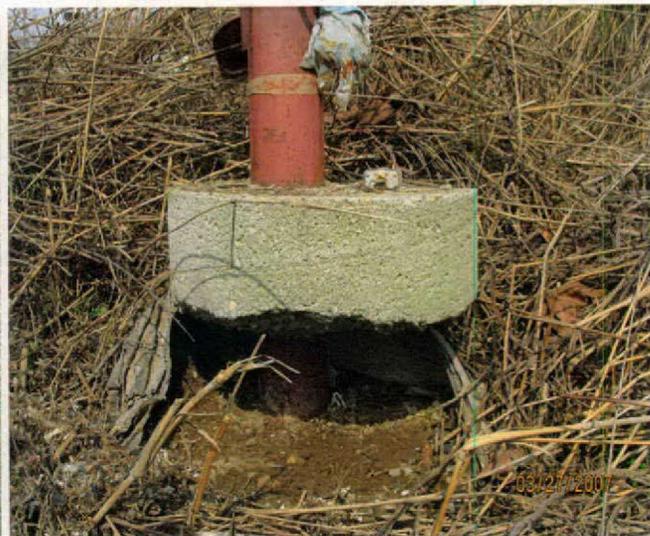
Figure 3: MW-4 severe erosion of well pad
