State of Ohio Environmental Protection Agency

RE: ~~GALLIA COUNTY~~
~~FAC~~ ~~GALLIA COUNTY LANDFILL~~
COM

On March 27, 2007, Ohio EPA conducted an inspection of the possible impact of a slope slip area on the northeastern portion of Cell 2 A of the Gallia County Landfill (facility). This inspection was necessary to ascertain that the cell's protective liner had not been damaged by the slip. This inspection was made by Brian Queen, Kiet Chung and Trevor Irwin with Ohio EPA's Division of Solid and Infectious Waste Management, Southeast District Office. During this visit, the leachate recirculation percolation sump areas were inspected. On November 29, 2004, Ohio EPA approved an alteration to the facility's permit to allow the recirculation of leachate by means of spraying leachate onto the open working face and by incorporating leachate into percolation sumps. The facility began using the percolation sump method of leachate recirculation in March 2007.

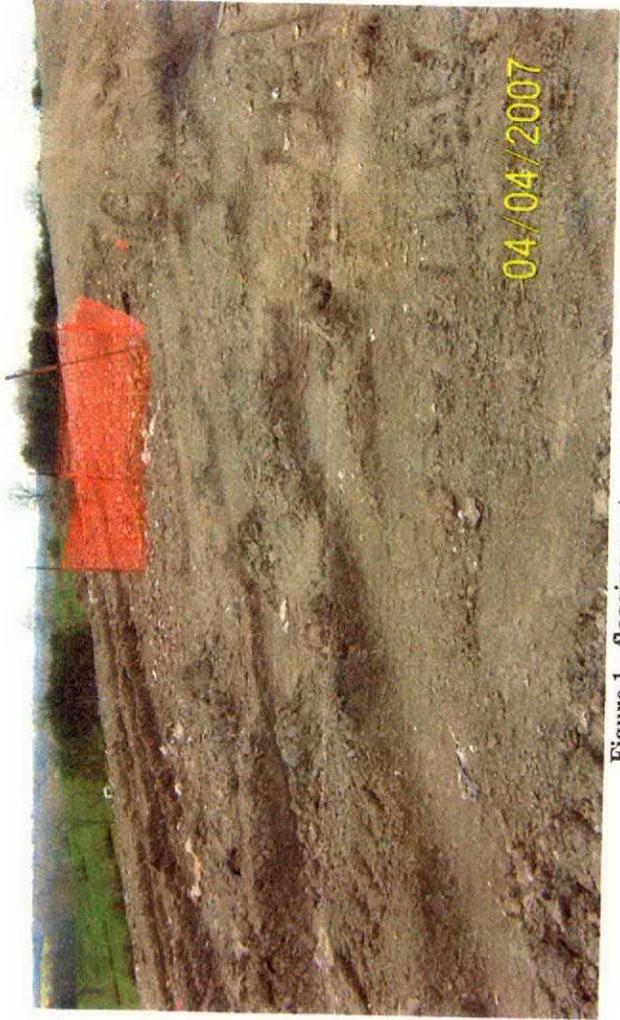
Figure 1 - flagging waste near western sump

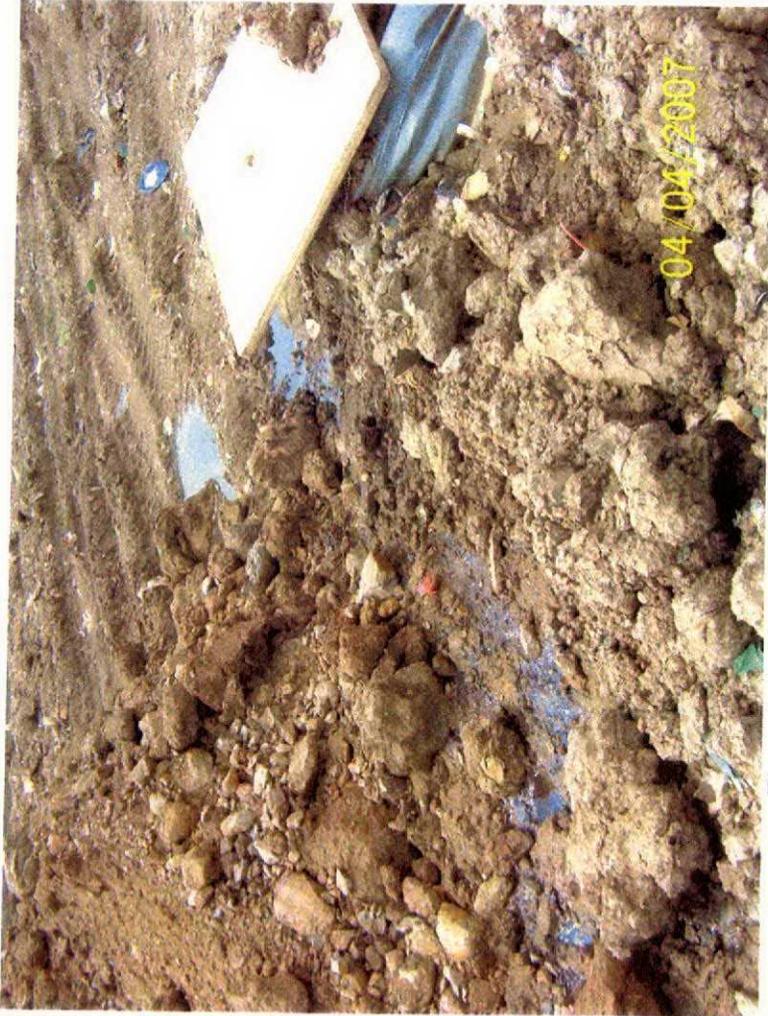
During the inspection of the sump areas, it was observed that the western sump had been overfilled and a pool of leachate had developed on the surface of the intermediate cover. On April 4, 2007, Mr. Irwin and Stuart Lentz, Gallia County Health Department, visited the site and found that a spill had occurred at the eastern sump location. Please see enclosed figures 2, 3 and 4. The western sump no longer had leachate pooled over the cover surrounding the sump pit. Orange staining was observed around the sump area. Please see enclosed figures 6 and 7. Also, it was determined that the sump had been installed thirty-six feet from the final outer slope of cell Phase 2 A. Please see enclosed figure 5. After reviewing the November 29, 2004, approved alteration (Approved Alteration), it was found that any sump was to be installed no closer than sixty feet from final outer slopes (Please see page 4 of the Approved Alteration).

Figure 2 - leachate release near eastern sump pit 2

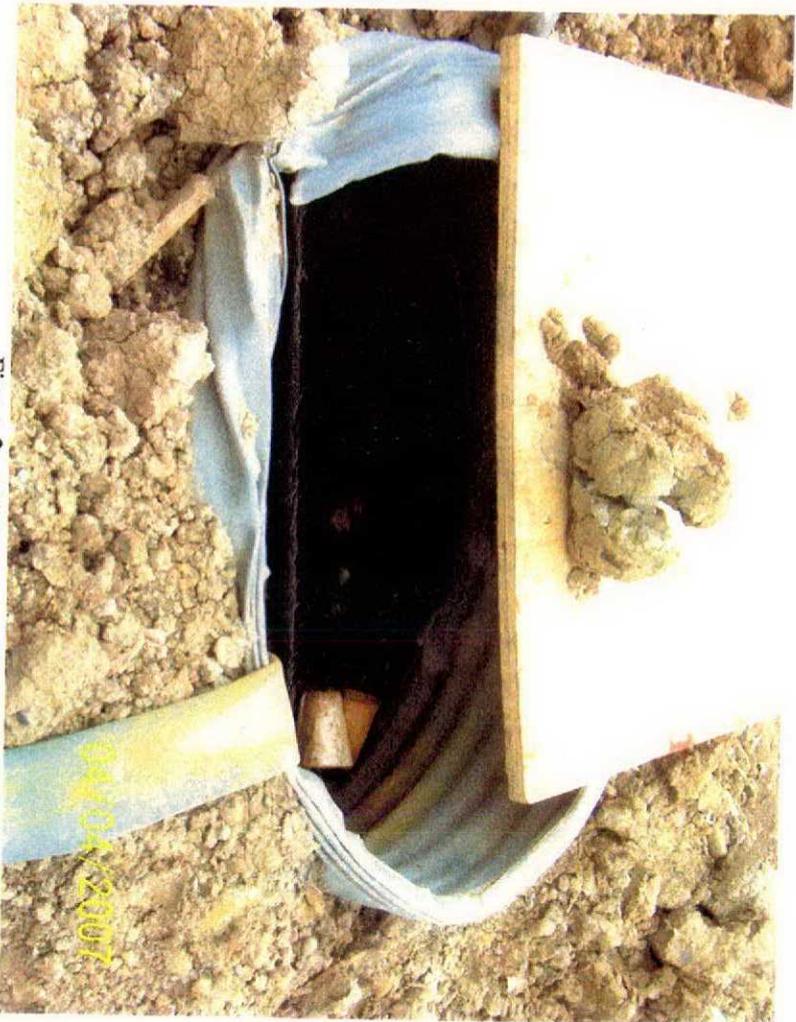
According to the Approved Alteration, if a storage tank was not readily available for use as a leachate sump, a 55 gallon drum would be used as the introduction point (Please see page 4 of the Approved Alteration). The leachate sumps were not constructed in accordance with the Approved Alteration. As per facility personnel, a pit was excavated approximately ten to fifteen feet below surface grade. A thirty-six inch culvert was then placed vertically into the excavation at each sump location. The excavation was then backfilled with fifty-seven aggregate, soil and waste.

Figure 3 - eastern sump pit

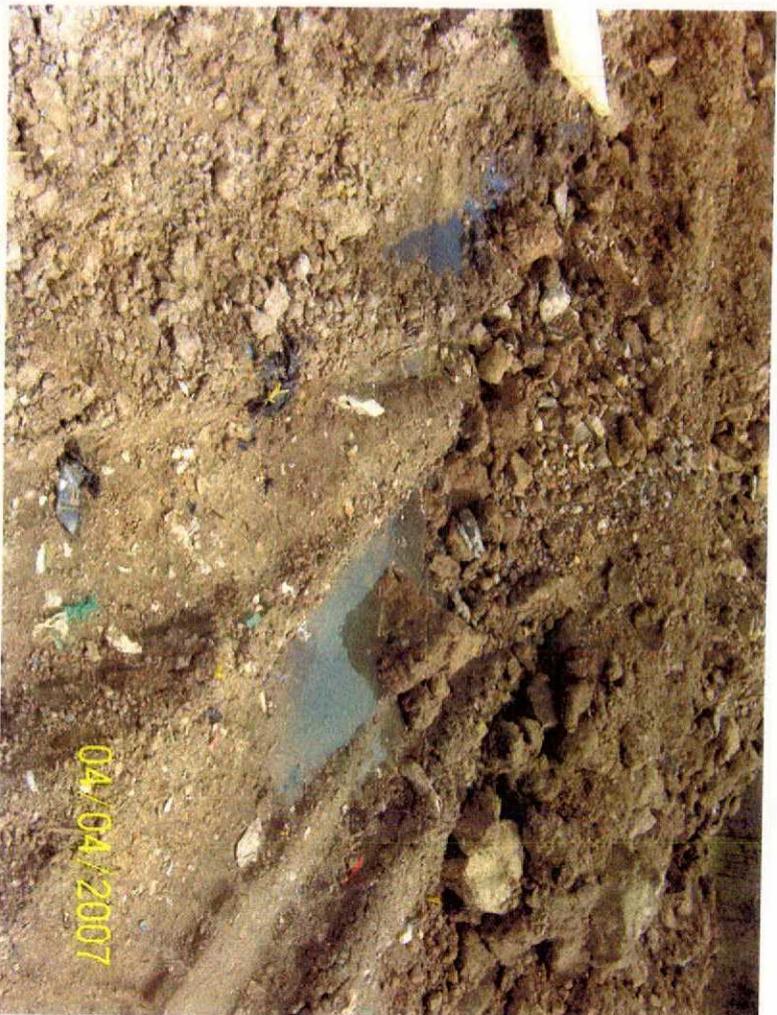
Figure 4 - leachate release near eastern sump pit 1

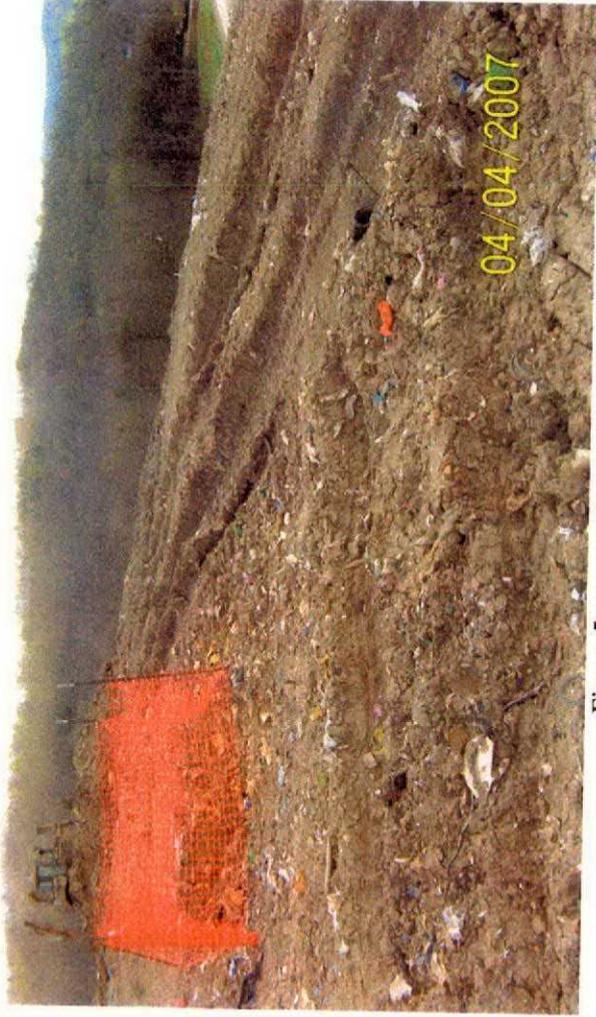
Figure 5 - western sump pit distance

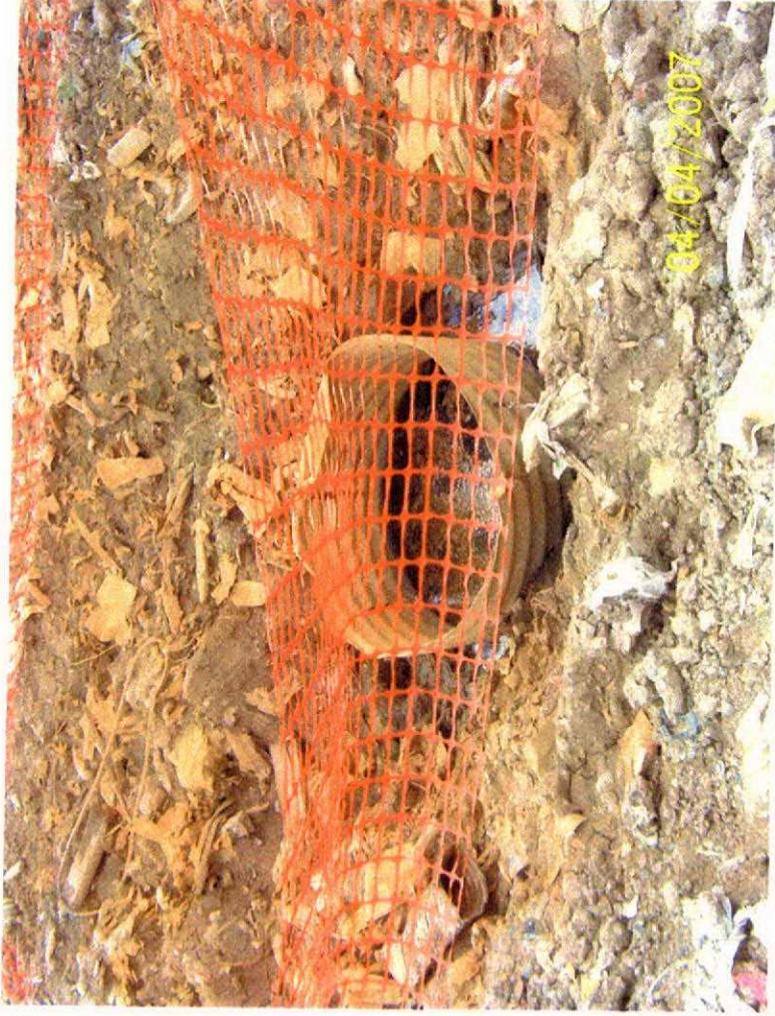
Figure 6 - western sump pit 2

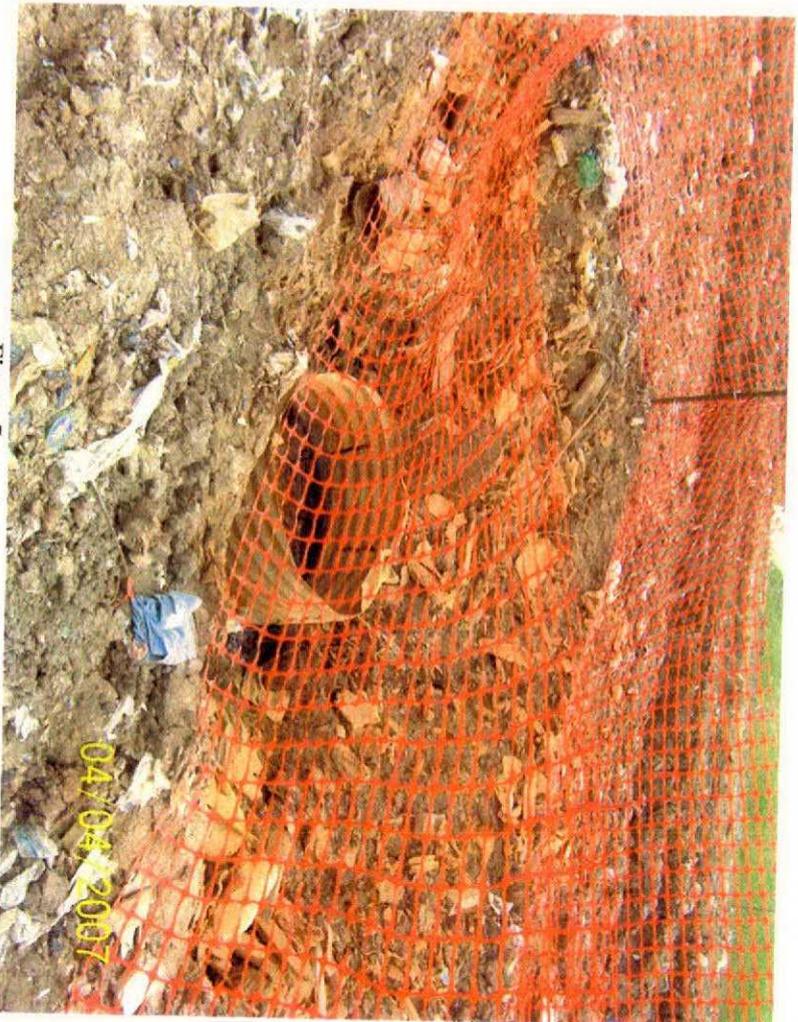
Figure 7 - western sump pit 1
