April 14, 2008

RE: VILLAGE OF KILLBUCK WWTP  
NPDES 3PB00067\*ED  
2008 CEI

On April 10, 2008, this office conducted a compliance evaluation inspection (CEI) of the Village of Killbuck Wastewater Treatment Plant (WWTP). Present during the inspection were this writer and Ken Dunham, Superintendent, Killbuck WWTP.

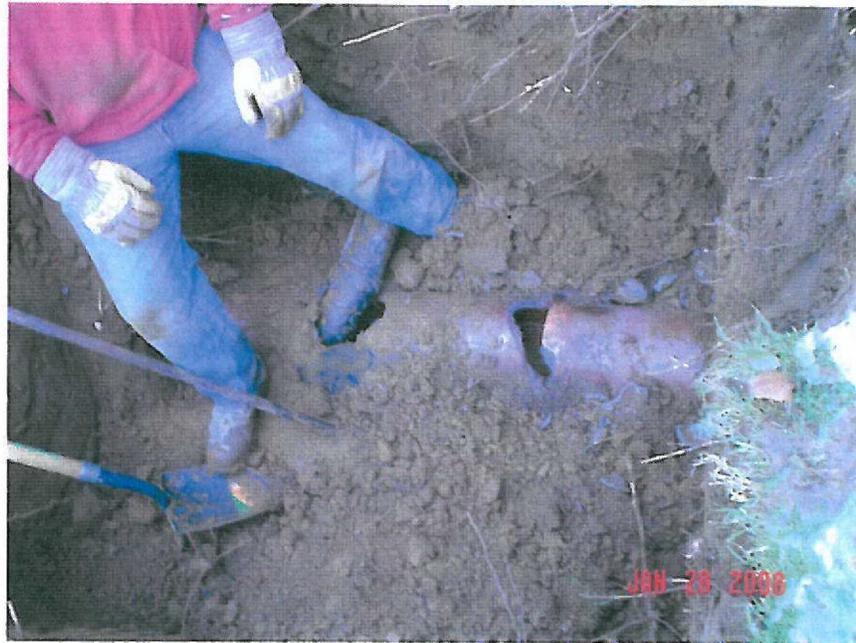
Building lateral (hammer tap) in the Village of Killbuck.

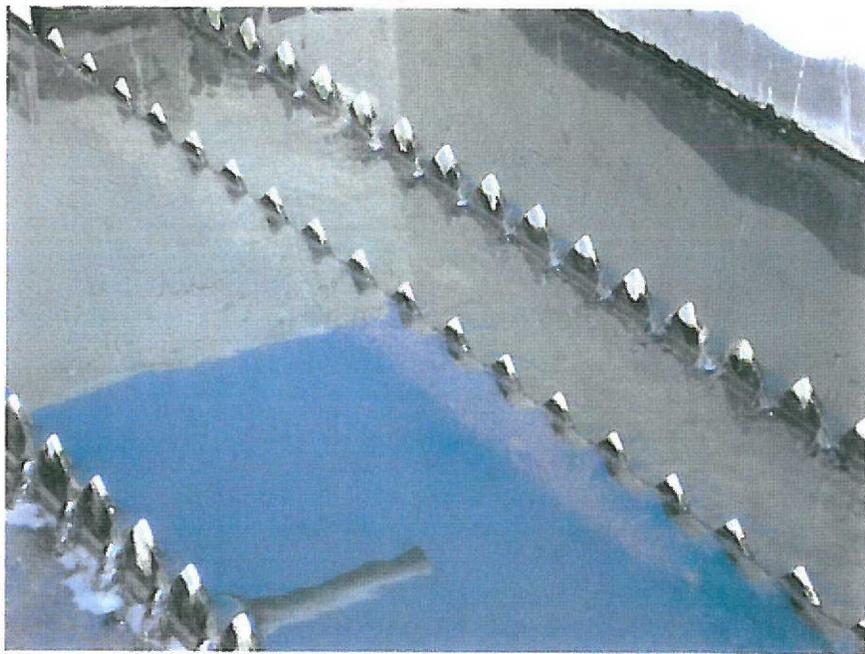
At the time of the inspection, the treatment system was hydraulically overloaded. The final effluent flow meter was pegged at 622 gallons per minute (0.896 MGD). Mr. Dunham was diverting seventy percent of the flow through the south aeration tank and clarifier. The south aeration tank contained clear water and the weirs in the south clarifier were submerged. See attached photos. The mixed liquor in the north aeration tank had a good color, however, there were excessive solids exiting the north clarifier.

North clarifier – note solids.

Phase II of the collection system rehabilitation began in January 2008. Construction has been postponed due to the excessive amount of precipitation that has occurred over the past few months. The project is on schedule, and should be completed as required by the schedule of compliance in your NPDES permit. As part of the Phase II project, eighty five percent of the laterals will be repaired, as these laterals were constructed by hammer taps. It is important that the collection system rehabilitation project reach completion, as the plant cannot operate as designed with the excessive flow.

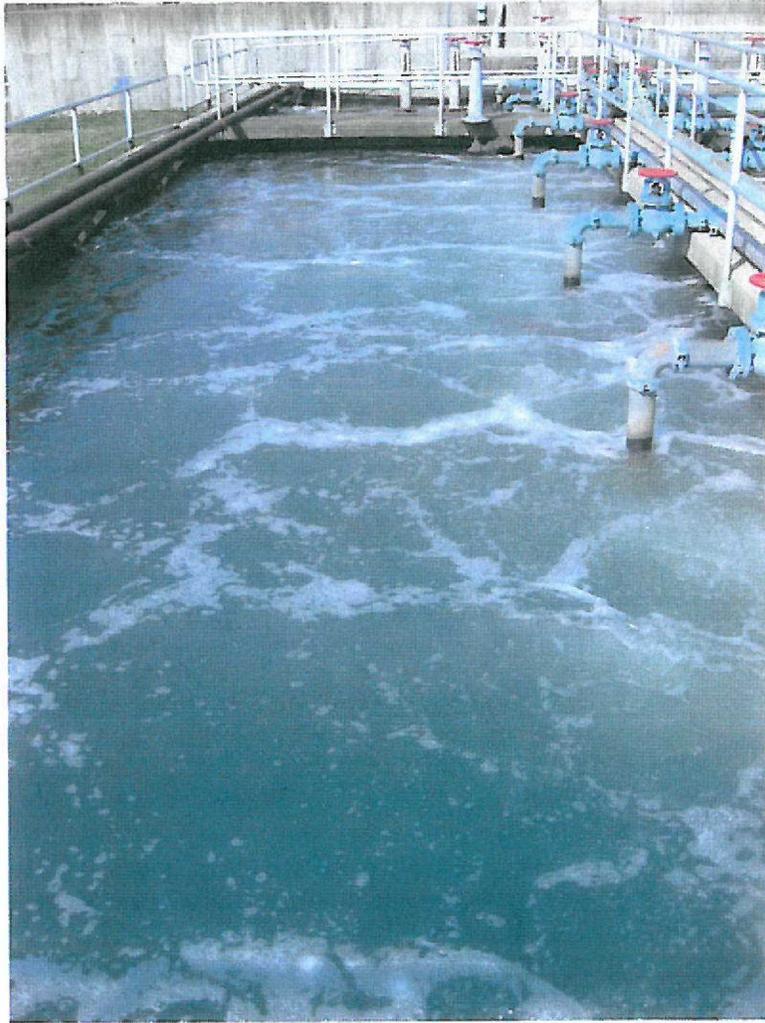
South aeration tank.

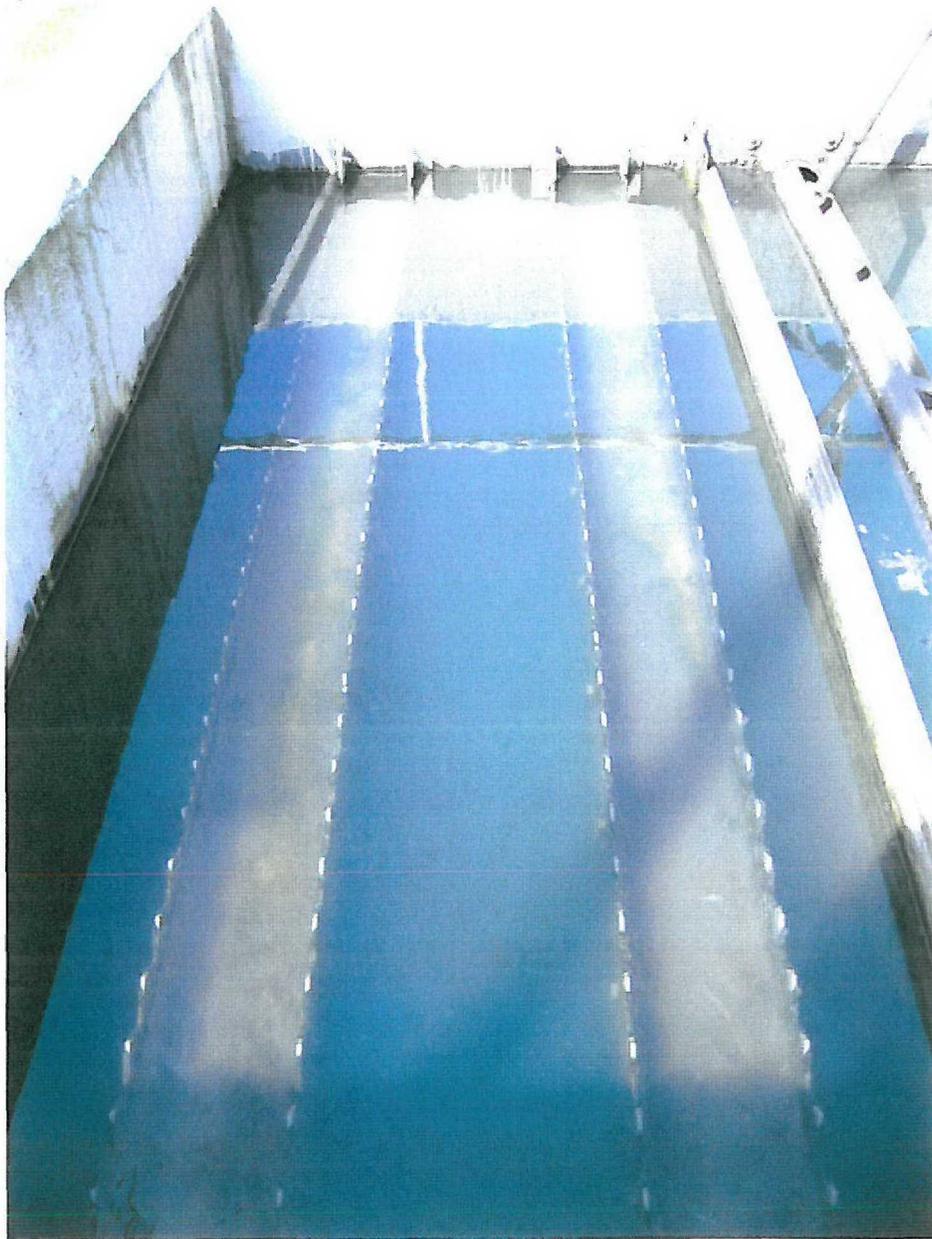
South clarifier – note submerged weirs.
