Environmental  
Protection Agency

July 11, 2011

RE: ASHTABULA COUNTY  
JEFFERSON TOWNSHIP  
DOLLAR GENERAL  
NPDES PERMIT NO. OHC000003  
OHIO EPA PERMIT NO. 3GC05416\*AG  
CONSTRUCTION STORM WATER

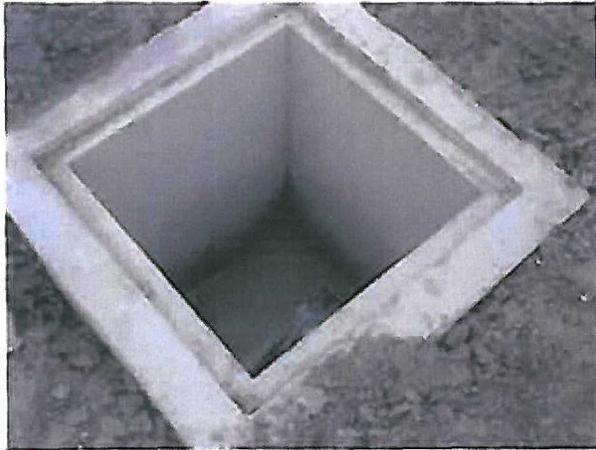
Figure 1. Catch basin with no grate or inlet protection installed.

- Several catch basins throughout the site appeared to be missing grates. In addition, the catch basins either did not have inlet protection whatsoever, or had inadequate protection. Please be sure to install grates on every catch basin and install inlet protection (i.e. geotextile wrapped frames reinforced with chicken wire, or dandy bags for inlets above grade) as specified in the Storm Water Pollution Prevention Plan (SWP3). Also, please remove any sediment that has already entered the catch basins (See Figures 1 & 2 & 3).

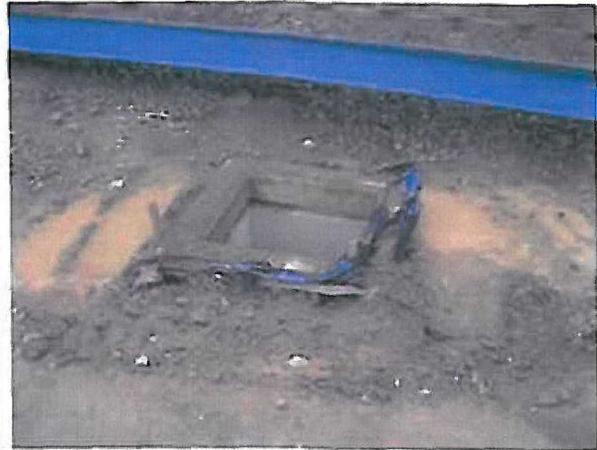
Figure 2. Inadequate inlet protection protecting a catch basin with no grate.

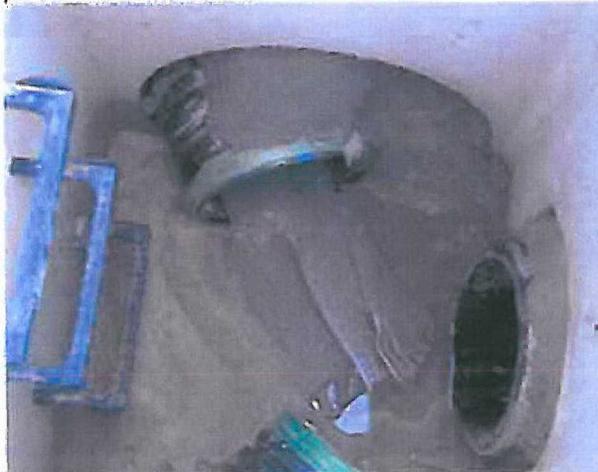
Figure 3. Catch basins already full of sediment.

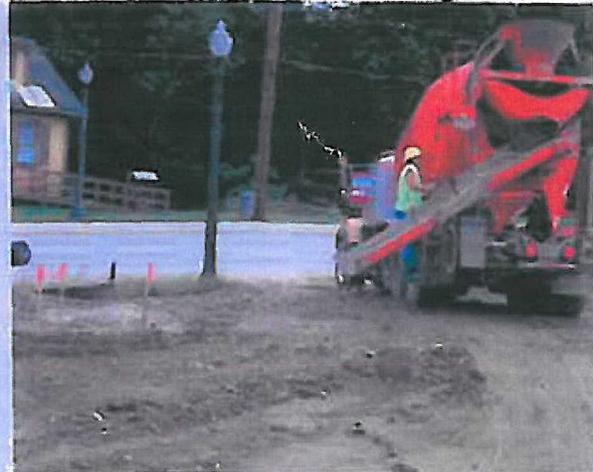
Figure 4. Worker washing out concrete onto exposed soil.

- While on site, I witnessed workers wash out concrete trucks onto exposed soil and into channels leading directly to unprotected inlets. If concrete is to be washed out on site, a concrete washout pit should be reinstalled to prevent wash water from discharging to surface waters of the State (See Figure 4). The NPDES permit does not authorize the discharge of wastewater such as concrete wash water.

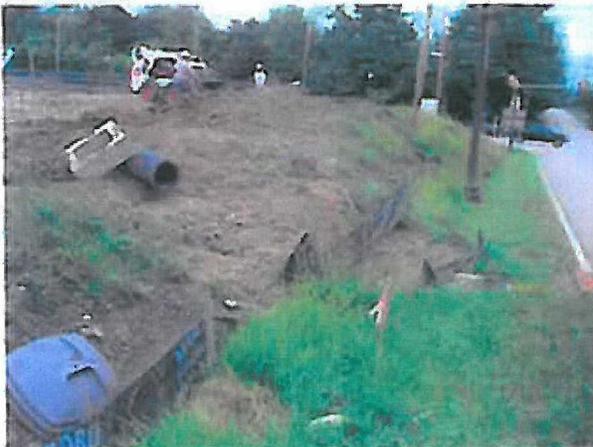
Figure 5. Silt fence has collapsed in several areas.

- The silt fence has collapsed in several areas throughout the site, specifically along Beech St. Please be sure to replace silt fence as necessary and with the specifications detailed in the SWP3 (See Figure 5).

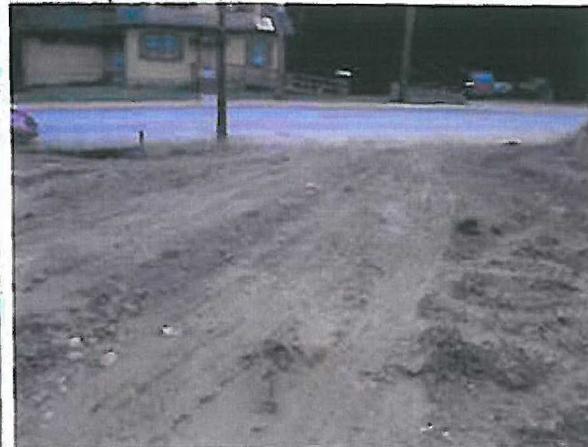
Figure 6. Construction entrance is inadequate.

- The construction entrances are inadequate, resulting in tracking of sediment onto Beech St. and Chestnut Rd. Please be sure to install construction entrances with the specifications detailed in the SWP3, and sweep any sediment already tracked out onto the roads (See Figures 6 & 7).
- There are areas throughout the site (specifically the stock pile) that appear that they will remain undisturbed for twenty one (21) days or greater. If this is the case, please stabilize these areas with seeding and mulch as specified in the SWP3 (See Figure 8).

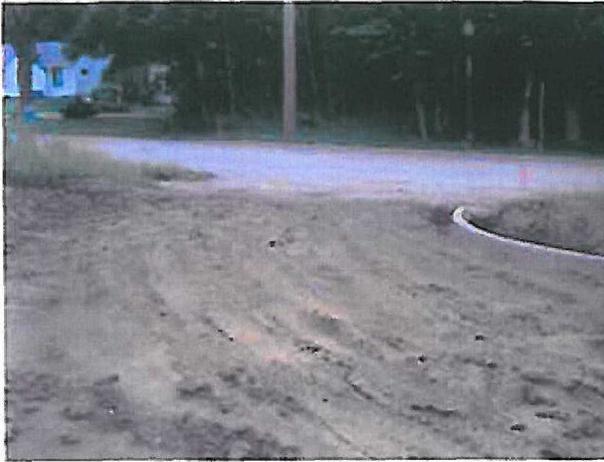
Figure 7. Sediment is being tracked onto the road.

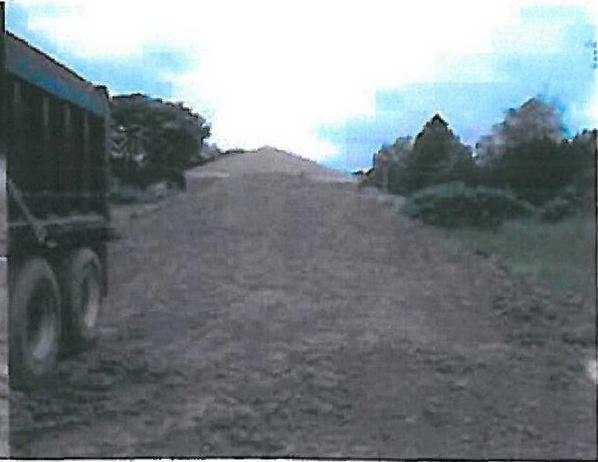
Figure 8. Areas that remain idle for 21 days or longer need to be stabilized.
