June 8, 2011

RE: ODNR WEST BRANCH STATE PARK
PERMIT NO. 3PP00010
PORTAGE COUNTY
RAVENNA

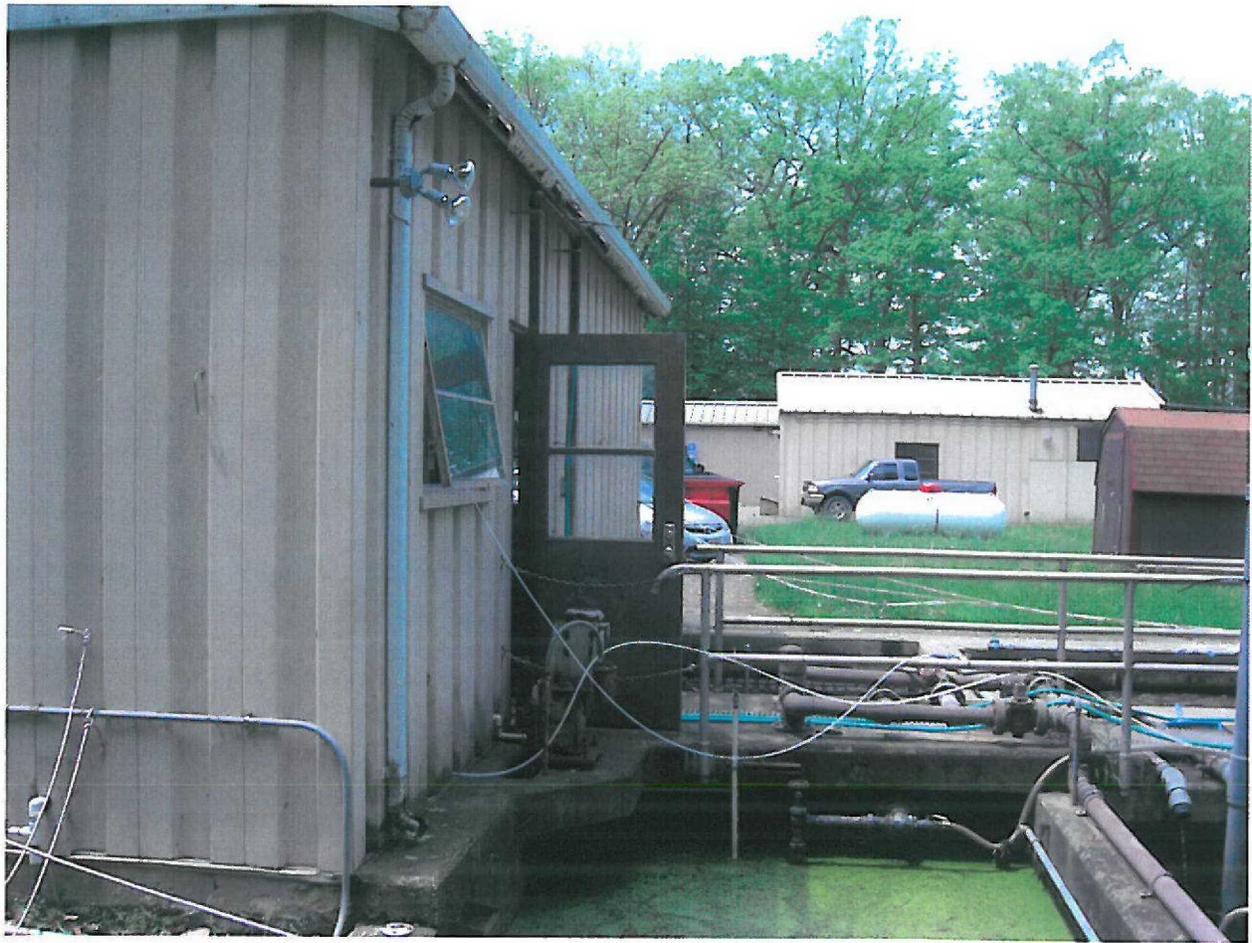
Figure 1

13. The storm water downspouts from the blower building drain directly into the clarifiers. Also the bottom of the gutters are severely deteriorated which also allows storm water to enter the clarifier. See Figure 1. This can cause hydraulic overload of the clarifier and result in a poor quality effluent. The gutters should be repaired immediately and be rerouted so that they do not discharge into the clarifiers
