State of Ohio Environmental Protection Agency

December 11, 2008

RE: STARK COUNTY  
BETHLEHEM TOWNSHIP  
LAKE SHERMAN MHP  
NPDES #3PV00035

On December 10, 2008 a compliance evaluation inspection (CEI) was conducted by this writer of the wastewater treatment system serving the above referenced facility. Present during the inspection was Ron Miller, Wastewater Treatment Plant Operator, Lake Sherman MHP.

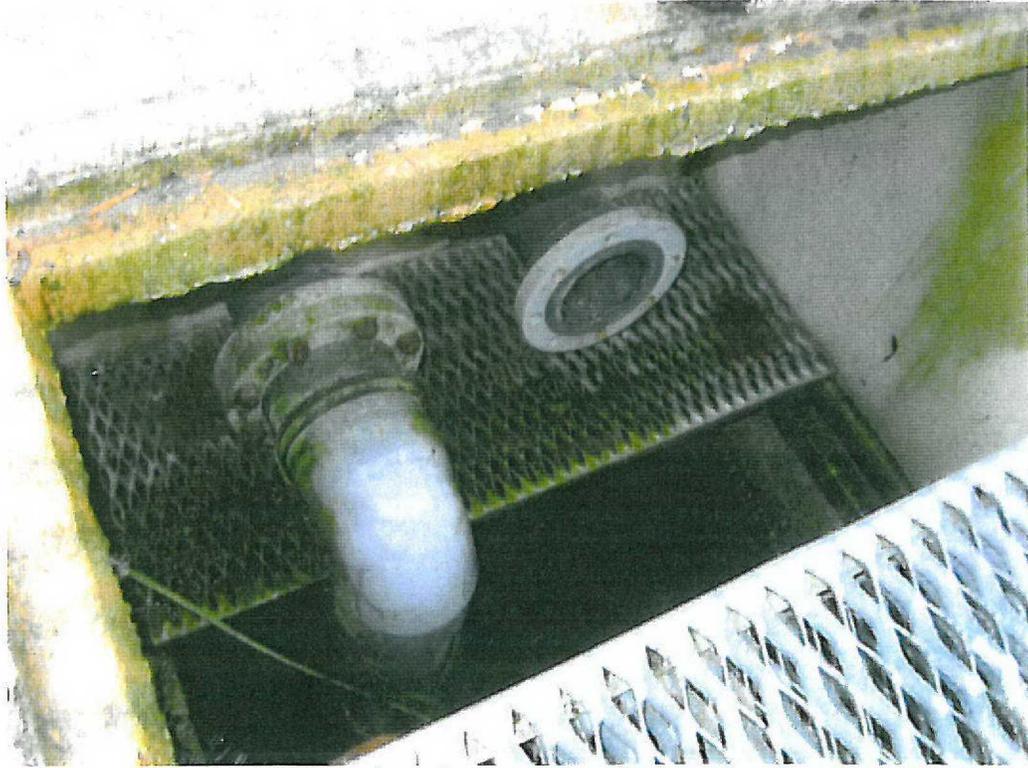
Upon the discovery of the solids in the effluent and at my request, Mr. Miller turned the doing pumps on to be sure that the clarifier effluent was being dosed to the surface sand filter. The dosing chamber has only one pump that is connected to the surface sand filter. The line from the second pump broke some time ago. It was then removed and never replaced. The pump did not activate when turned on manually. However, wastewater was still flowing to the chlorine contact tank. Upon my asking, Mr. Miller stated that there is a gravity overflow from the dosing chamber to the chlorine contact tank.

Dosing chamber – note missing pipe.

This is a direct violation of the conditions contained in Part III of your NPDES permit. The gravity overflow is to be removed immediately. The dosing chamber is to be repaired and equipped with two pumps. You are directed to notify this office, in writing, when the dosing chamber has been repaired.

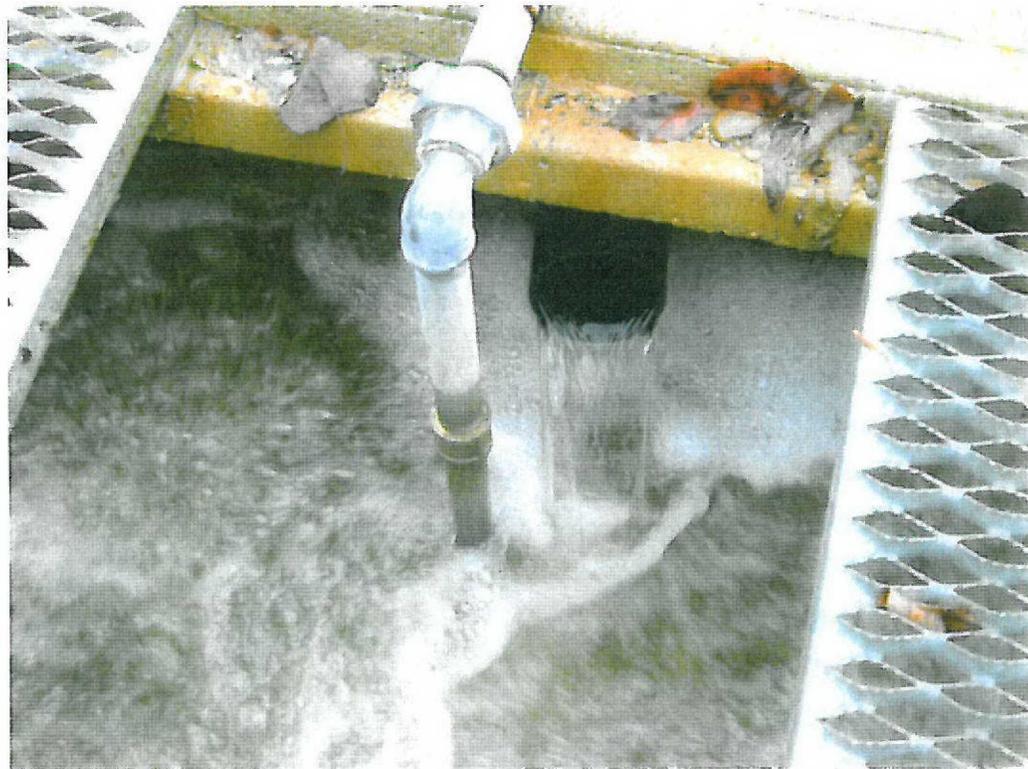
Gravity overflow from pump station to chlorine contact tank.

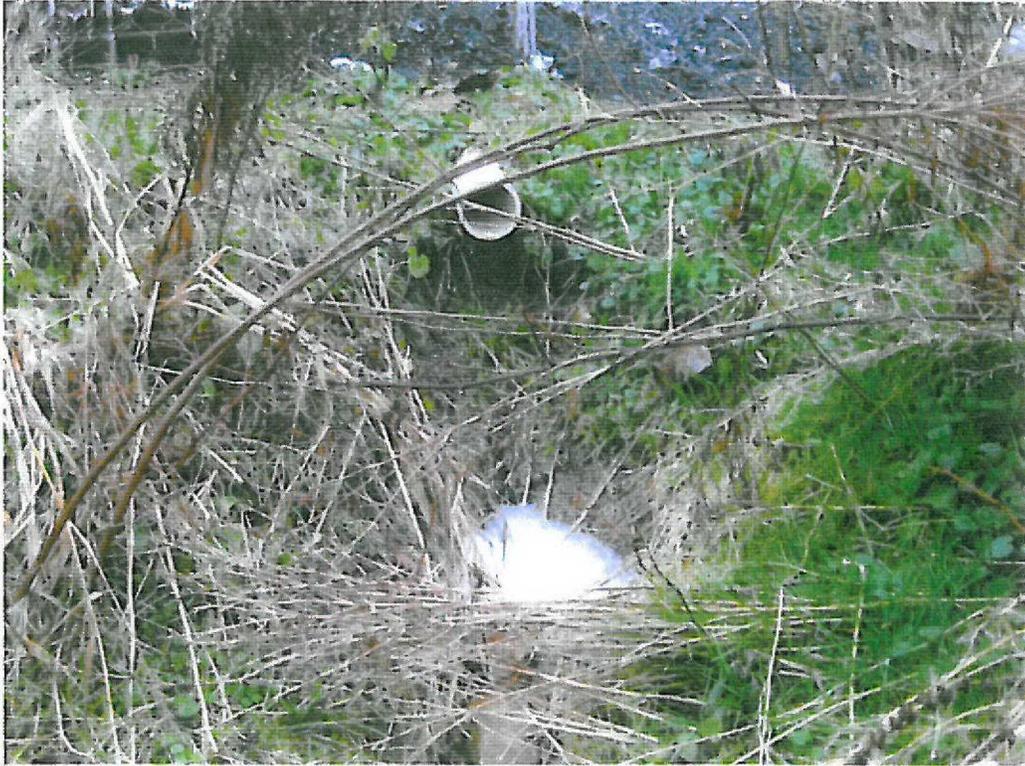
A drain from the sink in the operations building discharges onto the ground surface next to the treatment plant. This sink must be tied into the wastewater treatment plant immediately. Wastewater treatment plant solids were also noted in this area.

Drain from sink in operations building.

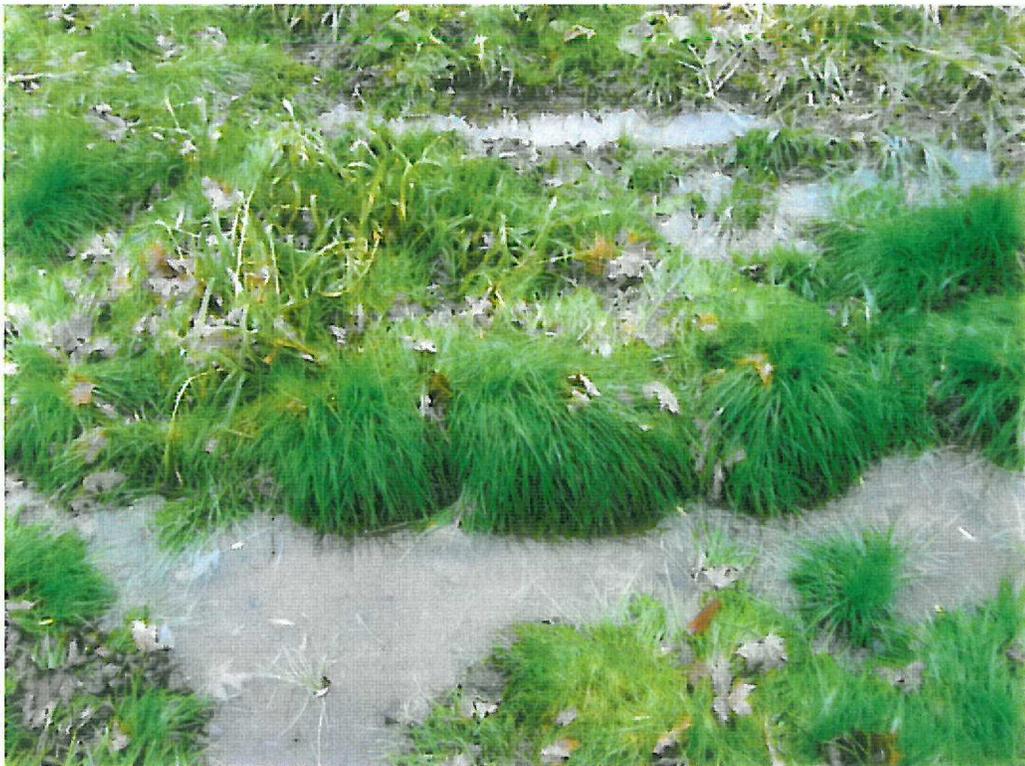
Solids downstream from sink drain.
