RE: CUYAHOGA COUNTY  
CITY OF BROADVIEW HEIGHTS  
BROADVIEW HTS COMMERCIAL DEVELOPMENT  
CONSTRUCTION STORM WATER

**NOTICE OF VIOLATION**

**BROADVIEW HEIGHTS COMMERCIAL DEVELOPMENT**

Photos Taken: November 1, 2011

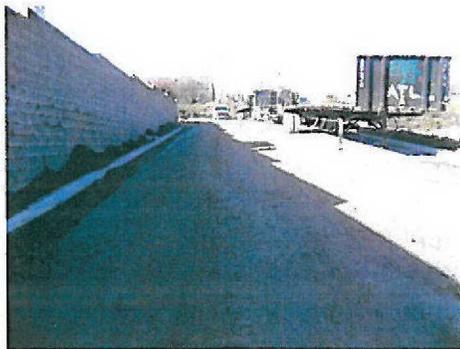
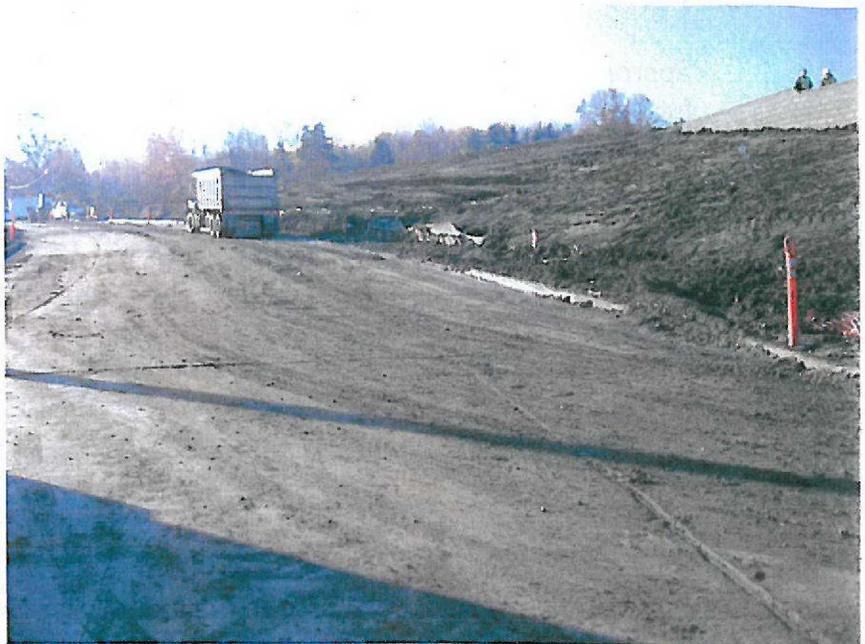
My inspection was conducted in response to a complaint received October 31, 2011, from a citizen regarding the off-site tracking of soil from the construction site onto adjacent roadways. My inspection revealed that an excessive amount of soil had indeed been tracked off the construction site and onto Treeworth Blvd and Royalton Road (see photos). Although construction vehicles were accessing the site from an asphalt-paved driveway, the contractor was not able to maintain a rock construction entrance at the transition between pavement at the top of the drive and disturbed areas of the site. Although Harp Contractors stated that they had redressed this entrance with stone, the volume of truck traffic was too great and they were not able to prevent the tracking using this best management practice. Further, Mr. Bucher stated that the street sweeper had broken down and, as such, Harp was unable to clean up the soil which had been tracked off-site.

**Fig 1 & 2.** Construction vehicles track sediment onto the paved driveway (ABOVE) and then onto Treeworth Blvd (RIGHT). The amount of off-tracking is excessive.

This letter will serve to notify you that Echo Broadview Heights LLC and Harp Contractors Inc are not in compliance with Part III.G.2.g.ii of the NPDES permit. **Failure to comply with the NPDES permit is a violation of Ohio Revised Code 6111.04 and 6111.07 and is punishable by fines of up to \$10,000 per day of violation.** You will remain in violation of the NPDES permit until measures are taken to minimize off-site tracking. Measures may include: (a) establishing a wheel wash station at the top of the asphalt drive, (b) keeping construction vehicles that will go off-site on pavement or stoned haul roads while they are on-site, and/or (c) vacuum sweeping the asphalt drive and adjacent streets to remove soils that have been tracked onto them. The frequency of street sweeping and number of street sweepers being used may need to be increased.

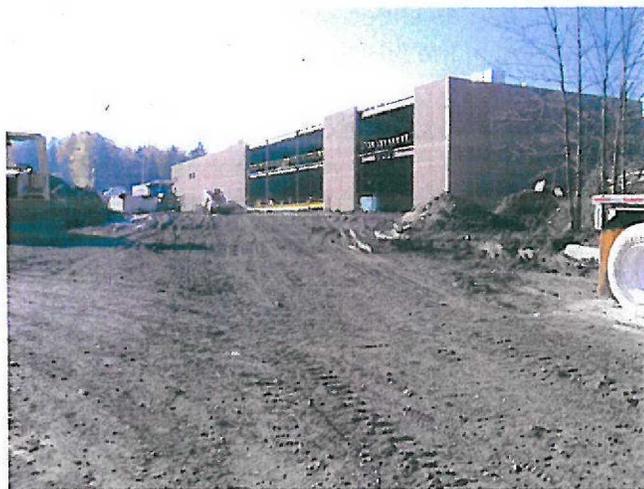
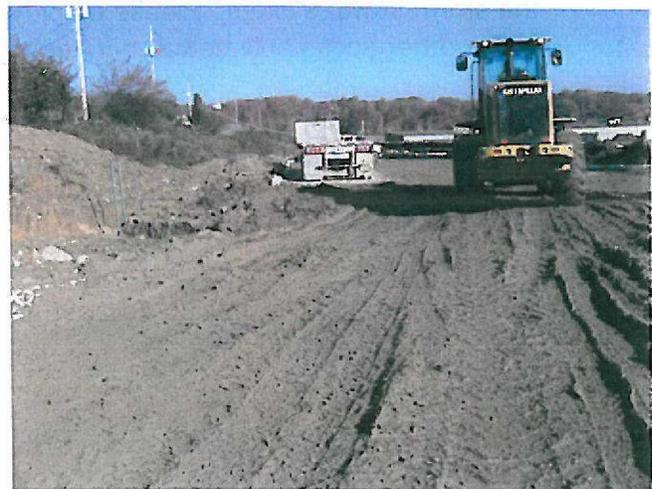
**Fig 3 & 4.** This photo (LEFT) is the transition area between the paved driveway and the disturbed areas of the construction site. The area has been stoned several times, but the rock surface is not being maintained. Additional measures such as a wheel wash are recommended. In addition, to prevent sediment-laden runoff from the disturbed areas from flowing down the paved driveway and off-site, a water bar is recommended at the top of the paved driveway to divert runoff toward a wheel wash pit, sediment pond or protected storm drain inlet. The photo on RIGHT is a view from the site looking down toward the paved driveway.

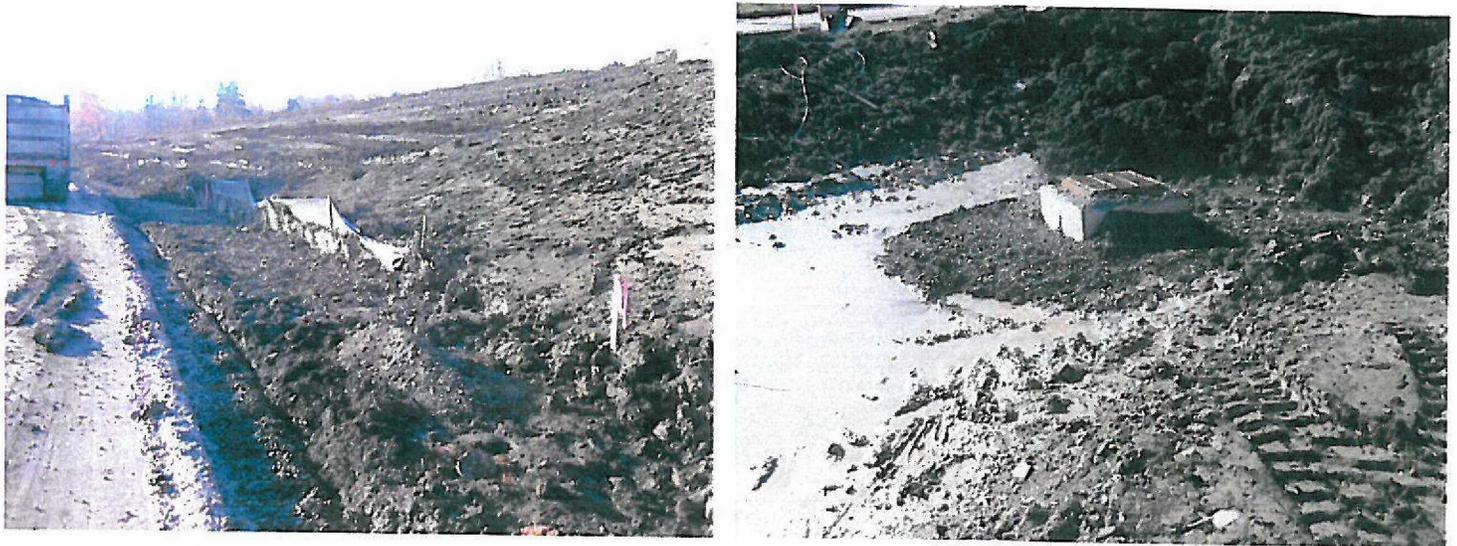
- Storm inlet protection is the only sediment control on this site; however, it has not been constructed per specifications contained in the storm water pollution prevention plan (SWP3). Please review the enclosed specifications for storm drain inlet protection from ***Rainwater and Land Development, Ohio's Standards for Stormwater Management, Land Development and Urban Stream Protection*** (Ohio Dept. of Natural Resources, 2006) and construct inlet protection per one of these accepted standards. From my review of the site, it appears that Excavated Drop Inlet Sediment Protection may be most

- Silt fence has been removed from the site perimeter, leaving perimeter slopes exposed with no sediment control to address them. Although we understand that silt fence was removed because it interfered with construction for road improvements on Royalton Road and Treeworth Blvd, rather than eliminating it completely, it should have been relocated such that it provides control for the still unstabilized slopes yet is out of the way of the Treeworth construction. Please reinstall silt fence as appropriate or apply permanent stabilization to perimeter slopes within seven days.

**Fig 5 (LEFT).** Silt fence previously installed along Treeworth Blvd has been removed or damaged by construction associated with improvements to Treeworth Blvd. Silt fence should be reinstated and the slopes should be final graded and permanently stabilized in a timely manner.

**Fig 6 (RIGHT).** Storm drain grates are generally wrapped in geotextile and many are above grade, but inlets have finger drains. Please note that the *Rainwater* manual recommends excavated drop inlet protection for this type of drain until final grading. After final grading, geotextile-stone inlet protection or commercially-available inlet protection is appropriate.

appropriate at this stage of construction for the catch basins that will be located within future paved areas. Appropriately-selected commercially-available storm drain inlet protection devices are also acceptable.

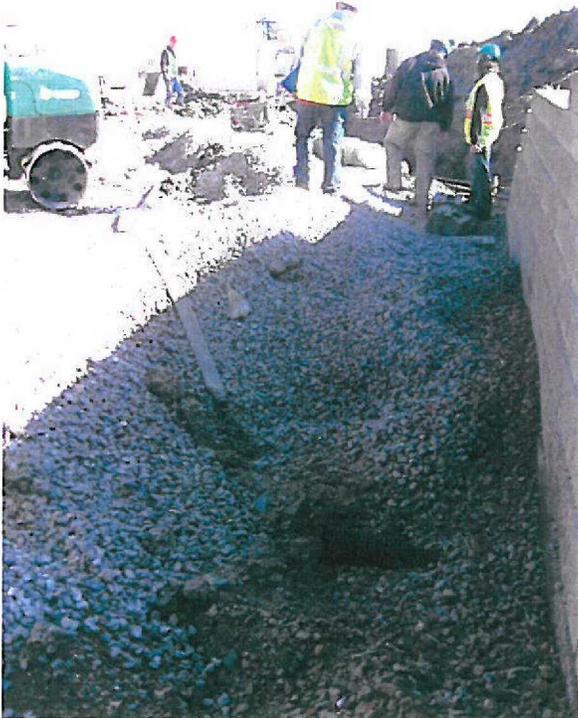
- The contractor had set up a dewatering operation for an excavation, but it was not in compliance with Part III.G.2.g.iv of the NPDES permit and specifications contained in the SWP3. The SWP3 indicates that a dewatering bag will be used. The NPDES permit allows additional options such as pumping to a sediment pond or settling in place. However, none of these practices were chosen. Rather, the contractor placed the discharge hose adjacent to what appears to be an underdrain pipe with a connection to the storm sewer system. Please employ a dewatering bag as stated in the SWP3 or one of the other acceptable dewatering techniques contained in the NPDES permit.

**Fig 7 (LEFT).** A hose has been set up to dewater a trench directly into an underdrain rather than a dewatering bag.

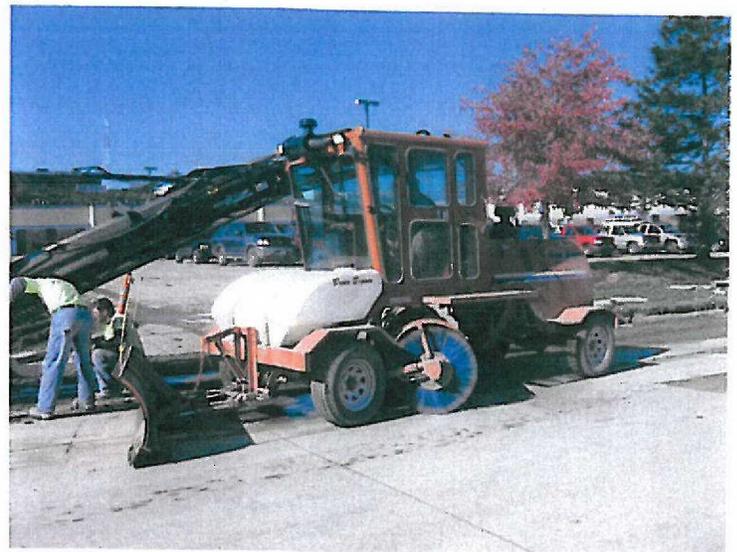
We noted that by the end of the inspection, the contractor had called Riley Sweeping, a contracted street sweeping company, to begin sweeping adjacent roads. In addition, the on-site broom sweeper was repaired and put back into operation. The broom sweeper is a Broce Broom CR350. In reviewing the product specifications for this product at the manufacturer's website ([www.brocebroom.com](http://www.brocebroom.com)), it should be noted that this sweeper does not have a dust pan to collect sediment, but simply dislodges it from the roadway and brooms it or pushes it off to the side. In addition, dust is kicked up into the air where it resettles on roadway surfaces. Please be aware that this does not accomplish the goals of street sweeping. In fact, on the manufacturer's website, the product is shown sweeping asphalt millings on a road resurfacing project but, it is followed by a truck that actually removes the dust and millings from the roadway. Thus, it appears that the Broce Broom CR350 is not the appropriate type of street sweeping product to clean up off-site tracking from a construction site.

**Fig 8 (ABOVE).** The Broce Broom CR350 is not equipped with a dustpan or other means to collect sediment.
