**Environmental
Protection Agency**

RE: CUYAHOGA COUNTY
CITY OF CLEVELAND
I-90 INNERBELT PROJECT
CONSTRUCTION STORM WATER

NOTICE OF VIOLATION

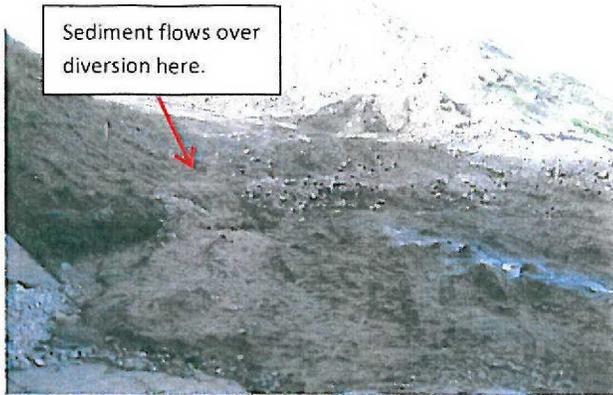
Fig 1 (LEFT). A diversion has been placed across the eastern construction entrance, but it may not be effectively directing runoff to the sediment basin pictured in Fig 2.

- **Diversion Needed to Sediment Basin.** Runoff is not adequately diverted to the aforementioned basin and some is bypassing it and running down Fairfield Avenue. Please construct a diversion such that runoff flows into and through the sediment basin before being discharged. Failure to construct diversions to intercept runoff and convey it to an appropriate sediment control is a violation of Part III.G.2.d.iii of the NPDES permit.

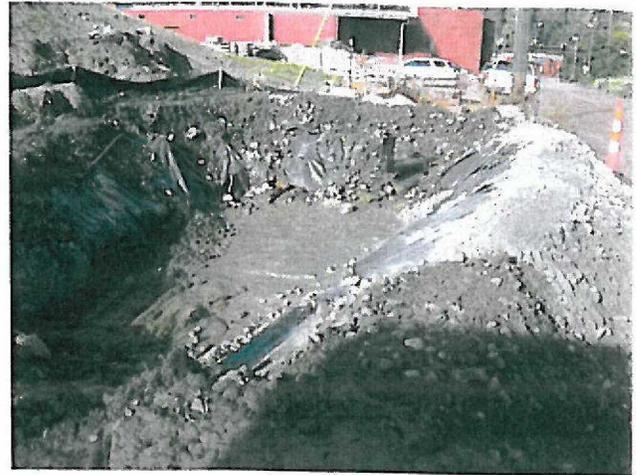
- **Integrity of Sediment Basin Embankment is Questionable.** A sediment basin has been added to control runoff from the eastern half of the construction activities occurring on the south side of Fairfield Avenue, however the embankment of this basin was constructed of stone, soil and granular fill and sits on top of pavement. Please ensure the embankment berm is structurally stable and is capable of ponding runoff within the basin.

Fig 2 (RIGHT). A sediment basin has been installed on Fairfield Road. The embankment consists of soil, stone and other granular materials.

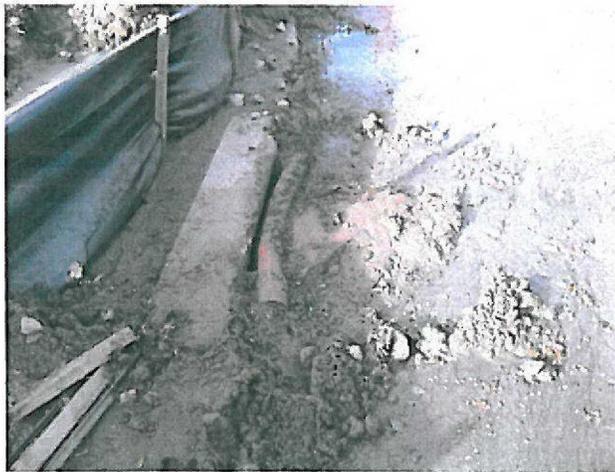
- **Storm Drain Inlet Protection Requires Maintenance.** Storm drain inlet protection I-27, I-52 and I-53 require maintenance. Although Dandy Curb Bags have been installed on these inlets, either the curb filter is not placed against the curb or holes have been cut into the bags. In either case, this would allow sediment-laden runoff to enter catch basins without ponding. In addition, sediment that accumulates on the Dandy Curb Bags must be removed from time to time to ensure continued function. Failure to maintain storm drain inlet protection so that it performs its intended function is a violation of Part III.G.2.h of the NPDES permit. Please clean, repair or replace storm drain inlet protection as needed.

Fig 3 (LEFT). Inlet protection I-27 requires maintenance. Remove accumulated sediments and ensure that the curb filter is resting against the curb.

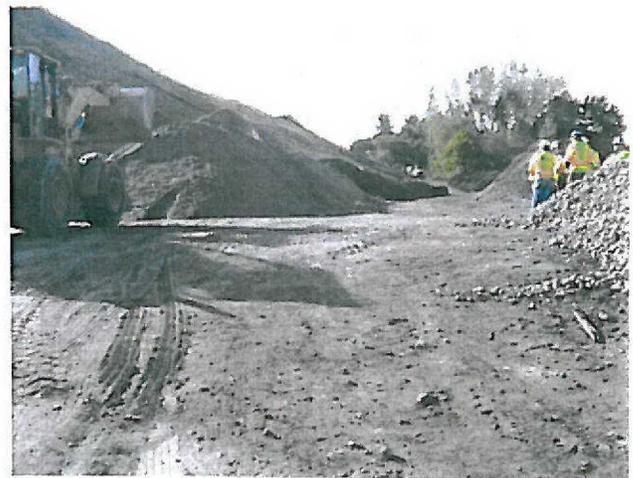
Fig 4 (RIGHT). No sediment control has been provided for the western portion of this area. The contractor places a rock check dam across the construction entrance pictured here, and removes it each work day (note pile on right side of photo).

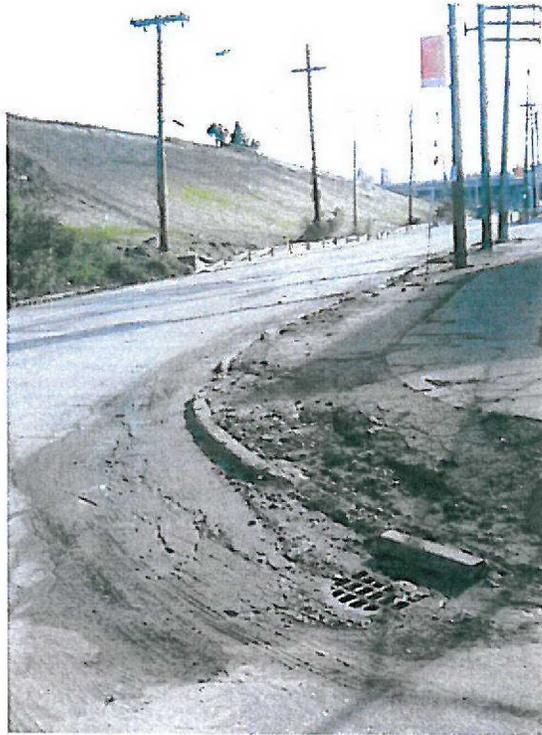
Fig 5. A plume of sediment flows west down Fairfield Avenue and into a storm sewer on Scranton Road.

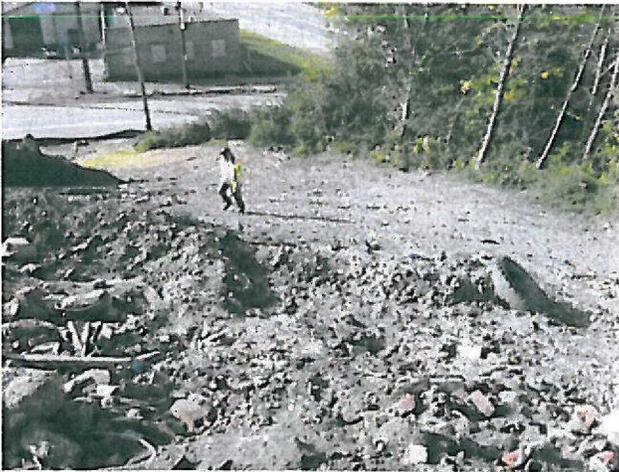
- **Additional Sediment Ponds Needed.** Sediment ponds must be installed to control runoff from areas where the design capacity of silt fence or storm drain inlet protection has been exceeded. Failure to implement sediment ponds is a violation of Part III.G.2.ii of the NPDES permit. This violation pertains to runoff from two areas of construction along Fairfield Avenue: (a) the west end of the construction area south of Fairfield Avenue and (b) the north side of Fairfield Avenue. The limits of silt fence usage can be found in Part III.G.2.d.iii of the NPDES permit. Rock check dams are a runoff control practice, not a sediment control practice. Rock check dams cannot substitute for sediment ponds. Please amend the SWP3 to provide sediment ponds capable of controlling runoff from these two areas of concern.

Fig 6 (LEFT). Filling has created a long, steep slope along the south side of Fairfield Avenue. The only sediment control is a silt fence. The allowable drainage area to silt fence has been exceeded. In addition, some of the runoff bypasses the silt fence.

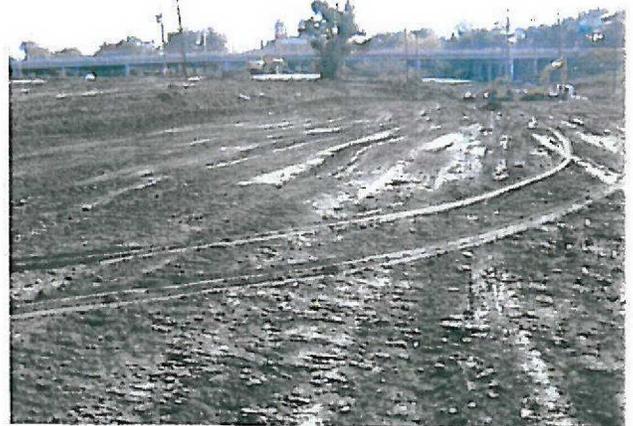
- **SB-1 Not Installed.** Failure to install sediment pond SB-1 within 7 days of first grubbing and prior to grading the area it is intended to control. This is a violation of Part III.G.2.d.i of the NPDES permit. The contractor indicates that the grade required to install SB-1 does not yet exist, so this is the reason it has not yet been installed. I indicated that this is a common problem with SWP3s for ODOT projects. They do not anticipate interim grades and do not provide the controls needed before final grade is reached. If SB-1 cannot be installed at this time, please amend the SWP3 to provide sediment controls which can be implemented at this time for the drainage area intended to be controlled by SB-1.

Fig 7 (RIGHT). SB-1 is to be located within this area, but has not been installed. Runoff flows east toward the construction entrance shown in Fig 8.

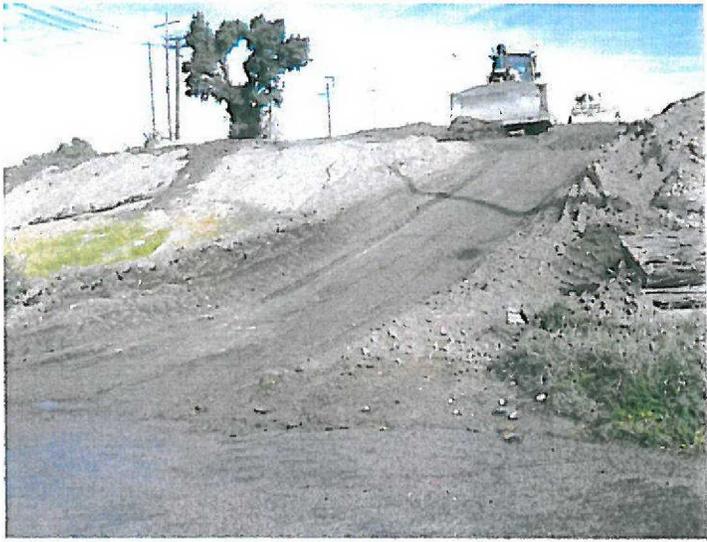
- **Rock Construction Entrance Needed.** Construction vehicles are accessing the area north of Fairfield Avenue from Fairfield Avenue, yet a stabilized rock construction entrance has not been provided. This results in off-site tracking of sediment onto Fairfield Avenue. Failure to control off-site tracking is a violation of Part III.G.2.g.ii of the NPDES permit.

Fig 8 (LEFT). Construction entrance on the north side of Fairfield Avenue. Note that it is not constructed per standard specifications for rock construction entrances and serves as a conduit for sediment-laden runoff to flow out onto Fairfield Avenue.

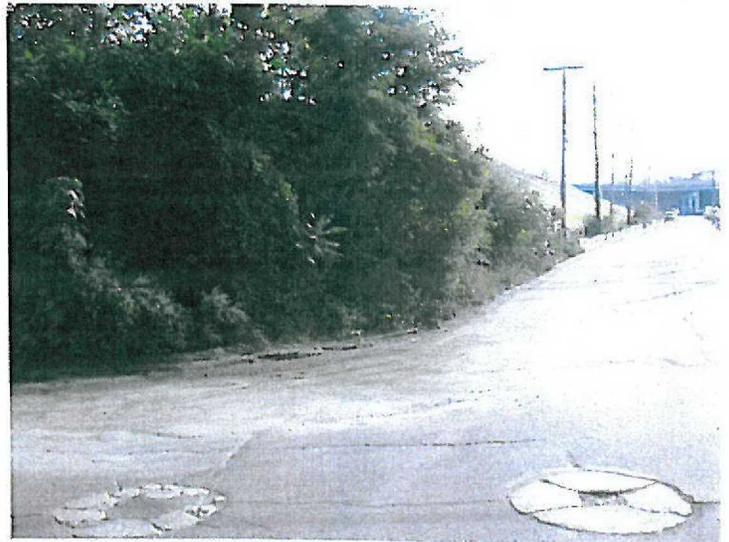
Fig 9 (RIGHT). Sediment flows west down Fairfield Avenue from the area of construction and continues down Scranton Rd. See photos below.

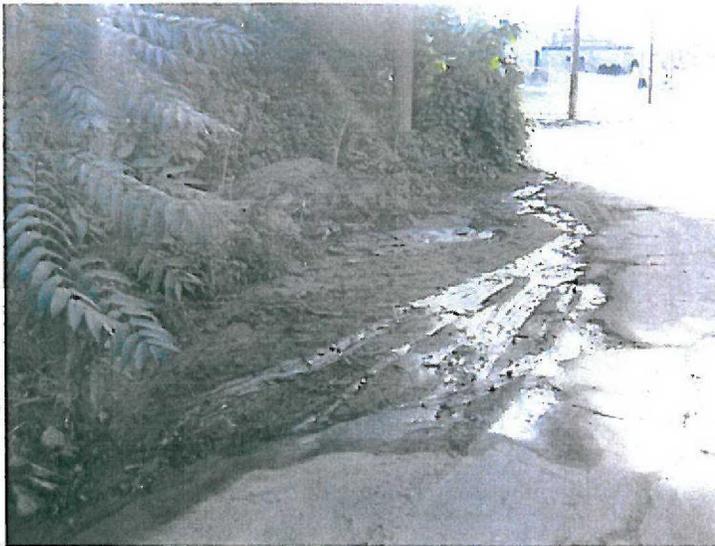
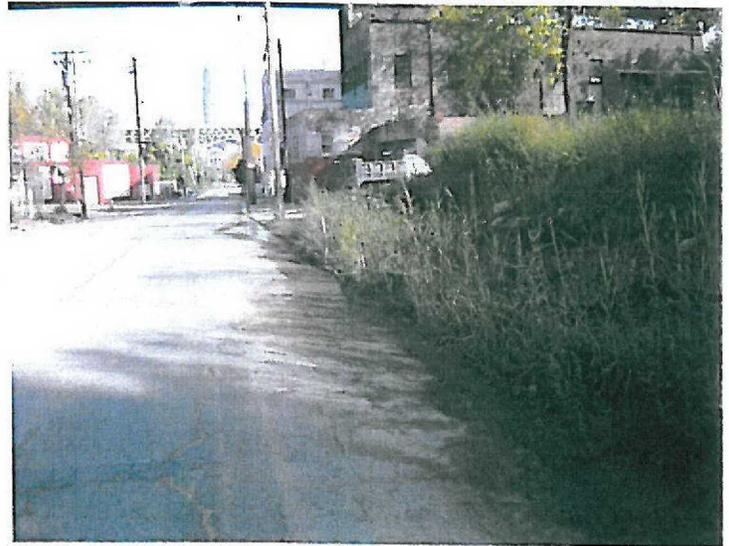
Fig 10 & 11. Sediment from the north side of Fairfield Avenue continues to flow north down Scranton Rd and into storm sewers located there.

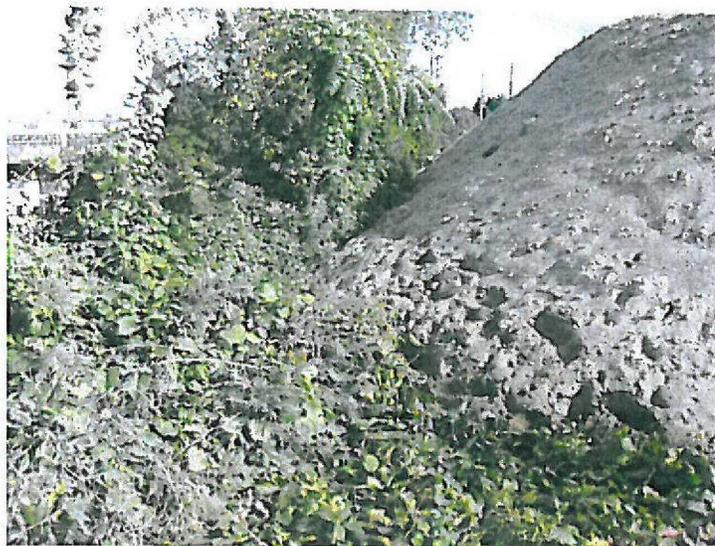
- **Controls Needed for Stockpiles.** There are stockpiles of sand and other fill materials placed along the top of the slope along the Norfolk Southern Railroad tracks and W. 15th St. Silt fence, compost filter sock or other perimeter sediment control is required around stockpiles of erodible material. Due to the placement of some of these piles, a tarp may be the only viable solution since there is limited to no room for perimeter controls or where silt fence cannot be staked into the ground and backfilled. A tarp cover will prevent contact with storm water and subsequent mobilization in runoff.

Fig 12 (LEFT). Stockpiles of erodible materials have been placed at the edge of the slope above the Norfolk Southern Railroad tracks. Either the stockpile can be pulled away from the edge so that silt fence can be installed, the pile can be stabilized with seed and mulch or it must be covered with a tarp to prevent off-site migration of sediment.

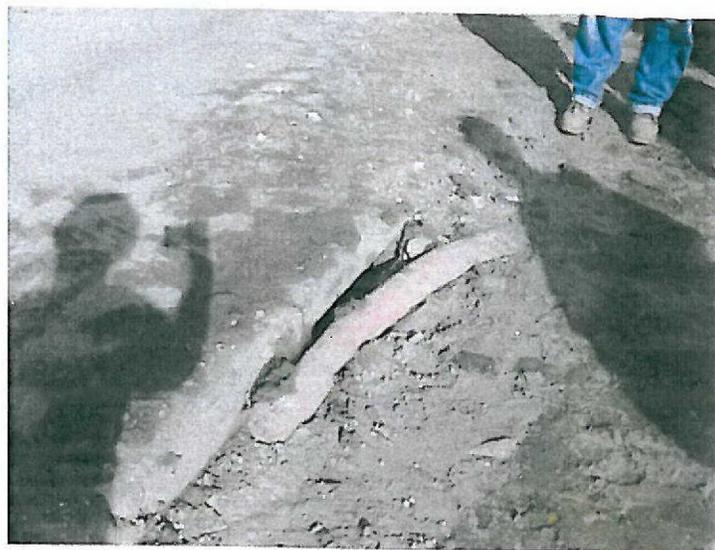
Fig 13 (RIGHT). I-52 has been installed, but requires maintenance. Accumulated sediments must be removed and the curb filter must rest against the curb.

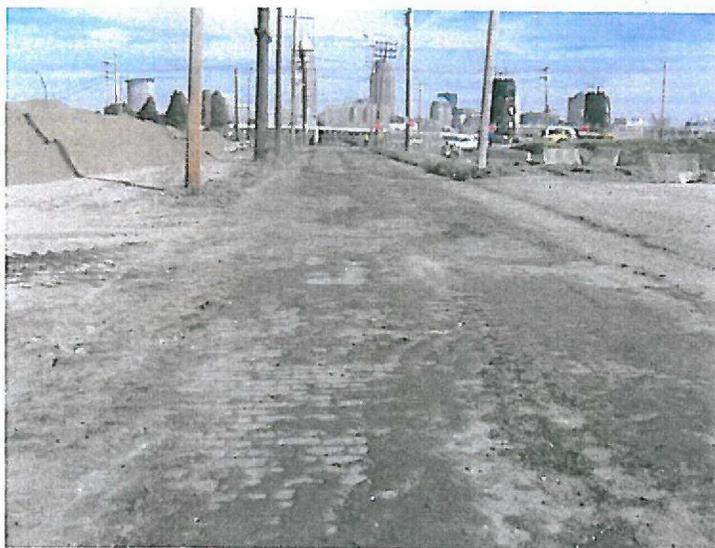
Fig 14 (LEFT). Sediments are tracked out onto W. 15th St. More frequent street sweeping is recommended.

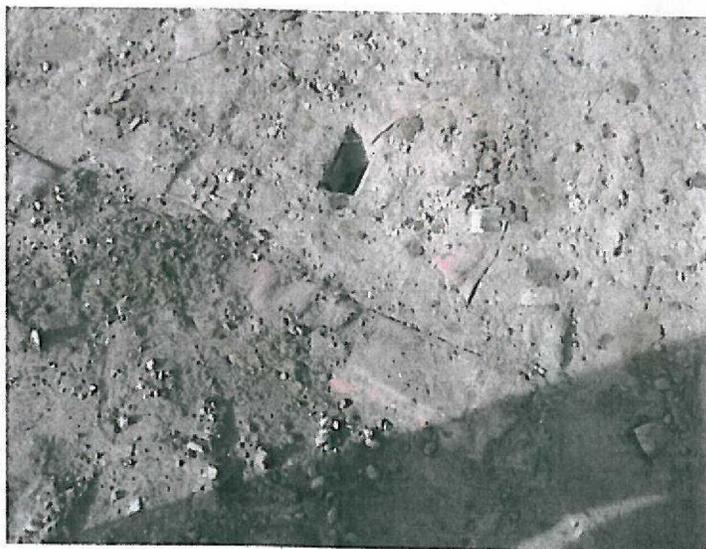
Fig 15 (RIGHT). I-53 has been installed, but a hole has been poked through the geotextile. This Dandy Bag must be replaced.

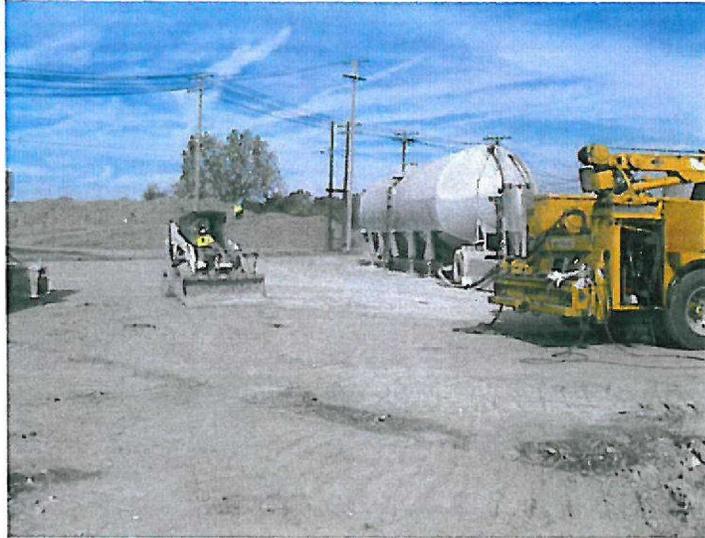
- **Good Housekeeping Needed Around Soil Stabilizer Tank.** Kiln dust from the soil stabilizer tank is spilled onto the ground during material transfer operations. Kiln dust that spills should be swept up as soon as possible to prevent mobilization by wind or storm water runoff. Failure to implement other controls to minimize the discharge of kiln dust and other non-sediment pollutants is a violation of Part III.g.2.g of the NPDES permit.

Fig 16. A dozer operator attempts to sweep up kiln dust spilled around the soil stabilizer tank. A street sweeper or push broom may do the job better.

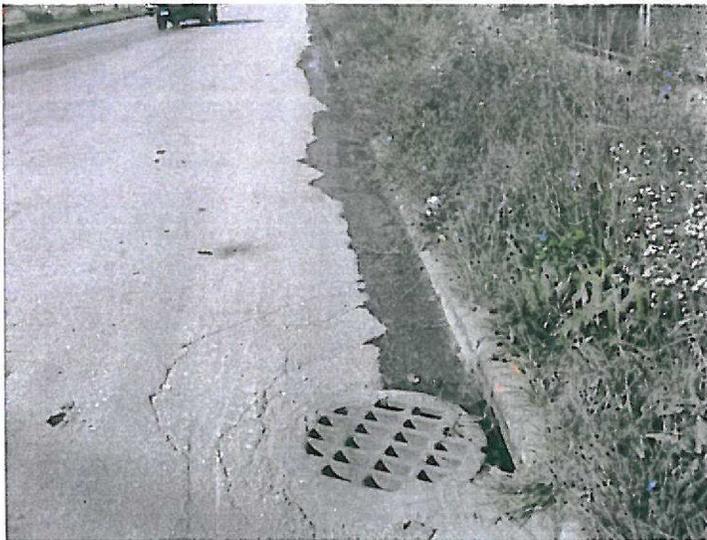
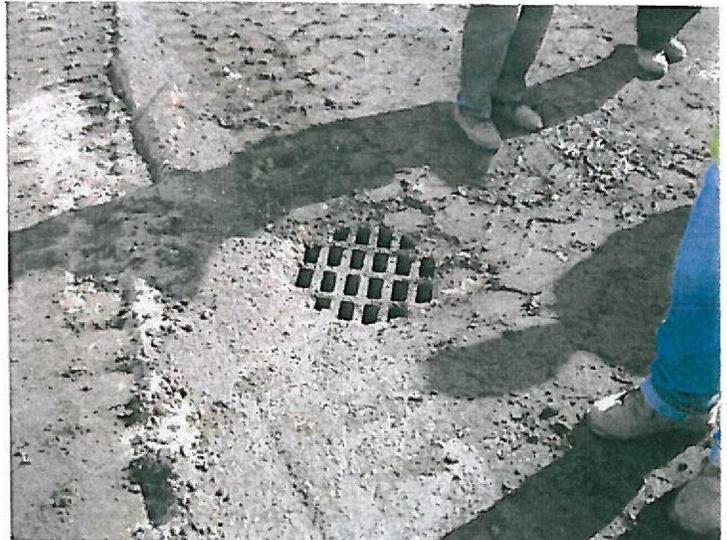
- **Storm Drain Inlet Protection Not Installed.** Storm drain inlet protection along Abbey Avenue (I-30 and I-34) has not been installed. Failure to install sediment controls within 7 days of the start of grubbing and prior to grading is a violation of Part III.G.2.d.i of the NPDES permit. Please install storm drain inlet protection on all active storm drainage systems.

Fig 17 & 18. I-30 and I-34 have not been installed, allowing sediments to enter the storm sewer system on Abbey Ave.

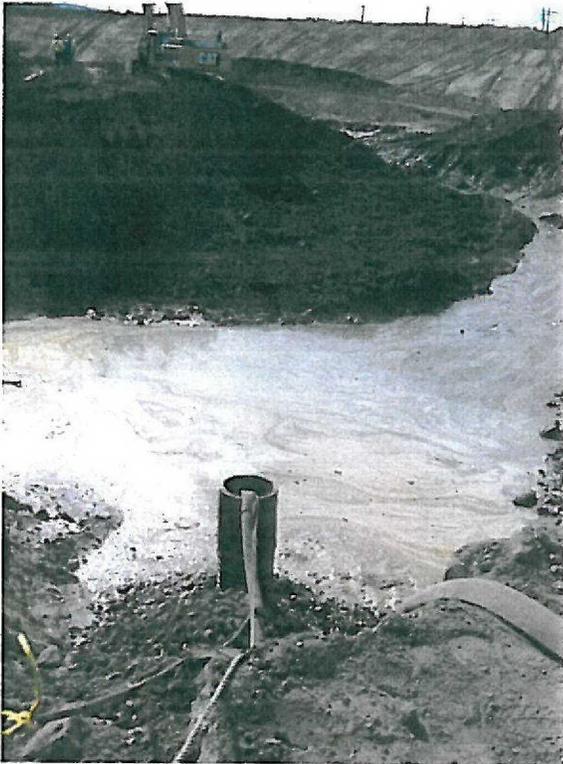
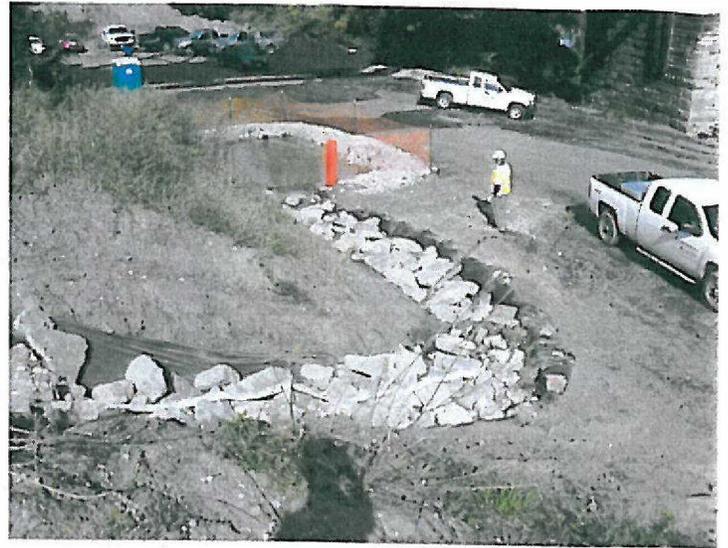
- **Conveyance of Discharge from Sump Pit.** A sump pit has been added on the south side of University Road. The discharge from the sump pit is directed to the north side of University Road and into Temporary SB-2. Please be aware that Temporary SB-2 is not sized to accept this runoff. The discharge from the sump pit should be routed around Temporary SB-2, but ensure that the discharge does not flow over disturbed portions of the site so as to mobilize sediment.

Fig 19 & 20. A sump pit has been established on the south side of University Rd, but its discharge is routed through Temporary SB-2. Temporary SB-2 has not been sized for this additional flow.

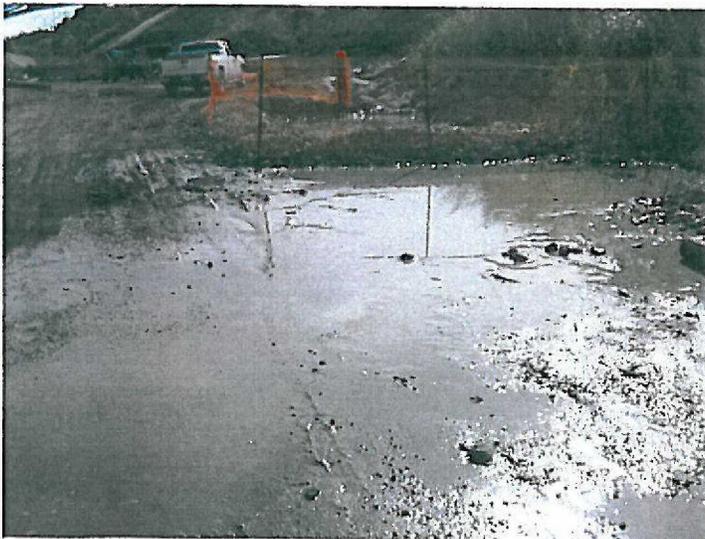
- **Integrity of Sediment Basin Embankment is Questionable.** Temporary SB-2 has been added to control runoff from University Road and portion of the area north of the road. However, the embankment was not constructed from compactible fill and runoff was observed seeping through the embankment. Please reconstruct the embankment using compactible soil such that it ponds runoff within the sediment basin and allows for discharge only from the riser pipe or emergency spillway. Please amend the SWP3 to show the location and sizing of Temporary SB-2.

Fig 21 (LEFT). The embankment of Temporary SB-2 is leaking resulting in a sediment-laden flow toward the Cuyahoga River.

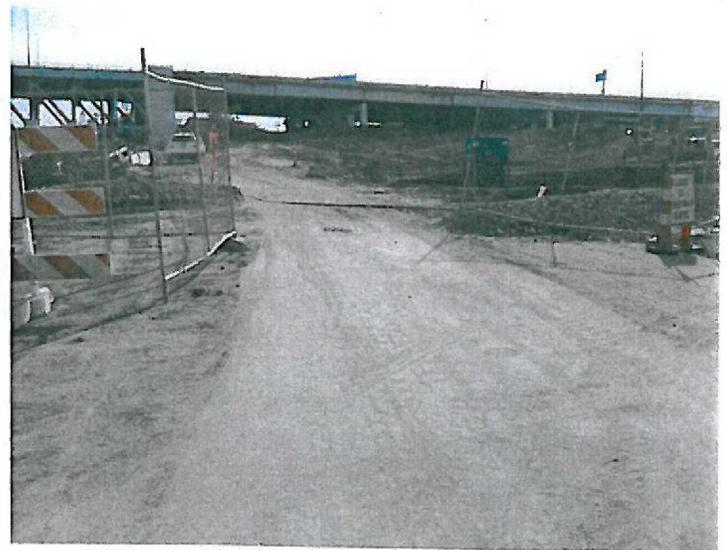
- **Diversion Across University Road Not Installed.** A diversion has not been installed across University Road to collect runoff and direct it to Temporary SB-2 as intended. As a result, runoff flows west off-project down University Road. Please install the required diversion.

Fig 22 (RIGHT). A diversion has not been established across University Rd. As a result, sediment migrates and is tracked off site rather than being diverted to Temporary SB-2. The fence marks the project boundary. Areas in the foreground are outside the project limits.

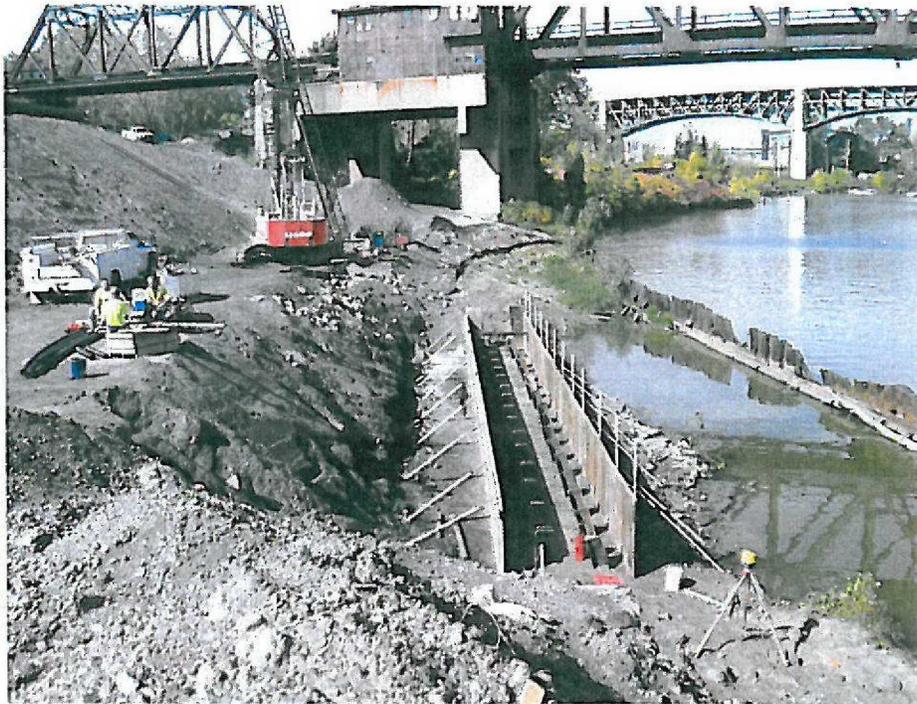
- **Drainage Area to Silt Fence along Cuyahoga River Exceeds Allowable Capacity.** The only sediment control downslope of Temporary SB-2 is silt fence placed along the Cuyahoga River. The drainage area to the silt fence exceeds the allowable capacities stipulated in Part III.G.2.d.iii of the NPDES permit. The contractor is concerned that installation of SB-2 and SB-3 as shown on the SWP3 will destabilize the slope above the Cuyahoga River. We discussed several options of how the drainage area to the silt fence could be reduced to meet allowable capacities and where additional sediment controls could be installed. Please amend the SWP3 to provide adequate sediment control for disturbed areas downslope of Temporary SB-2.

Fig 23. Additional sediment control measures are needed downslope of Temporary SB-2. Note that the only measure in place is a silt fence and it does not stretch across all areas of disturbance. Further, the drainage area to the silt fence exceeds allowable limits.

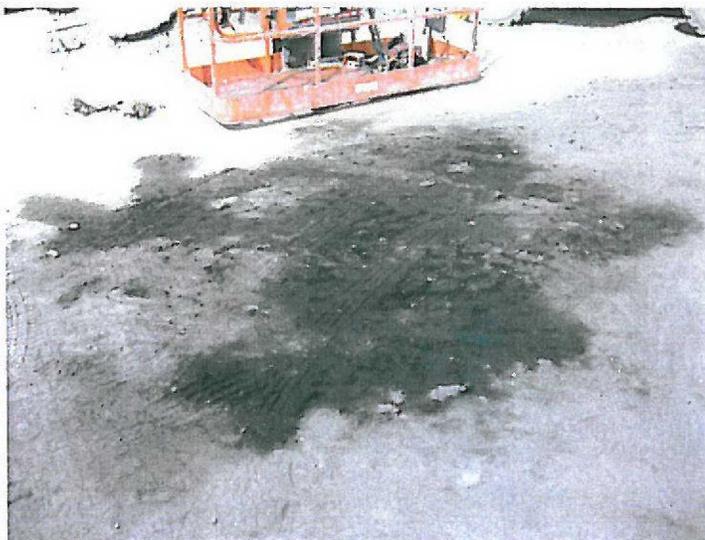
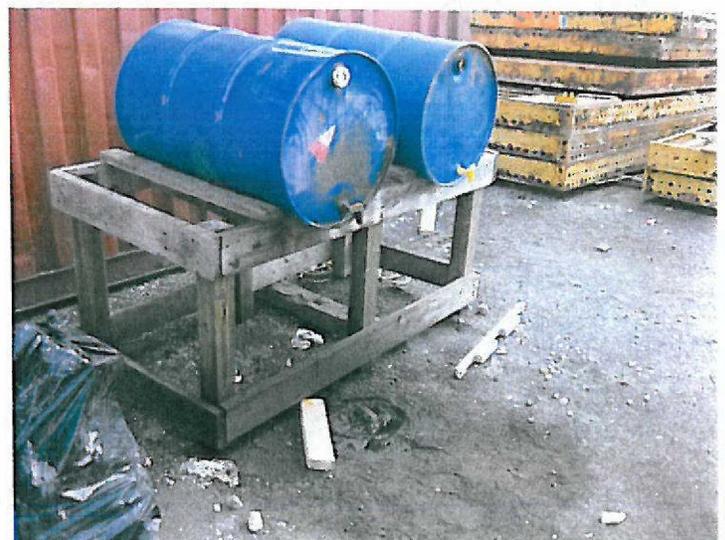
- **Spill Response.** I observed a spill of what appears to be automotive fluid from a construction vehicle near Pier 5 as well as fluid dripping from the spigot of a drum of curing compound at the drum storage area. There was no apparent attempt to clean up the spill or implement drip pans to prevent the mobilization of these pollutants by storm water runoff. Failure to implement non-sediment pollutant controls is a violation of Part III.G.2.g.i of the NPDES permit.

Fig 24 & 25. Additional training appears necessary regarding spill prevention and clean-up practices. Stains from construction vehicle fluid and a leaking drum of curing compound were observed on site.

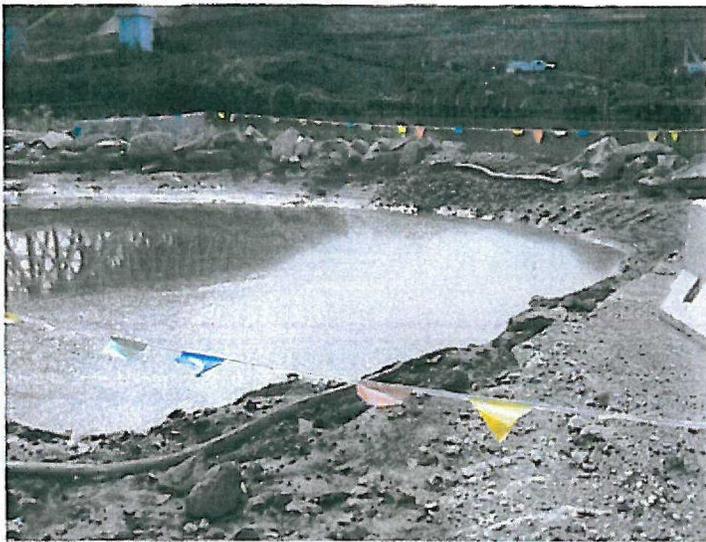
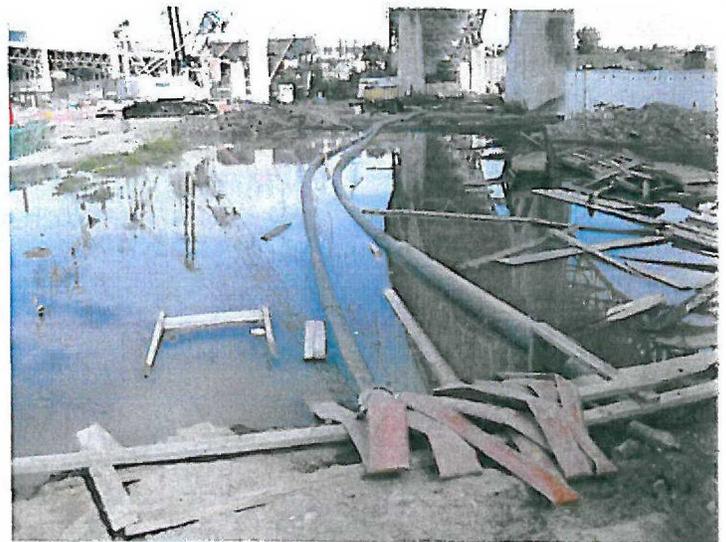
- **Stated Dewatering Practices Not Being Implemented.** The contractor is discharging trench and groundwater onto the ground. In their response letter dated August 29, 2011, to my previous inspection, KCI indicated that the contractor was to be using dewatering bags. It is Ohio EPA's expectation that the contractor will use the specified practice. Failure to implement allowable dewatering practices is a violation of Part III.G.2.g.iv of the NPDES permit.

Fig 26 & 27. Although some dewatering activity is being directed to a sediment basin or a dewatering bag (LEFT), some is just being pumped out onto the ground (RIGHT).

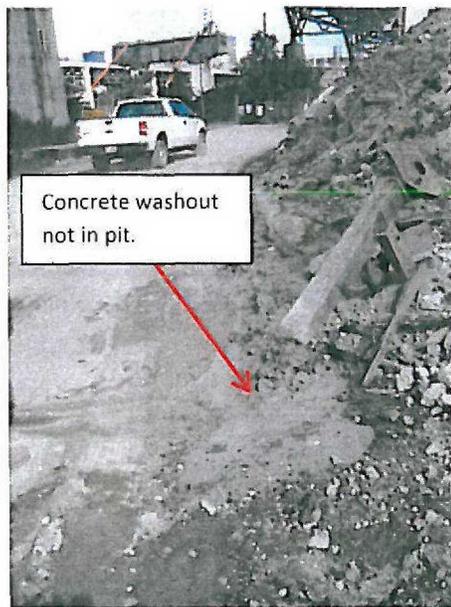
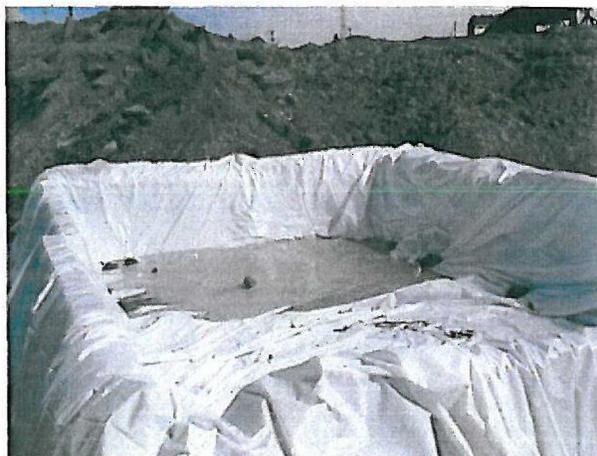
Fig 28 & 29. Although a concrete washout pit has been provided (RIGHT), truck drivers still need to be reminded to use it. Consider installing a sign to direct cement trucks to the pit.

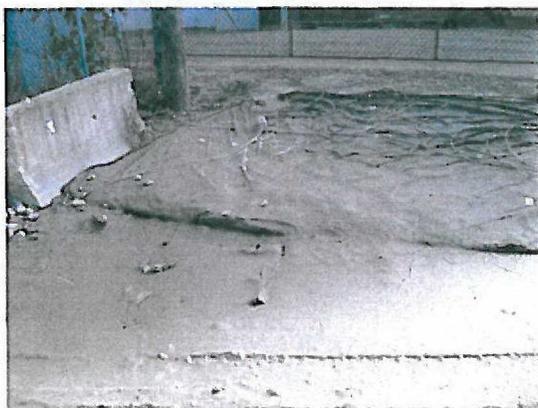
Fig 30. The combination of a dewatering bag and storm drain inlet protection appear to be effective at controlling sediment from dewatering activities. Please remove accumulated sediments from the inlet protection to allow maintain continued function.

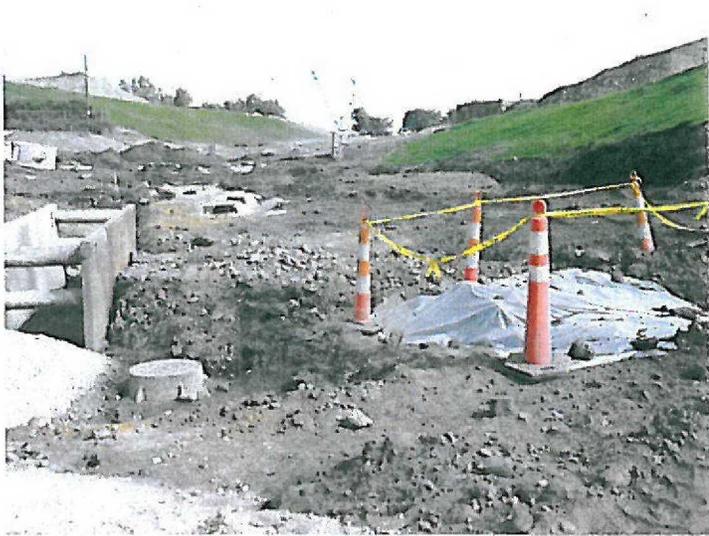
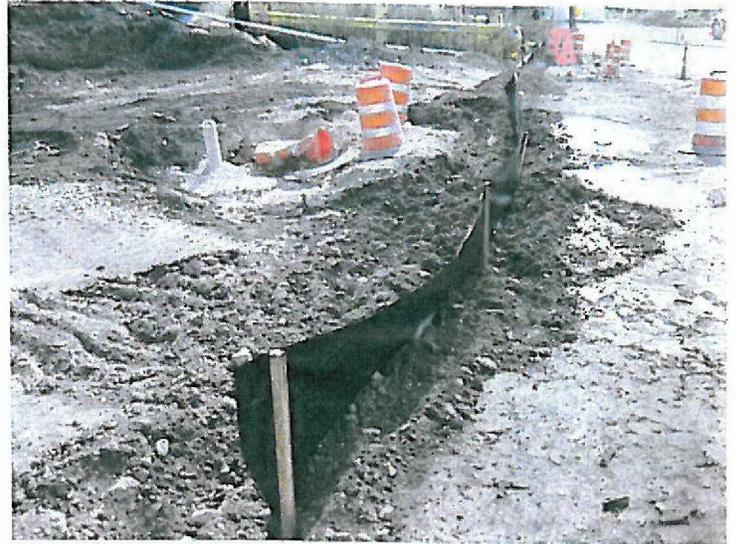
- **SB-2 Has Been Removed.** The temporary version of sediment basin SB-2 has been removed and replaced with a line of silt fence along Commercial Road and a sediment basin further upslope. Please be aware the drainage area to the silt fence exceeds the allowable capacity contained in Part III.G.2.d.iii of the NPDES permit. Please install SB-2 as shown on the SWP3 or amend the SWP3 to provide equivalent controls.

Fig 31 & 32. SB-2 has been removed (LEFT) and replaced with a line of silt fence (RIGHT). Note that the drainage area far exceeds the allowable limits for silt fence. A sediment pond must be re-established. **NOTE:** The plastic covers a previously unknown underground storage tank. Measures have been taken to provide cover over the area of contamination, but you may also want to install a berm to divert run-on away from the area of contamination.

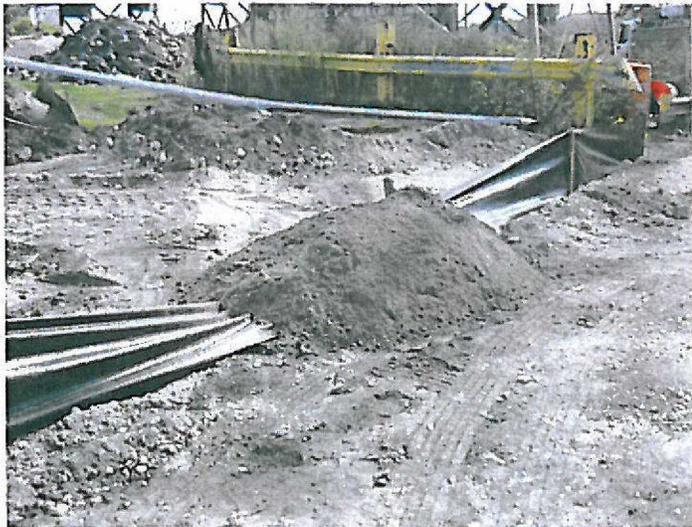
Fig 33 (LEFT). Soil has been placed on top of silt fence along Commercial Road. This compromises the function of silt fence.

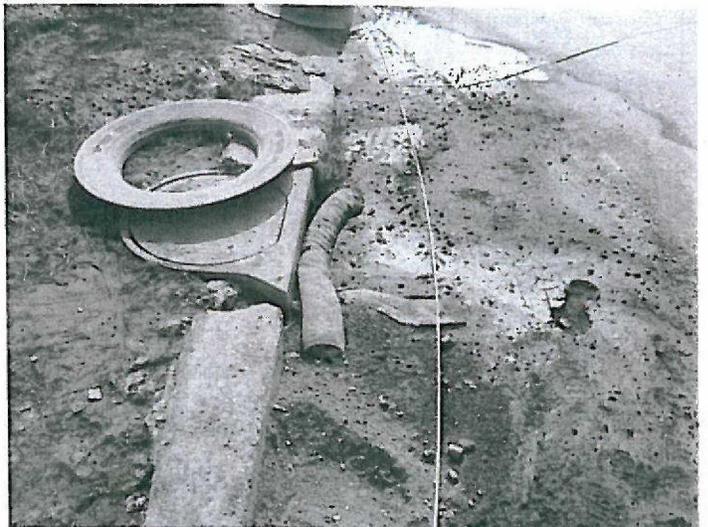
Fig 34 (RIGHT). Storm drain inlet protection along Commercial Rd requires maintenance. Note that the curb filter does not rest against the curb allowing sediment to enter the storm drain.

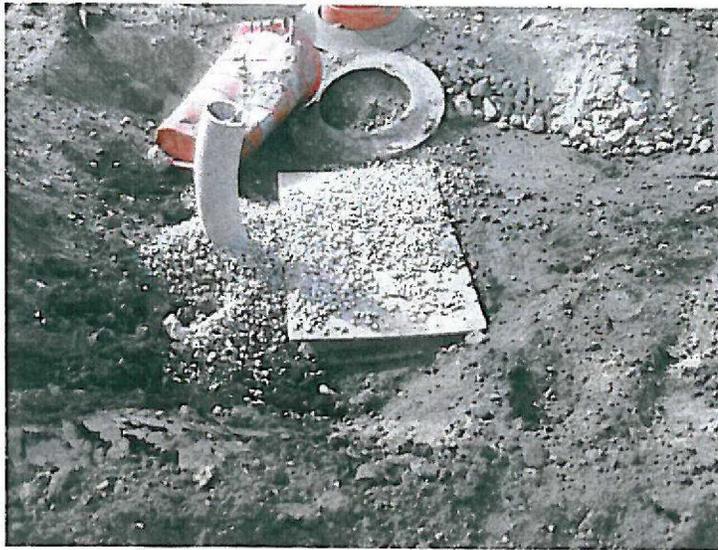
- **Inlet Protection for New Storm Sewer System.** The contractor has begun to install the storm sewer system that will service the new E. 9th St. Extension. Measures must be taken to keep sediment from entering the storm sewer system. Currently, the contractor has only placed plywood boards and gravel across openings in the manhole castings, but this is not adequate to keep sediment out of the storm sewer.

Fig 35 (LEFT). The storm sewer system for E. 9th St. Extension is currently being installed, however measures to keep sediment out of the sewer system is adequate. Here, a plywood board has been placed over a manhole.

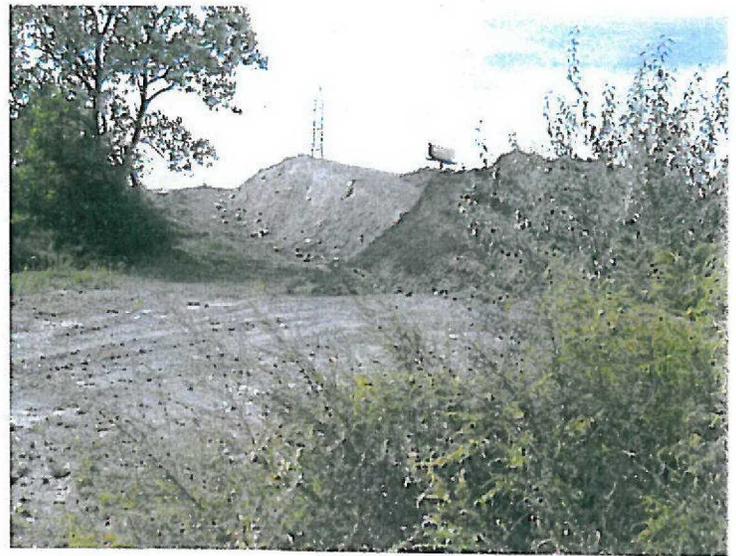
- **Additional Silt Fence Needed.** Soil has been stockpiled in an area between the proposed East 9th Street Extension and the Norfolk Southern Railroad tracks. Silt fence is required around the stockpile to control runoff. Please amend the SWP3 to show the location of this stockpile and the silt fence.

Fig 36 (RIGHT). Silt fence must be installed around the back side of the soil stockpiles between Commercial Rd and the Norfolk Southern Railroad tracks. This area slopes down toward the railroad and then to the Cuyahoga River.

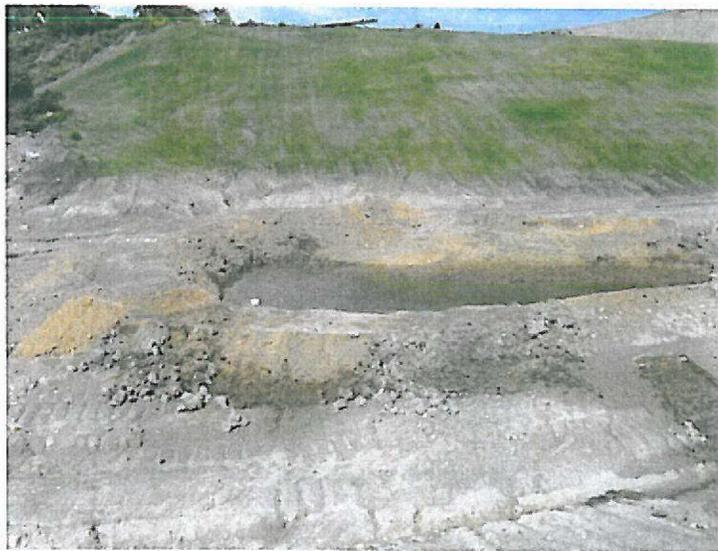
Fig 37 (LEFT). There has been an attempt to establish a sediment basin for at least a portion of the E. 9th St. Extension area, but this basin is not shown on the SWP3. Further, it appears to simply discharge out onto disturbed soils, defeating the purpose of the basin.

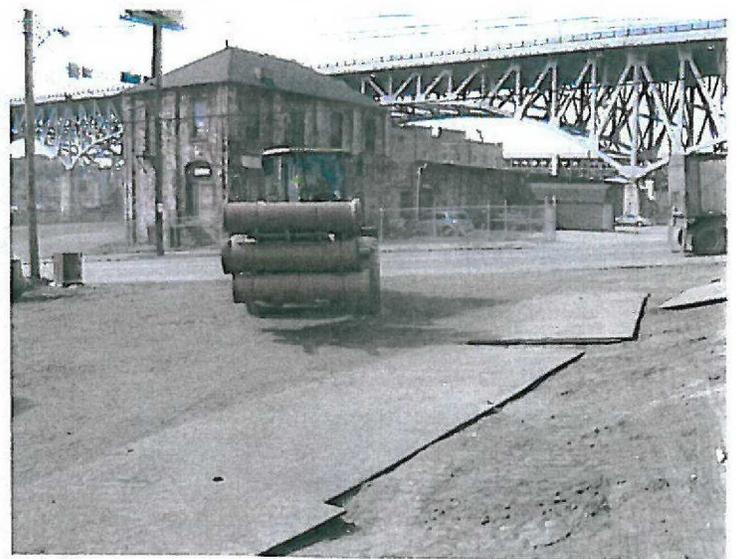
- **Rock Construction Entrance Needed off Commercial Road.** Construction vehicles are accessing the site off Commercial Road in an area not shown on the SWP3. A rock construction entrance has not been installed in this location. Please install a rock construction entrance at the location shown in the SWP3 or amend the SWP3 to provide construction entrances at desired locations.

Fig 38 (RIGHT). Construction vehicle accesses the site off Commercial Road. No rock construction entrance has been established.

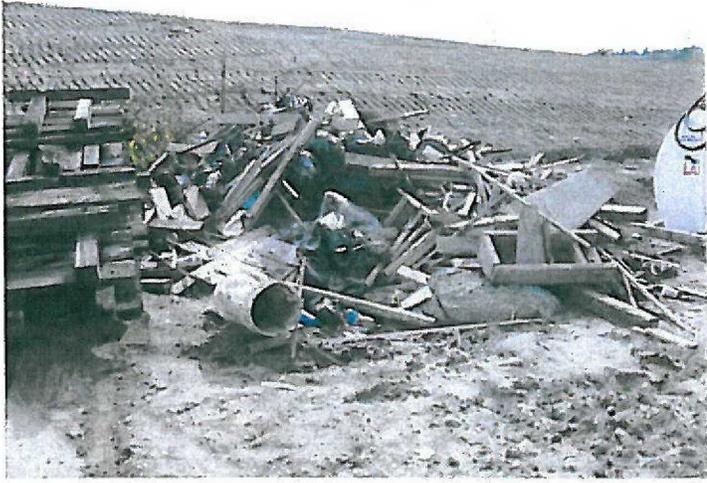
- **Improper Storage of Solid Waste.** Solid waste from the construction site was observed piled on the ground. Please provide a lidded or tarped dumpster for the disposal of solid waste. Failure to implement non-sediment pollutant controls is a violation of Part III.G.2.g.i of the NPDES permit.

Fig 39 (ABOVE). Trash and other solid waste must be stored in dumpster, not on the ground.

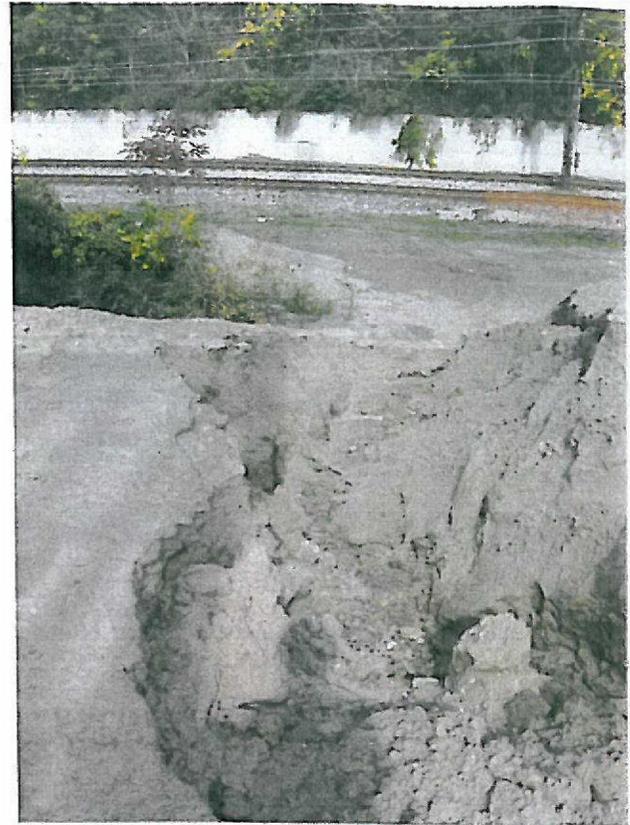
- **Erosion Gully at Bridge 13.** An appreciable erosion gully was observed at the abutment of Bridge 13. The erosion gully must be repaired and the area draining toward the abutment may need to be regraded to prevent reoccurrence. In addition, silt fence F-13 must be installed to control sediment. Failure to install silt fence within 7 days of grubbing and prior to grading is a violation of Part III.G.2.d.i of the NPDES permit.

Fig 40 (RIGHT). An erosion gully has formed near the Bridge 13 abutment. Silt fence F-13 has not been installed at the base of the slope along the RTA tracks.

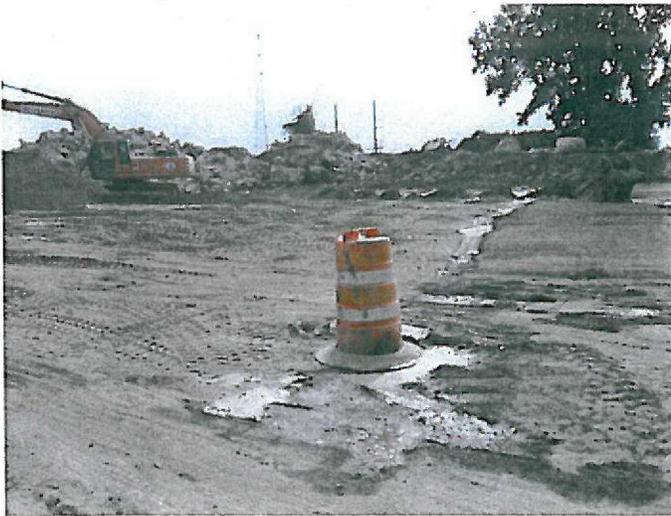
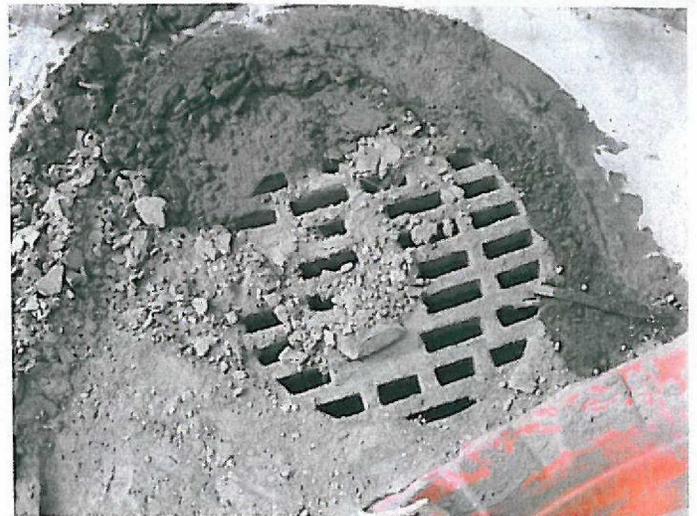
- **Inlet Protection Not Installed.** Storm drain inlet protection I-65 has not been installed. I observed a flow of sediment to this storm drain, which was simply covered with a construction barrel at the time of inspection. Failure to protect storm drain inlets is a violation of Part III.G.2.d.iv of the NPDES permit.

Fig 41 & 42. I-65 has not been installed. Rather, it has been covered by a traffic barrel. As a result, sediment has entered the storm drain system.

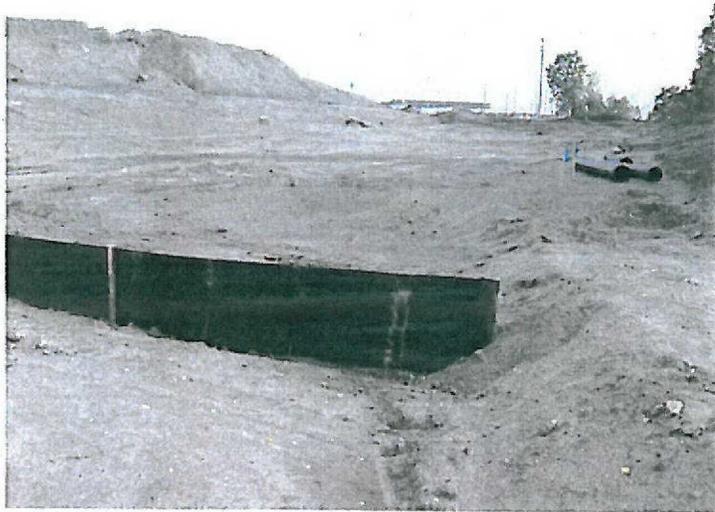
- **Additional Sediment Pond Needed.** Although a silt fence has been placed across the proposed S. Broadway Ave., the drainage area to the silt fence appears to exceed the allowable capacity contained in Part III.G.2.d.iii of the NPDES permit. Please review the drainage area and if it exceeds the capacity of silt fence, please install a sediment pond to address runoff from this area. The sediment pond would be located somewhere in the vicinity of C-4.

Fig 43 (LEFT). A silt fence has been placed across the width of the future S. Broadway Ave., the drainage area directed to it exceeds the allowable capacity of silt fence. This area likely will require a sediment pond.

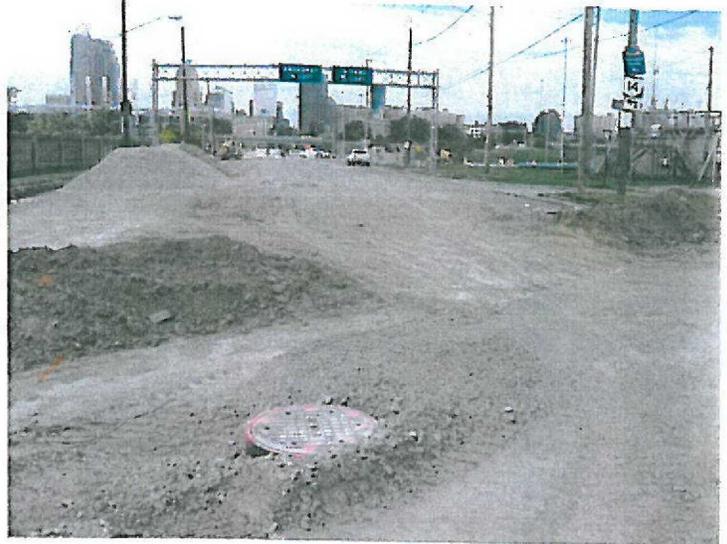
- **Construction Entrances Not Installed.** Off-site tracking of sediment onto Broadway Avenue and W.14th St. were evident because there are no stabilized construction entrances to access this construction area. Failure to control off-site tracking is a violation of Part III.G.2.g.ii of the NPDES permit. Please install rock construction entrances at appropriate locations.

Fig 44 (RIGHT). There is no rock construction entrance to access the site off existing Broadway Ave.

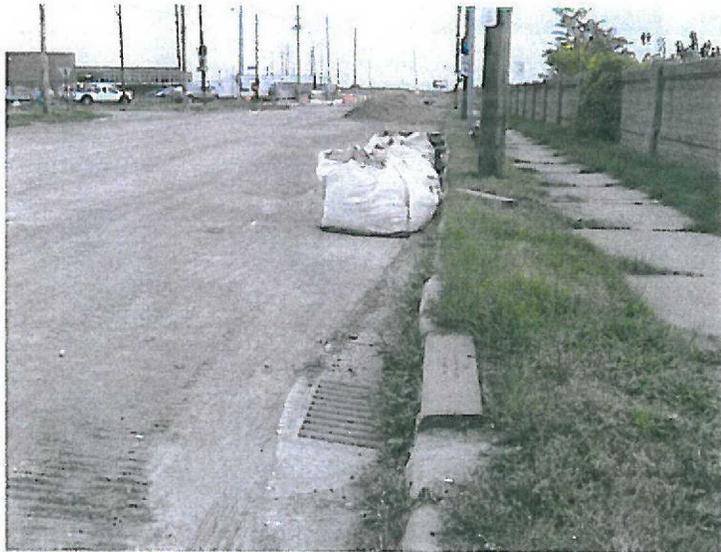
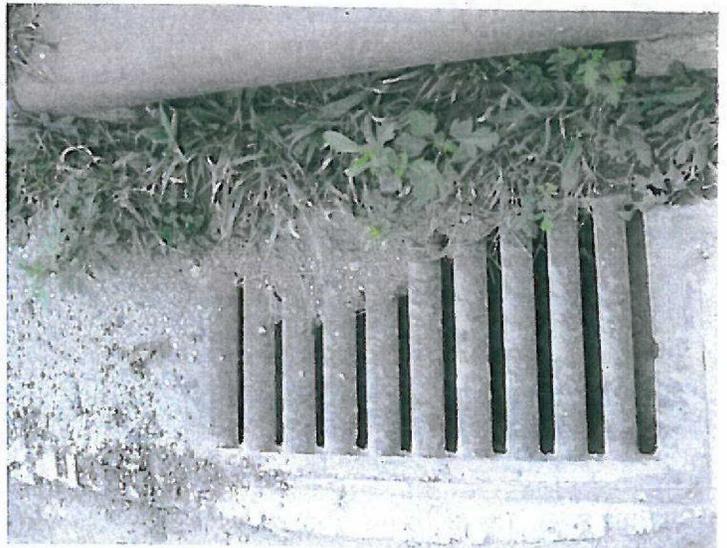
- **Inlet Protection Not Installed.** Storm drain inlet protection has not been provided on I-53, I-53B, I-70, I-71 or I-72. Please install to minimize discharges of sediment to the storm sewer system.

Fig 45 & 46. Existing storm drain inlets along Broadway Avenue, E. 14th St and Orange Avenue are not protected, allowing sediment to enter the storm drain system.
