**Environmental
Protection Agency**

RE: CUYAHOGA COUNTY
CITY OF CLEVELAND
I-90 INNERBELT PROJECT
CONSTRUCTION STORM WATER

NOTICE OF VIOLATION

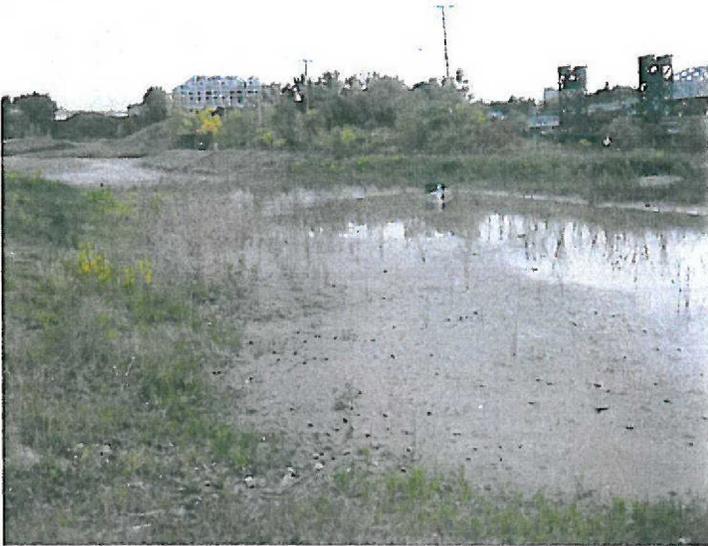
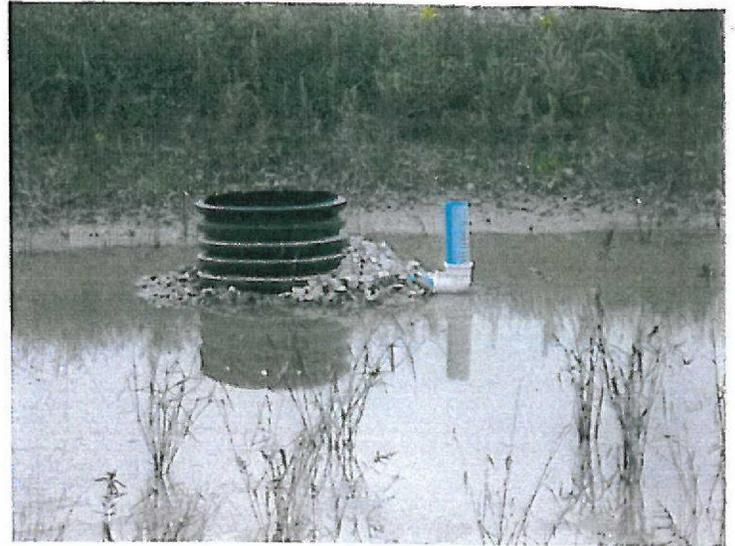
- **Riser Pipe Not Per Specification.** Sediment basin SB-1 has been installed, but the riser pipe has been slotted rather than designed per the schedule for number of holes and hole diameter contained in the SWP3. Please ensure that the riser provides a minimum 48-hour drawdown for the dewatering volume of the SB-1.

Fig 47 & 48. SB-1 has been installed and appears to be effective. However, the outlet structure installed does not match the design specified in the SWP3.

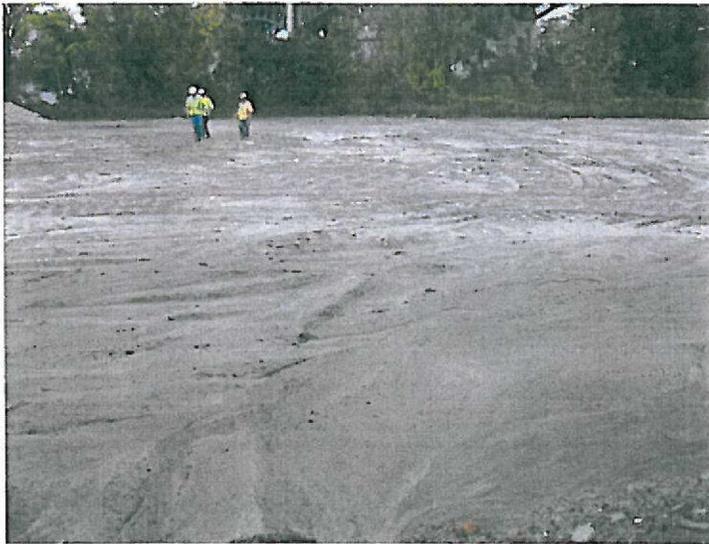
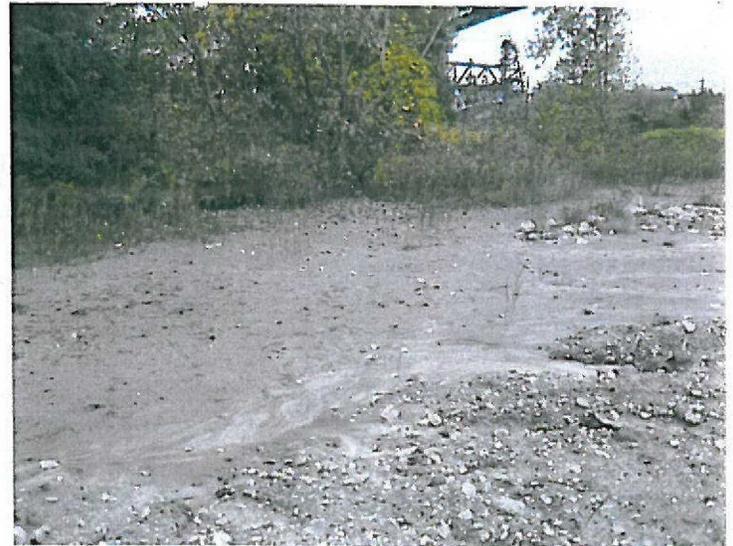
- **Additional Sediment Ponds Needed.** Upon review of the site, it appears that two additional sediment ponds are required. The SWP3 indicates that runoff from the SE portion of the site is to be diverted to SB-1. However, due to topography, this is not possible. As such, an additional sediment pond is required in the SE corner of the site. In addition, the 2.40-acre drainage area depicted in the SWP3 discharges primarily at one spot. Thus, the silt fence depicted in the SWP3 is not adequate. Please amend the SWP3 to provide a sediment trap for the 2.40-acre drainage area.

Fig 49 & 50. The SE corner of the staging area is shown as tributary to SB-1 on the SWP3, but it drains off to the SE corner of the site instead. An additional sediment basin is needed in the SE corner to address this.
