Environmental
Protection Agency

October 25, 2011

RE: ASHTABULA COUNTY
CITY OF CONNEAUT
CITY OF CONNEAUT EAST SIDE
INDUSTRIAL PARK
NPDES PERMIT NO. OHR000004
OEPA PERMIT NO. 3GC04614*AG
CONSTRUCTION STORM WATER

Notice of Violation

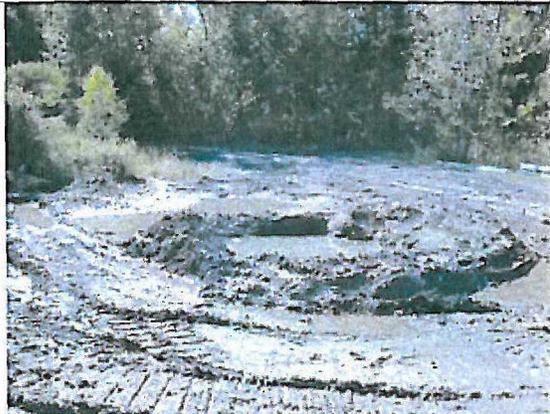
- The sediment basins depicted on the site's SWP3 have not been installed. Sediment-laden runoff was discharging directly into Conneaut Creek (Figure 1). **The sediment basins must be immediately installed with properly designed dewatering skimmers.** The failure to provide structural practices to control erosion and trap sediment from a site remaining disturbed for more than fourteen (14) days constitute violations of Ohio Revised Code (ORC) chapter 6111.07 and Part.III.B and Part III.G.2.c of the General Storm Water Permit.
- The diversion channel located south of the Conneaut Creek is being dewatered via a pump and is pumping sediment-laden runoff directly to "surface waters of the State" (Figure 2) **The southern sediment basin must be immediately**

Figure 1 - Sediment-laden runoff was discharging directly into Conneaut Creek.

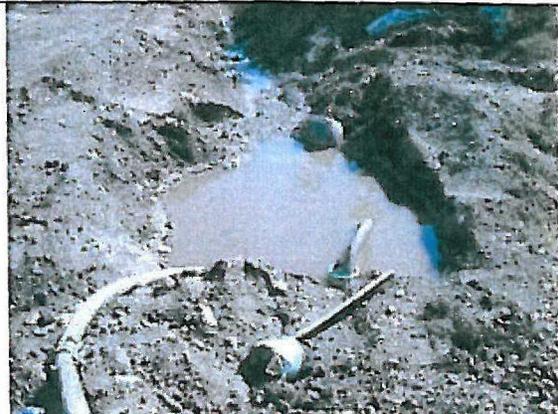
installed with properly designed dewatering skimmers. The failure to provide proper dewatering BMPs constitute violations of ORC chapter 6111.07 and Part III.G.2.g.iv of the General Storm Water Permit.

Figure 2 - Sediment-laden runoff is being pumped directly to Conneaut Creek.

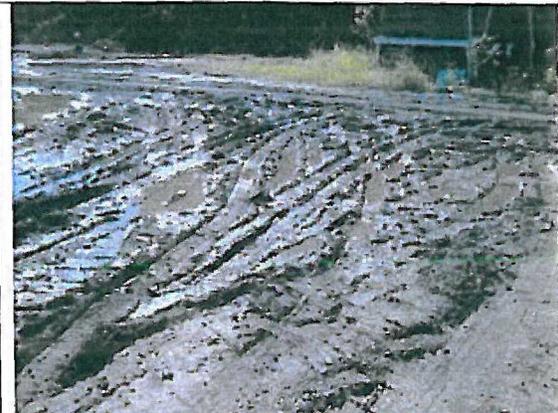
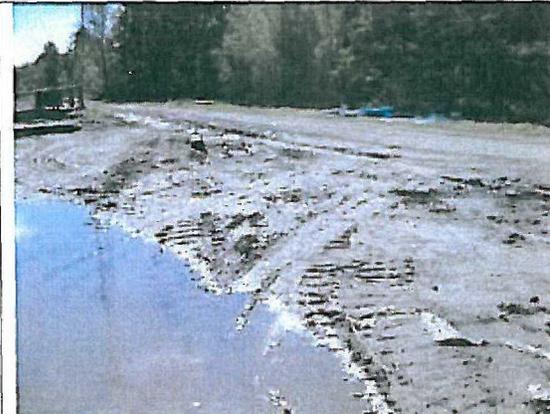
- No construction entrances have been installed to prevent the offsite tracking of sediment (Figures 4 to 5). Properly designed construction entrances must be installed in location where construction vehicles access the site. The failure to prevent the offsite tracking of sediment constitutes violations of ORC chapter 6111.07 and Part III.G.2.g.ii of the General Storm Water Permit.

Figure 4 - No construction entrances have been installed to prevent the offsite tracking of sediment.

Figure 5 - No construction entrances have been installed to prevent the offsite tracking of sediment.

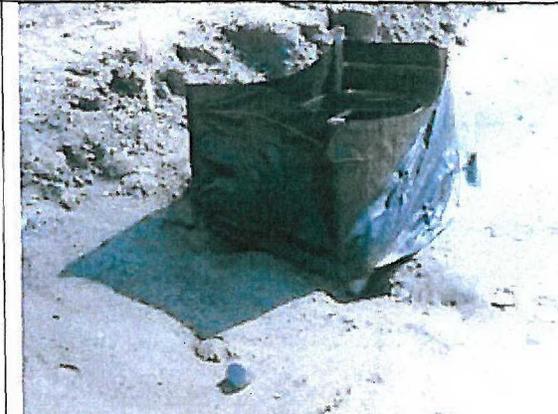
- Inlet protection has not been installed correctly and must be trenched into the ground and backfilled (Figure 6). All sediment control practices must be capable of ponding runoff in order to be considered functional. Failure to have functional inlet protection constitutes violations of ORC chapter 6111.07 and Part III.G.2.d of the General Storm Water Permit.

Figure 6 - Inlet protection has not been installed correctly.

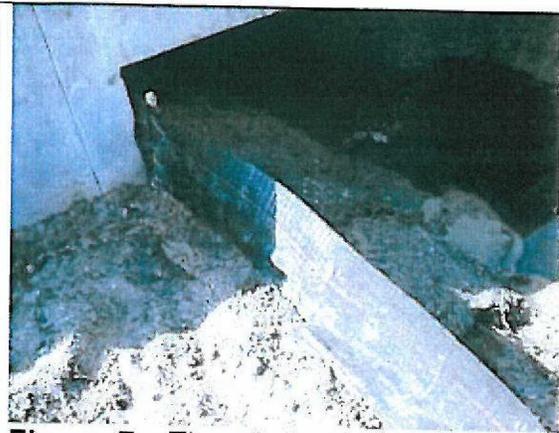
- Silt fence has been installed along the Conneaut Creek; however, the silt fence was failing in many locations and requires maintenance (Figure 7). In addition, silt fence is depicted on the SWP for installation south of the cul-de-sac. The silt fence has not been installed in this location. All sediment control practices must be capable of ponding runoff in order to be considered functional. Failure to have functional silt fence constitutes violations of ORC chapter 6111.07 and Part III.G.2.d of the General Storm Water Permit.

Figure 7 - The silt fence was failing in many locations.

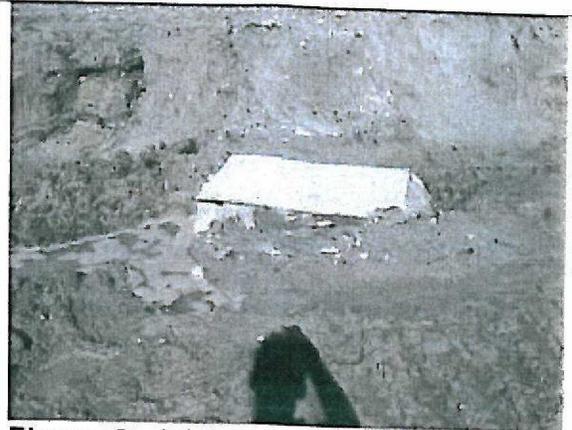
- The site's storm sewer system has been installed south of the Conneaut Creek. Inlet protection has not been installed to prevent sediment-laden runoff to "surface waters of the State" (Figure 8). Failure to have functional inlet protection constitutes violations of ORC chapter 6111.07 and Part III.G.2.d of the General Storm Water Permit.

Figure 8 - Inlet protection has not been installed to prevent sediment-laden runoff.

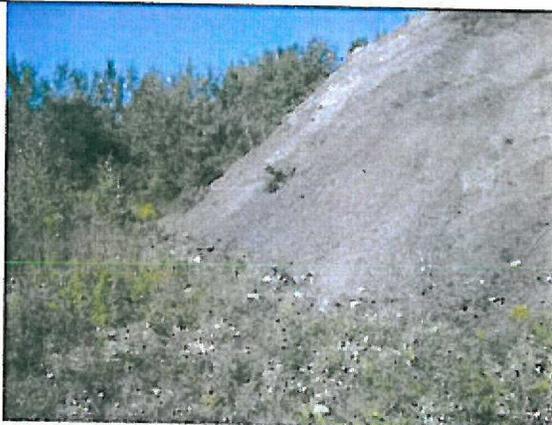
- No BMPs have been installed to prevent the discharge of sediment-laden runoff from the soil stockpile area (Figure 9). Silt fence must be installed around the soil stockpile area. If the soil stockpile area will remain idle, temporary stabilization must be performed. The failure to have BMPs installed constitute violations of

ORC chapter 6111.07 and Part III.G.2.b.i and Part III.G.2.d and Part of the General Storm Water Permit.

Figure 9 - No BMPs have been installed to prevent the discharge of sediment-laden runoff from the soil stockpile area.
