State of Ohio Environmental Protection Agency

June 10, 2009

Karel Vande Kolk
Chesterfield Dairy, LLC
15710 County Road 14
Lyons, OH 43533

Re: **Notice of Violation** – Noncompliance with NPDES permit

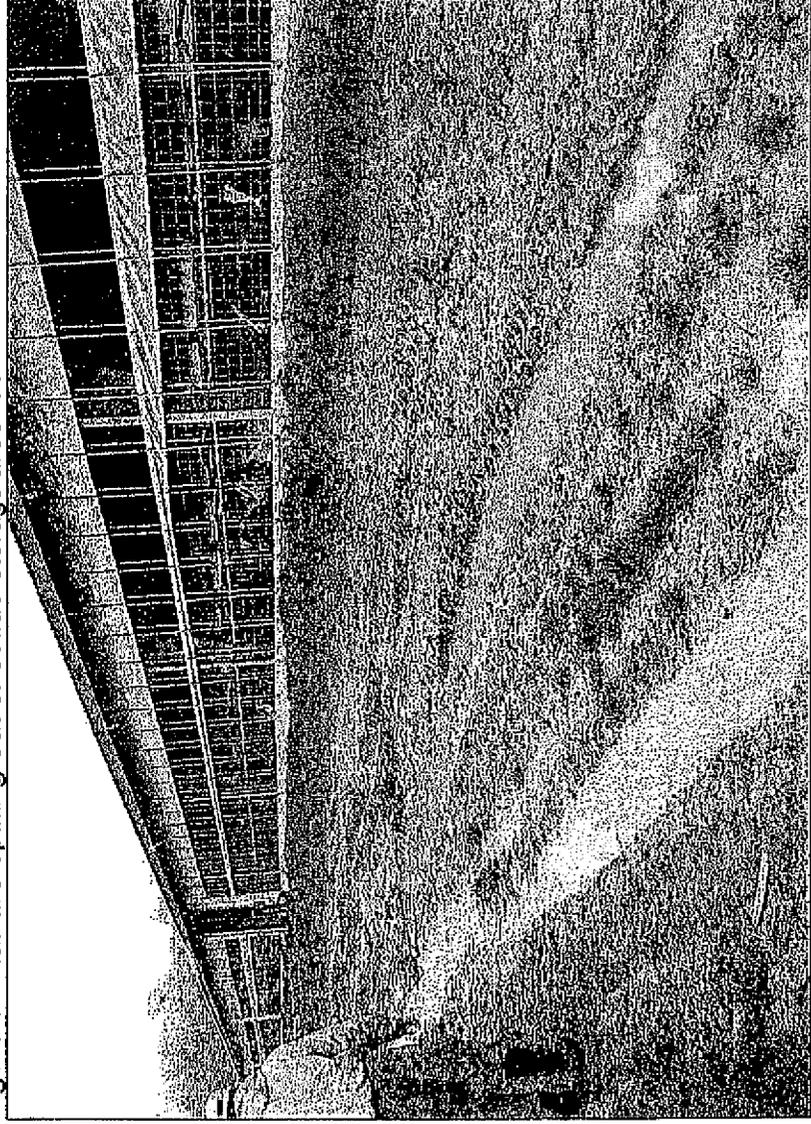
Figure 6. Area north of free stall barn in need of seeding

4. **Practice better housekeeping.** There were several areas around the dairy which were in need of greatly improved housekeeping, especially the area around the solids storage pad "A". Efforts must be made to ensure that manure and other contaminants are kept away from direct contact with stormwater which may leave the site. You should also attempt to seed locations where bare soil is exposed, such as the area next to the north free stall barn (See Figure 6).

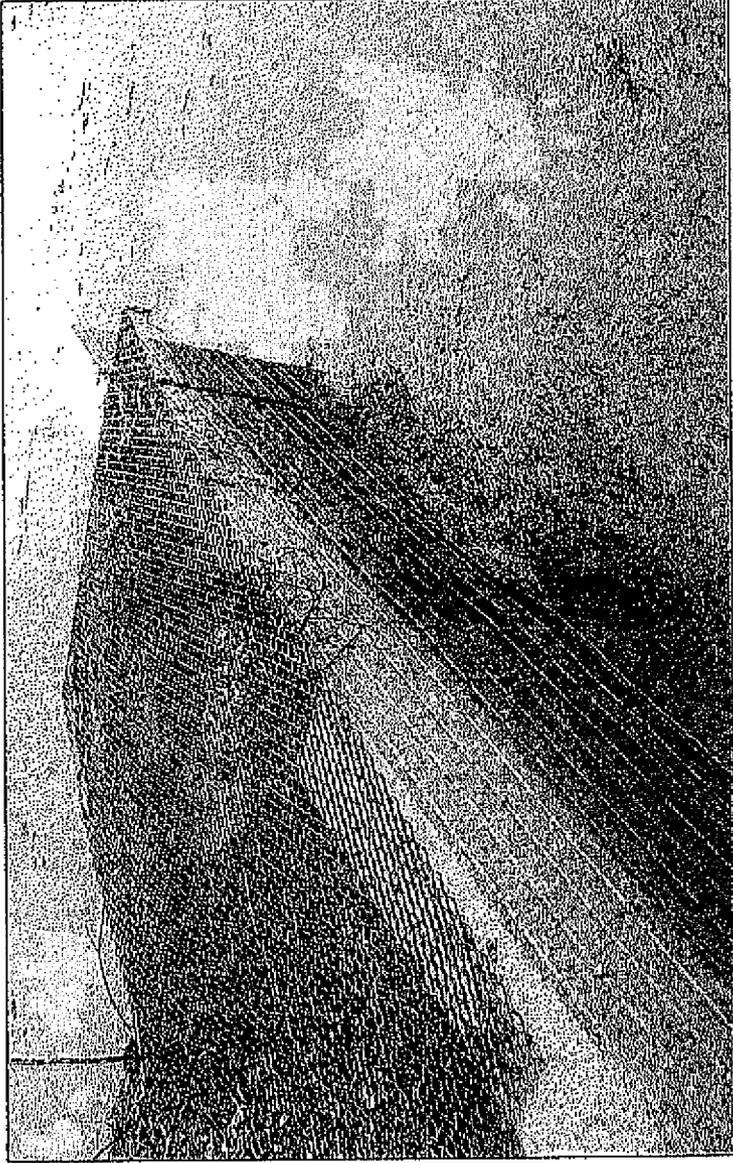
It was alternating between a light rain and heavier rain during the April 30 inspection. The concrete settling basin was observed first during the visit. The basin appeared to have at least one foot of freeboard. However, ODA noted that during their April 29 partial inspection the basin did not have the required one foot of freeboard and capacity for the 100-year, 24-hour storm. Prior to my inspection, the manure level in this basin was taken down approximately two feet with the manure applied to a field just south of the facility. See Figure 1. Even though the manure was worked into the field, the application was done in violation of your NPDES permit. According to www.noaa.gov, there was an 80% chance of precipitation on April 30 with at least 1/2" of rain expected through May 1.

Figure 1. Concrete settling basin with previous manure level visible

- 1. Complete the actions required of Chesterfield Dairy by ODA in their March 2, 2009 inspection report.** These actions include pouring a concrete pad on the east side of the concrete settling basin, installing additional curbing on the concrete driveway on the east side of the barns, and constructing a permanent solution to address any potential leachate or runoff from the north or south sides of the silage storage area. These actions are to be completed by September 15, 2009.
