State of Ohio Environmental Protection Agency

**RE: YMCA Camp Wilson Reconnaissance Inspection, NPDES Permit No.
1PR00052*CD/OH0046451, Logan County**

NPDES Compliance Inspection Report

Inspection Findings

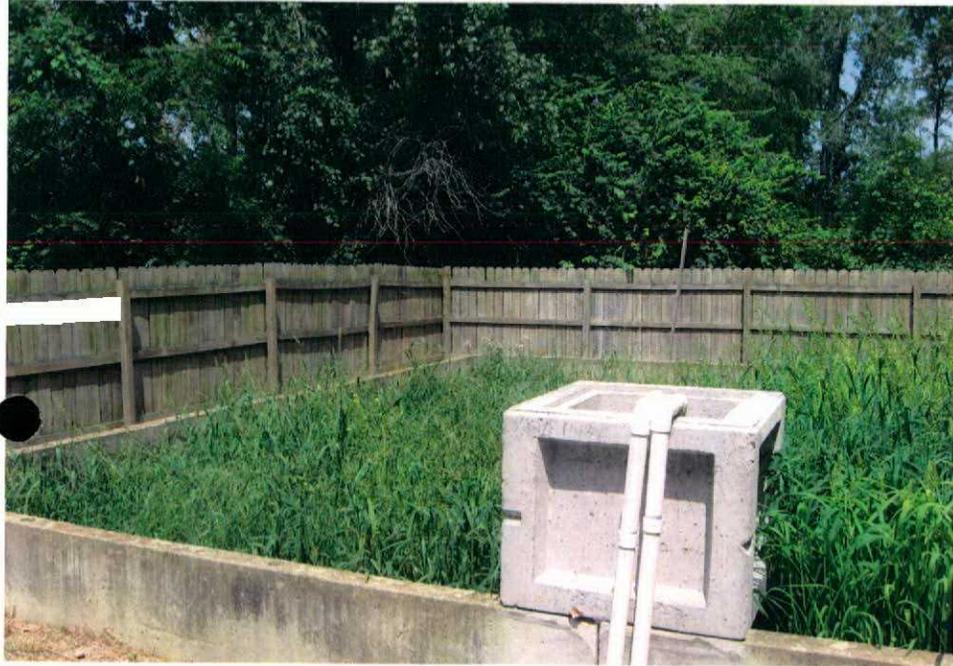
YMCA Camp Wilson 7/21/10
Sand filters

The plant has two tertiary filters. Both filters were over grown with weeds. There were solids in both filters. The filter on line has 2" of water in it. Waste water was leaking from a joint on the filter furthest from the lake.

1. The flow equalization electrical control system needs to be repaired in order to allow the system to work properly.
2. Solids need to be removed from the system in order to control solids carry over to the tertiary system.
3. Weeds located in both tertiary sand filters need to be removed (weed killers should not be used). Additionally, all solids that have carried over from the secondary system need to be removed. Filter wall leaks need to be repaired.

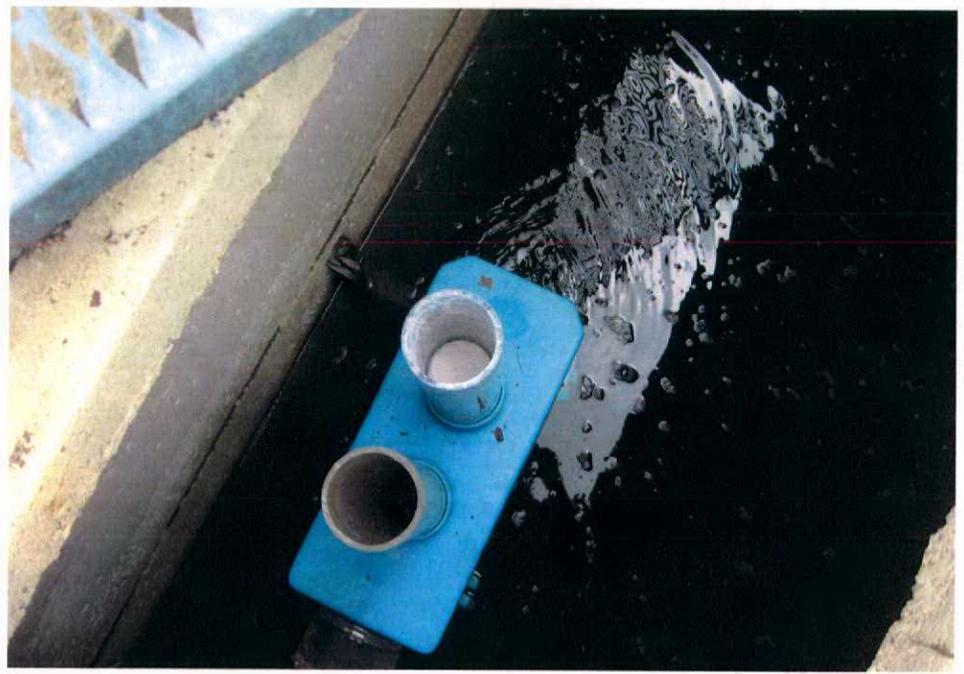
YMCA Camp Wilson 7/21/10
Chlorine contact

Both the chlorination and dechlorination systems are tablet systems. Tablets were present in both systems.
