**Environmental  
Protection Agency**

Re: Montgomery County, Brookville Lake Estates Mobile Home Park, Compliance  
Evaluation Inspection and Notice of Violation

NPDES Compliance Inspection Report  
Semi-Public Sewage Disposal Inspection Form

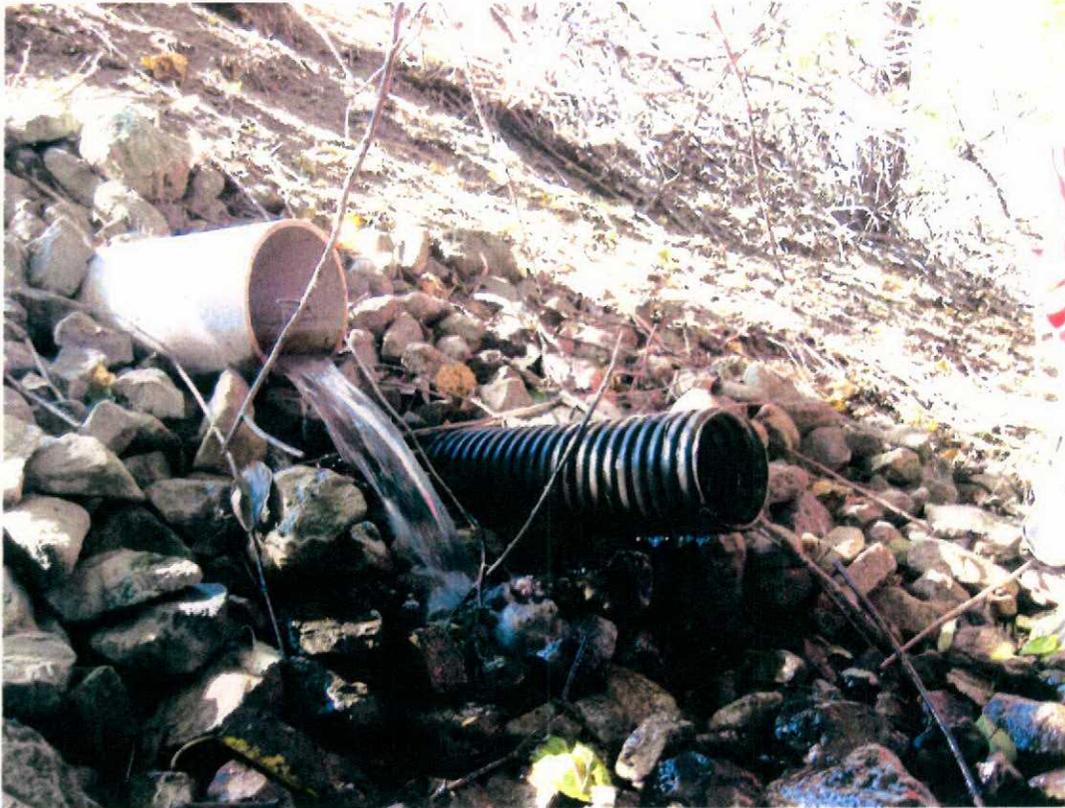
A black drain tile adjacent to the Final Effluent discharge pipe was discovered during the inspection Mr. Shell was unaware of the tile and its purpose. Please advise this office as to the purpose and intended use of the tile in question.

Unknown black drain tile
