State of Ohio Environmental Protection Agency

June 15, 2010

**Re:** Jefferson County  
Severstal Wheeling, Inc. Yorkville Plant  
Notice of Violation  
Correspondence (IWW)

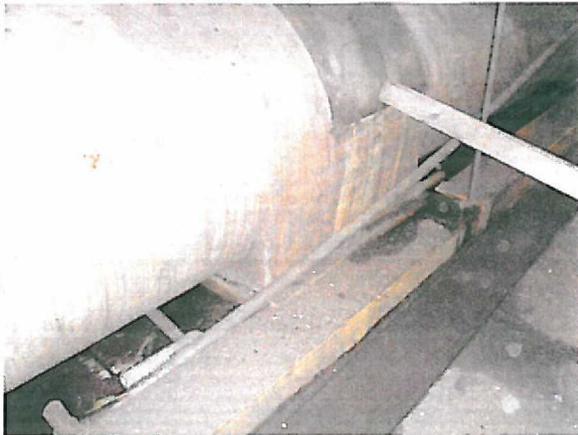
On May 13, 2010, we were contacted by both Severstal Wheeling personnel and Yorkville Sanitary Treatment Plant Personnel about a spent pickle liquor release. Severstal reported that flow originating from the pickle baths had reached outfall 002. A strainer on the piping system had reportedly clogged in the bath which caused an elevated liquid level extending into the fume hoods. The flow exited the baths through the fume hood to an underground ductway. In this underground ductway, it was theorized that the liquid flow found a nexus to both the 002 outfall sewer and the sanitary sewer.

Ductwork to Underground Ductway

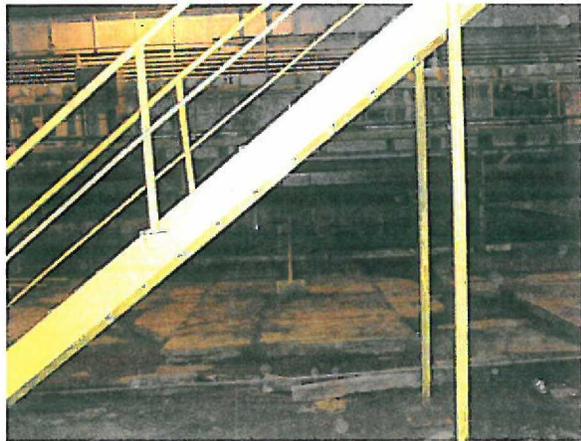
Underground Ductway path

002 flow was reported with low pH, discoloration, and a sheen which are all in violation of the NPDES permit. Flow reportedly continues in the sewers associated with 002 since the bath level has been corrected. The flow is described as possibly water supply leaks and a Fume Hood Condensate. The Fume Hood Condensate needs addressed. This condensate is not permitted for discharge. **Respond in writing with a plan to manage and treat the condensate.**

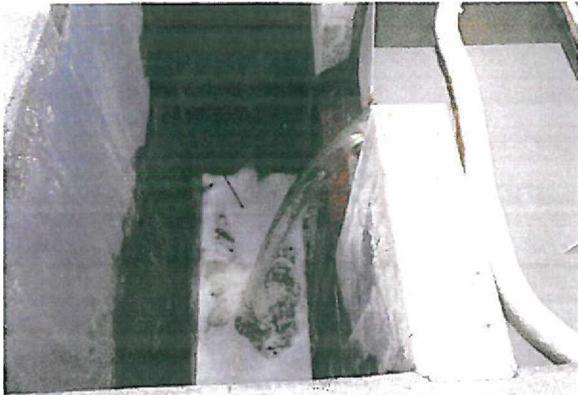
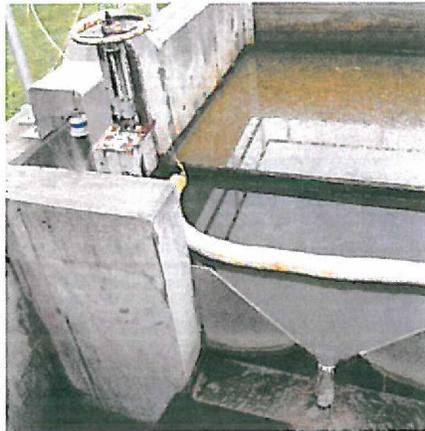
The Yorkville Sanitary Treatment Plant (STP) reported an effluent pH of 3.8 the morning of May 13, 2010 which is out of compliance with its NPDES limits and considerably "adverse" to normal operating condition. The acidic wastewater present in the WWTP influent throughout the night preceding May 13th had apparently upset the STP. Effluent conditions included sheen, foaming, and discoloration. The spent pickle liquor that affected the plant has accumulated in the sludge in the aerobic digester and one of the two oxidation ditches. The discharge to the Yorkville STP was in violation of OAC 3745-3-04.

Yorkville STP Chlorine contact/flow monitoring structure (2 train)

Severstal Wheeling is reportedly assisting Yorkville in securing a portable press to remove the solids from the aerobic digester for lime stabilization and disposal at a landfill. Separated liquids from the oxidation ditch are planned to be routed to the STP chlorine contact tank for disinfection. The washwater from the portable press was planned to be accumulated in a portable frac tank and tested before concluding whether to reintroduce it to the STP. Please keep Ohio EPA informed on your actions to assist Yorkville in restoring the STP. Please also describe how the pickle liquor was able to enter the sanitary sewer and what measures have been taken to prevent a recurrence of the discharge to the Yorkville sewer.
