State of Ohio Environmental Protection Agency

November 26, 2008

**RE: MTD PRODUCTS INC./SHILOH INDUSTRIES, INC., CUYAHOGA COUNTY
OHD 059 058 263, NOTICE OF VIOLATION**

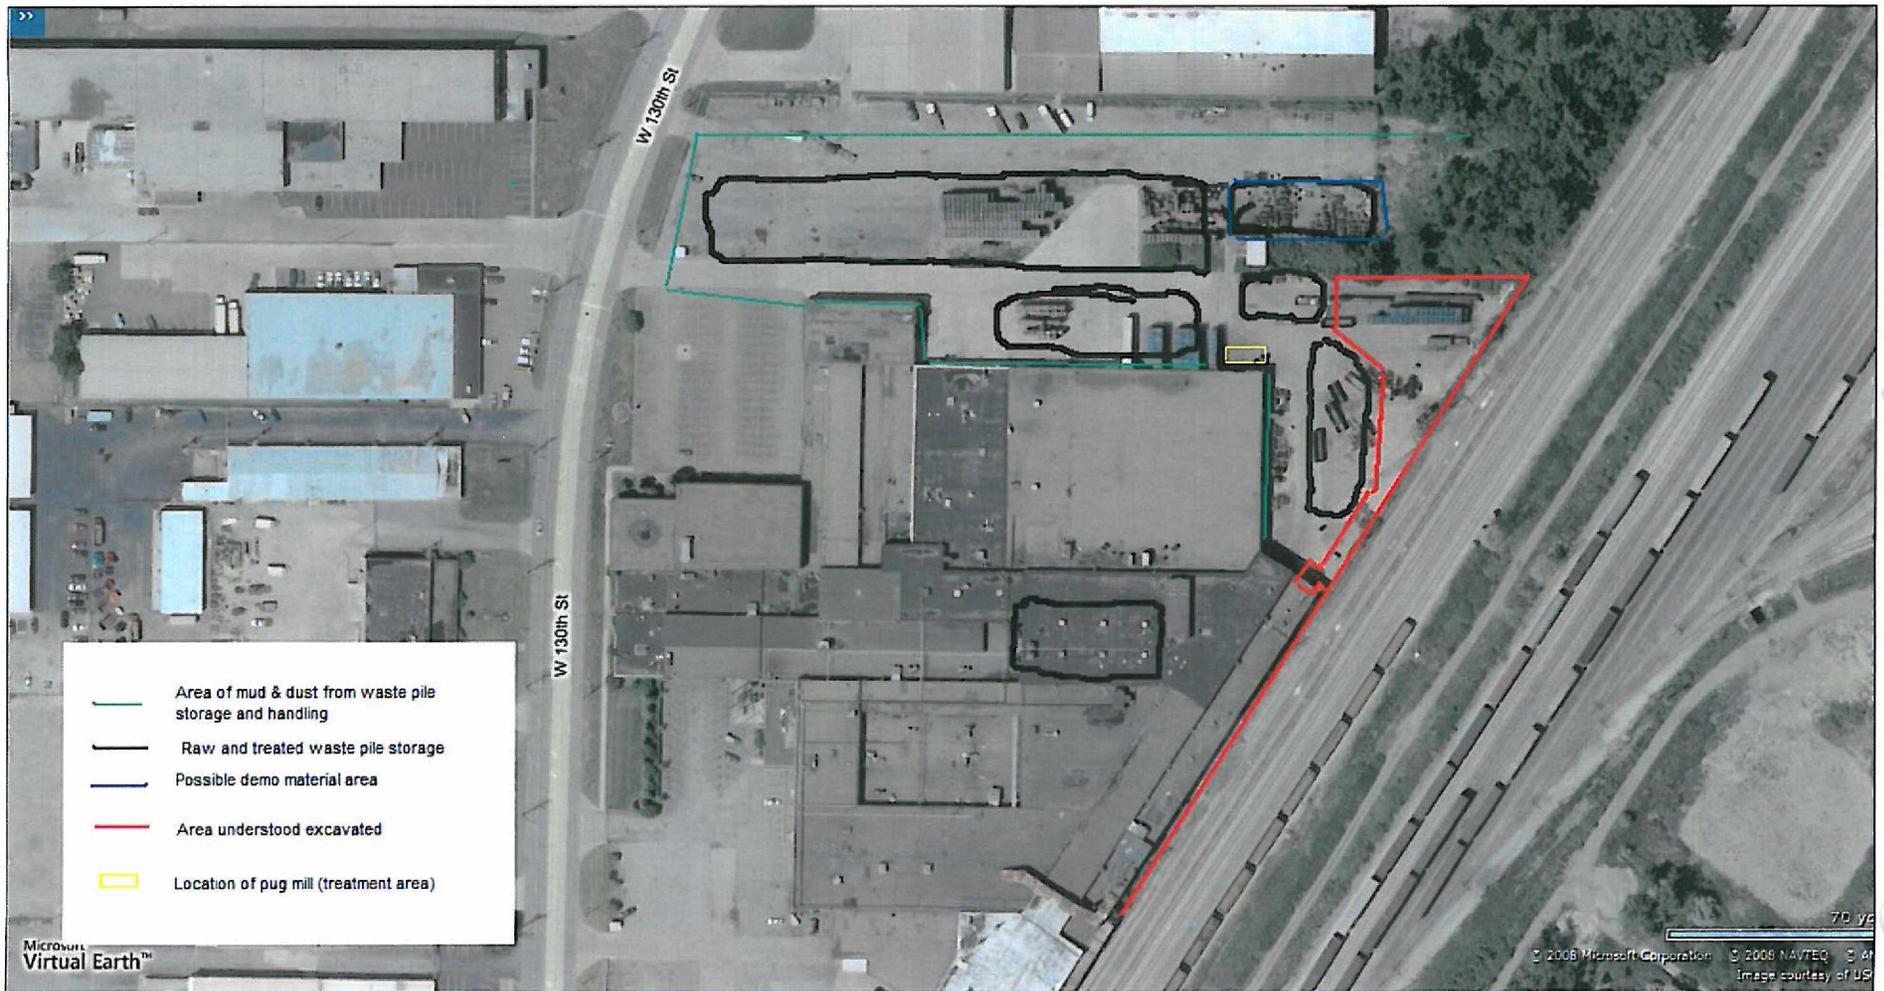
Figure 1: MTD Hazardous Waste Operations and Waste Pile Areas

During remediation activities, MTD used the concrete and asphalt parking/drive areas north of the building as a hazardous waste storage and disposal area and thus created a hazardous waste pile (Figure 1 & 2). A hazardous waste pile requires a hazardous waste installation and operation permit. MTD did not first obtain a permit before creating these hazardous waste management units. According to documents submitted, the areas where the hazardous waste piles have been located are outside the area of TCE contamination.

At the time of the November 13, 2008 site visit approximately 20,000 cubic yards of soil had been excavated. MTD has contracted with RMT, Inc. of Greenville, South Carolina, to provide oversight and operation of the remediation project, including the operation of a pug mill used to treat the TCE contaminated soil. The pug mill was located at the northeast corner of the former die warehouse (Figure 1). Untreated TCE contaminated soil was stockpiled in the vicinity of the pug mill. Additionally, contaminated soil which had been run through the pug mill as well as untreated TCE contaminated soil was placed in piles in the northern concrete/asphalt parking/drive area. Soil from outside treated piles was being moved to inside building areas where a former paint line had existed (Figure 1).

2. Contaminated soil from the hazardous waste piles and the treatment process was being dispersed via wind and runoff. The area of immediate impact is identified in Figure 1. You reported that storm drains in the central northern parking/drive area had been blocked. However, we observed that other drains in the impacted area were not blocked. You also stated that a storm water control plan had not been developed for the site and it did not appear that there was a provision to capture or properly manage runoff in the area.

Site Photo showing areas of hazardous waste excavation, treatment, storage and areas immediately affected by fugitive dust and run-off. Drawn by R. Shadrach, DHWM Representative, November 14, 2008.

MTD must stop managing hazardous waste contaminated soil in waste piles and begin managing the contaminated soil according OAC rule 3745-52-34(A) (e.g., manage the contaminated soil in containers).

Please provide information which demonstrates further dispersal of contaminated media will be contained and how runoff storm water will be properly managed. Please include any permits/exemptions you have received from the Cleveland Division of Air Authority and the Ohio EPA Division of Surface Water (DSW) for the remedial activities which are taking place.

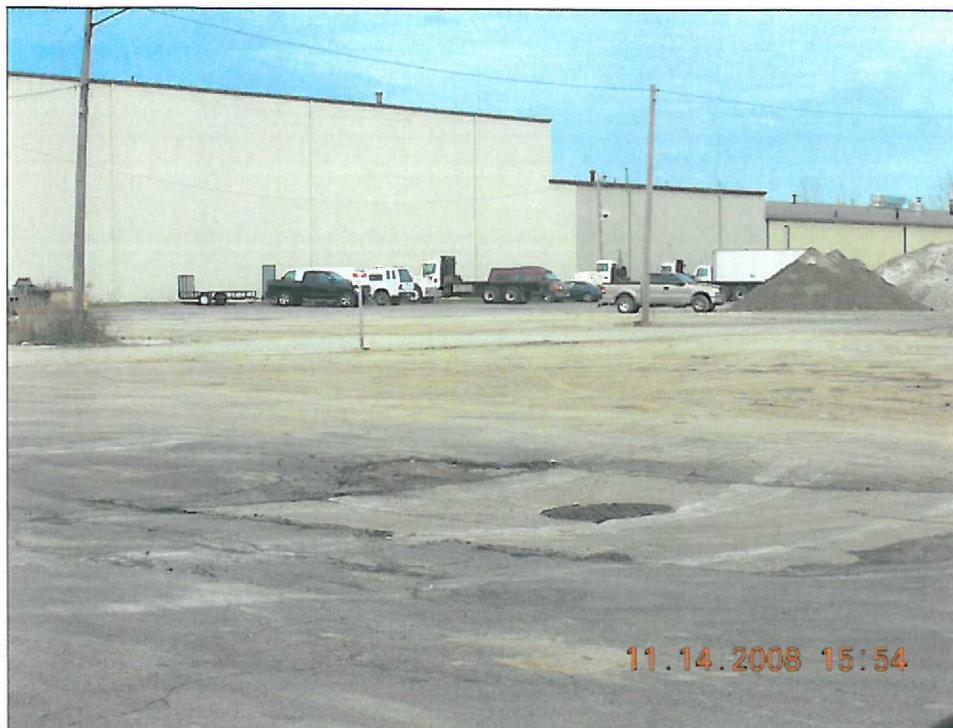
1) View northeast from northern entrance to property. Hazardous waste treated piles in background had extended to phone pole at left.

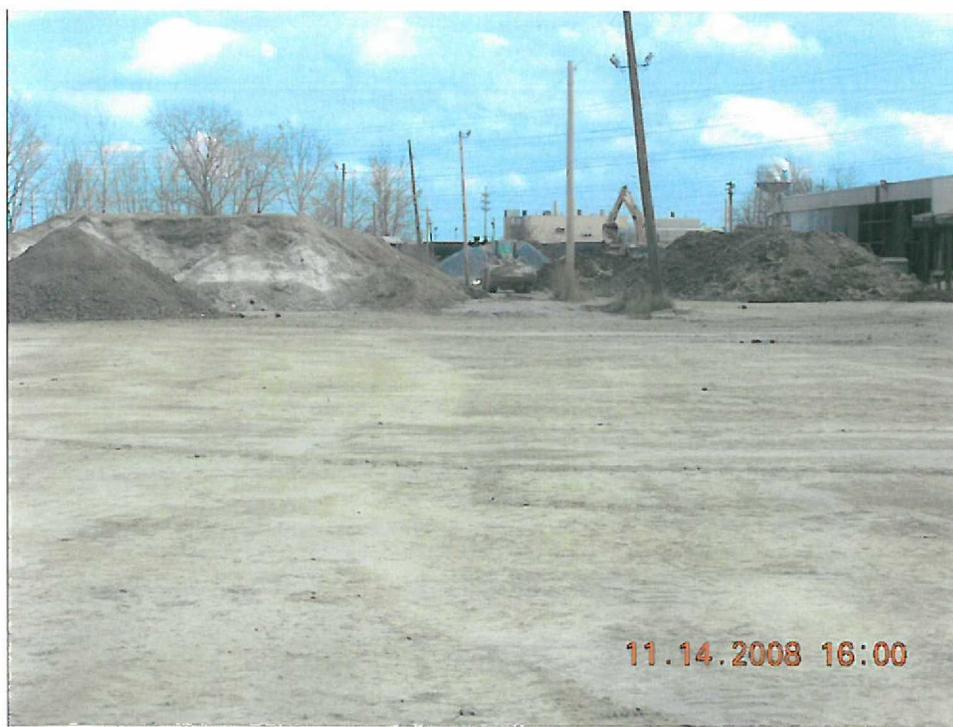
2) View eastward along north side of building where hazardous waste are being staged. Foreground soil cover shows former extent of waste piles.

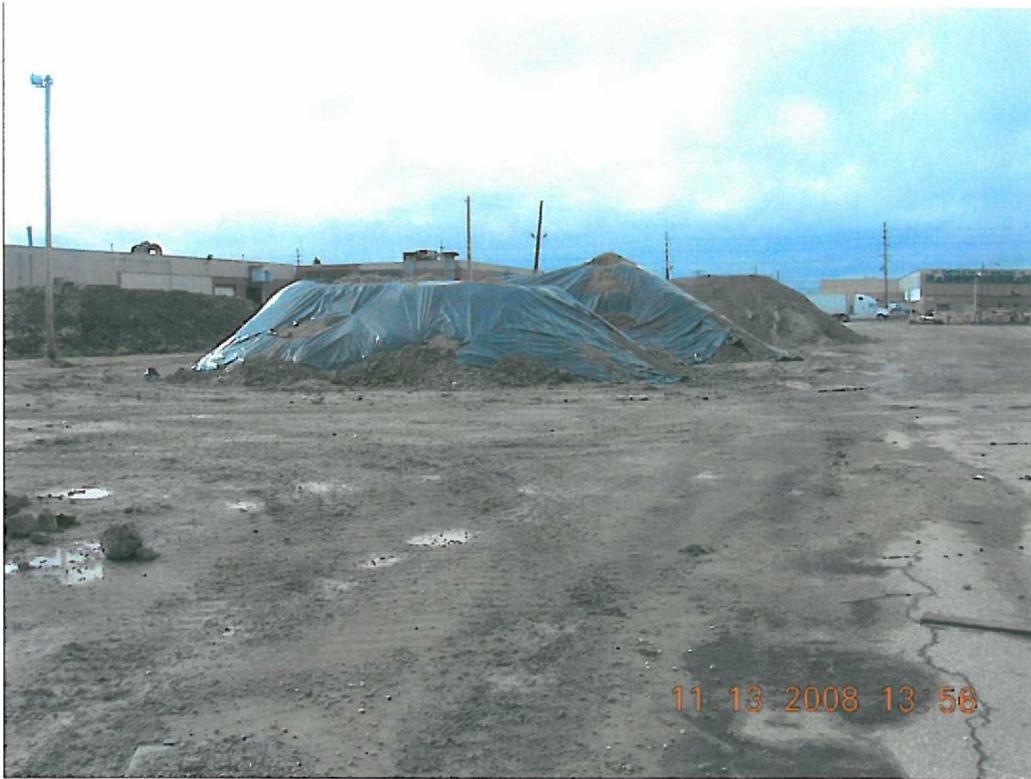
3) View westward of hazardous waste pile areas along north side of the building. Piles under plastic may consist of untreated hazardous waste.

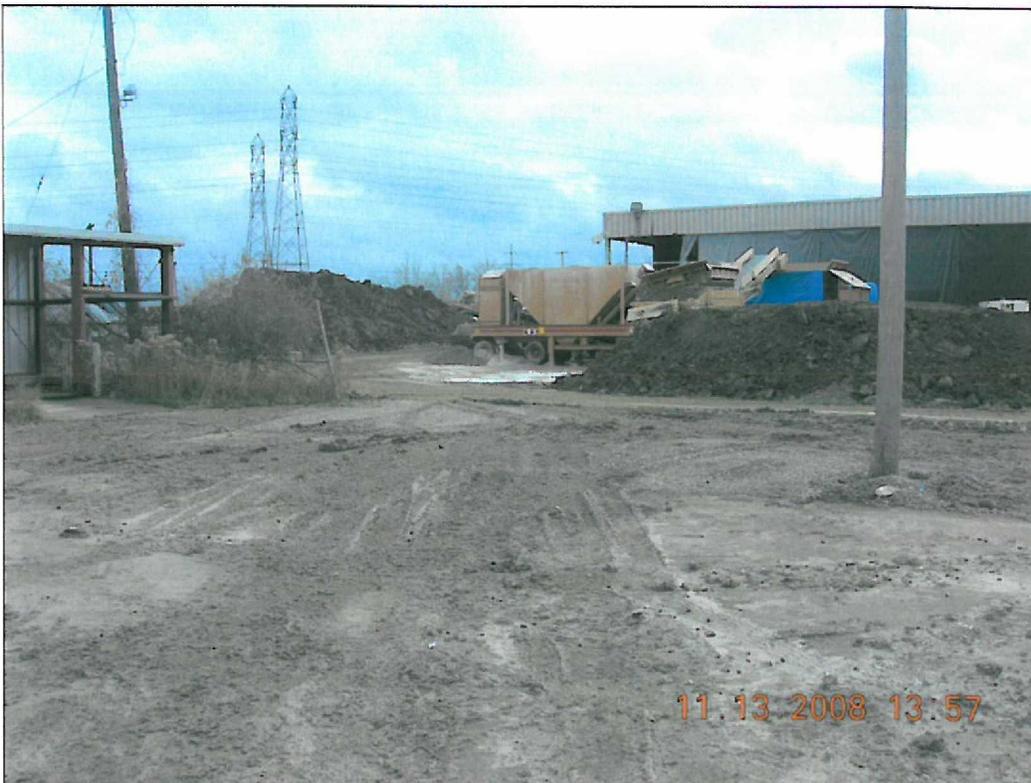
4) Pug mill in background along northeast corner building area. Raw waste was observed staged nearby and loaded in mill for treatment.

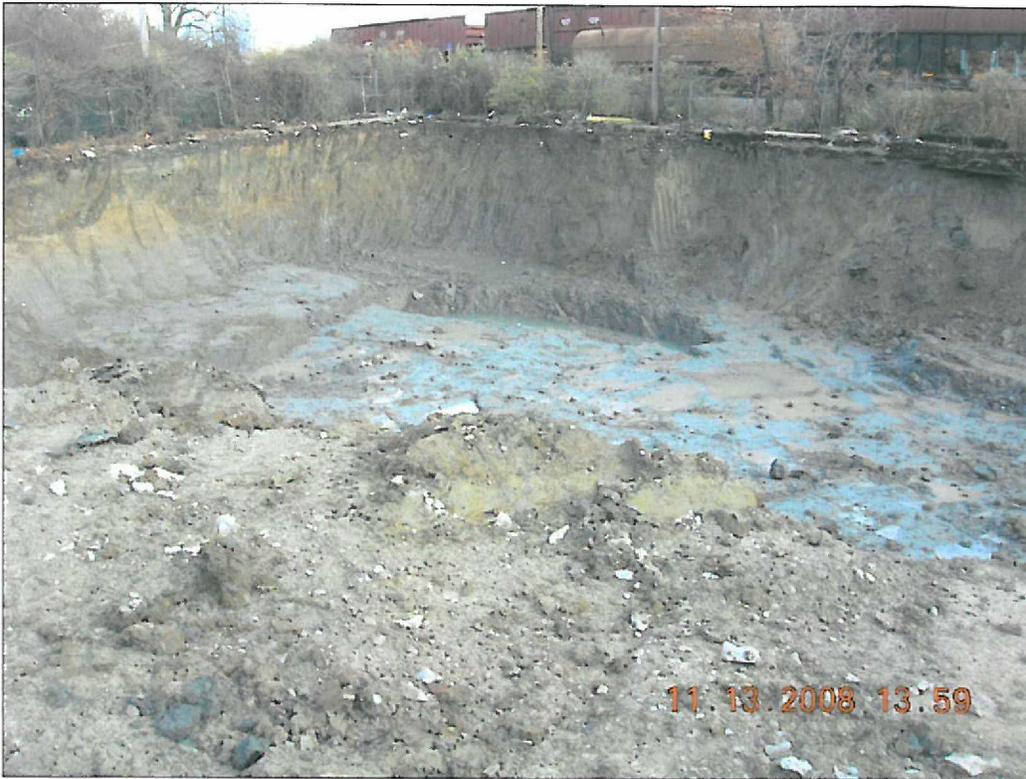
5) Northeast parking/storage and sewer area excavation. Excavation extends several feet into bedrock in central background area.

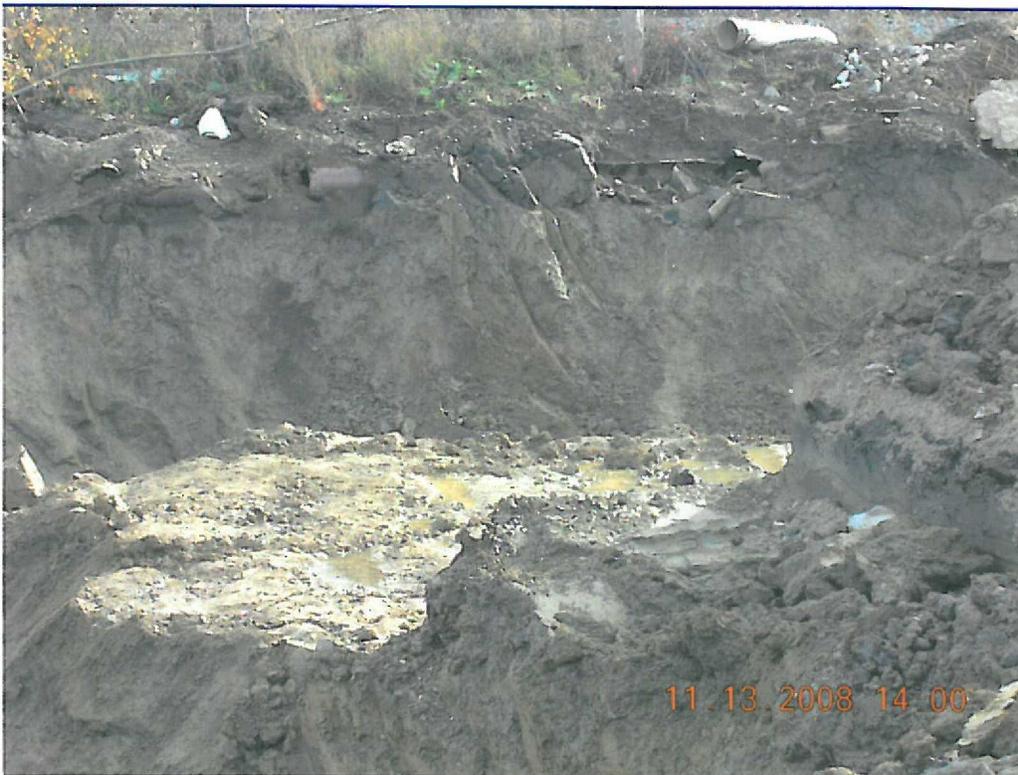
6) View of vitrified clay storm sewer partially in place along excavation. Other sewer pipe is noted in the background.
