OHIO PAPERBOARD

April 28, 2010

**Re: Ohio Paperboard / Fairfield County
Industrial Storm Water Permit 4GR00120*DG**

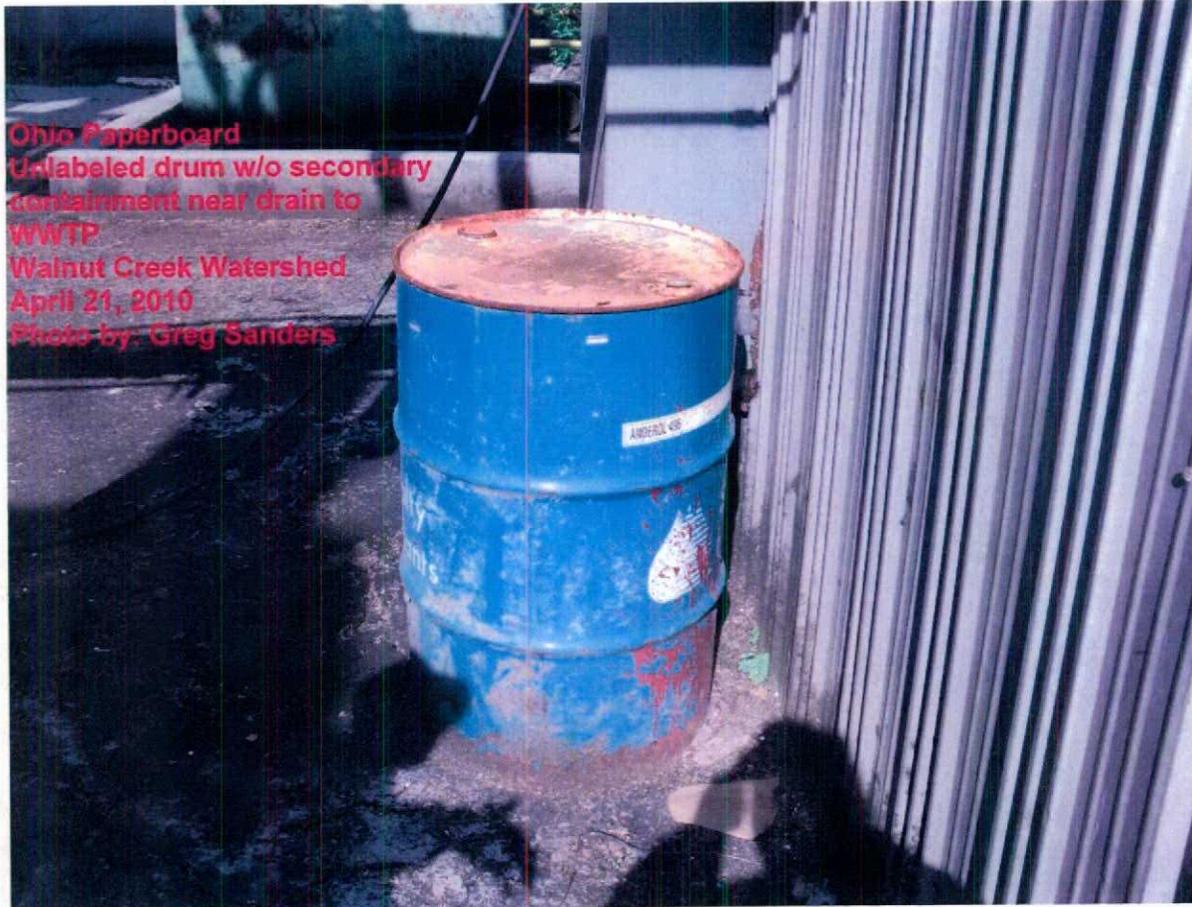
1. Your company had a storm water pollution prevention plan (SWP3) and a spill prevention plan at the facility. The plans were reviewed annually or after a change in staff.
2. Unloading is done in a contained area. Most of the unloading areas have secondary containment and under roof.
3. There were several drums stored outside. The drums need to be labeled. The drums either need to be stored inside the building or they need to be stored with lids and in secondary containment.
4. A map of your storm water discharge points were provided to me. It is recommended that the outfall that serves the main part of the outside production area have a gate valve. The gate valve could be closed in the event of a spill.

Ohio Paperboard
Unlabeled drum w/o secondary
containment near drain to
WWTP
Walnut Creek Watershed
April 21, 2010
Photo by: Greg Sanders

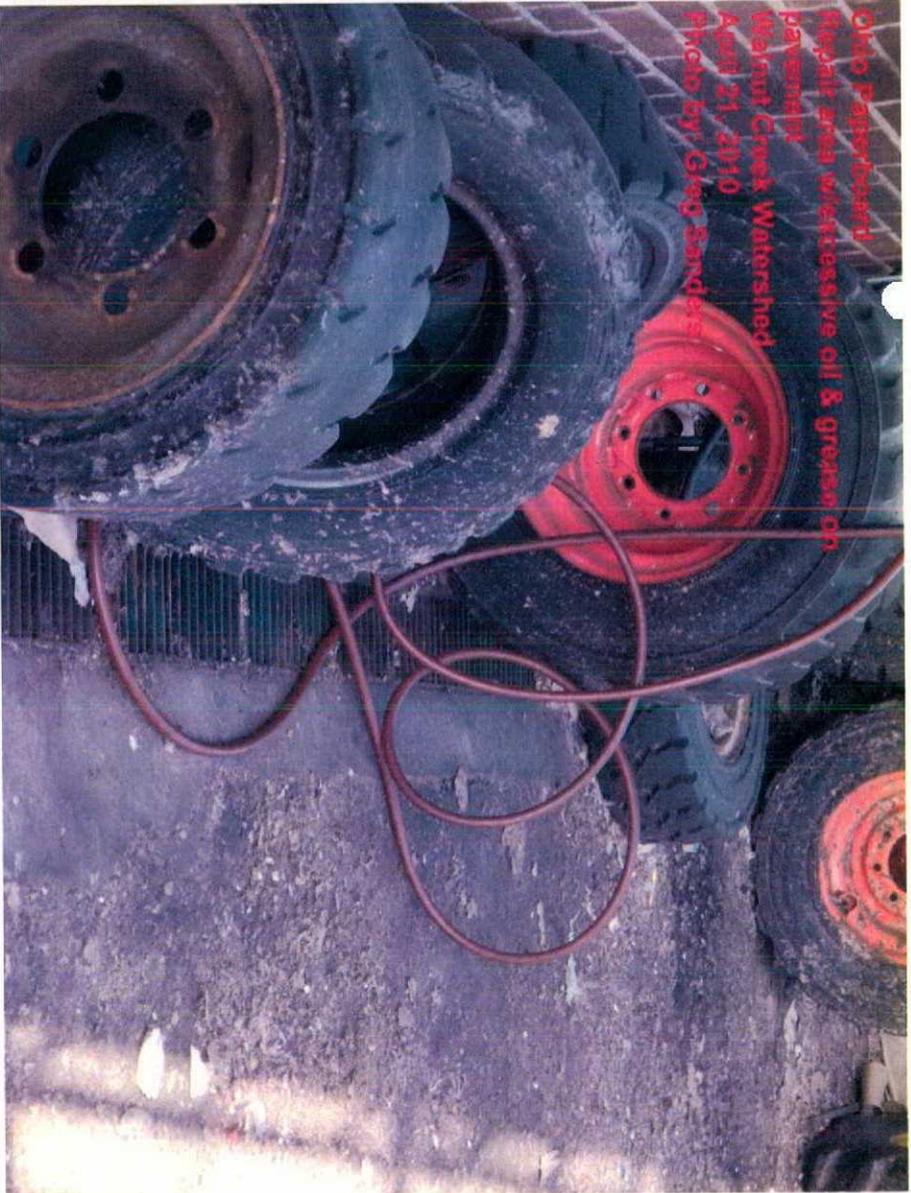
5. It was noted that vehicle repair was done outside on a concrete pad which discharged to the WWTP and could also discharge to a storm water drain. The concrete pad had excessive oil and grease. Vehicle repair should be done inside or in a contained area under roof. Please see attached picture.

Ohio Paperboard
Fugate area w/ excessive oil & grease on
pavement
Marion Creek Watershed
April 21, 2010
Photo by Greg Sanders

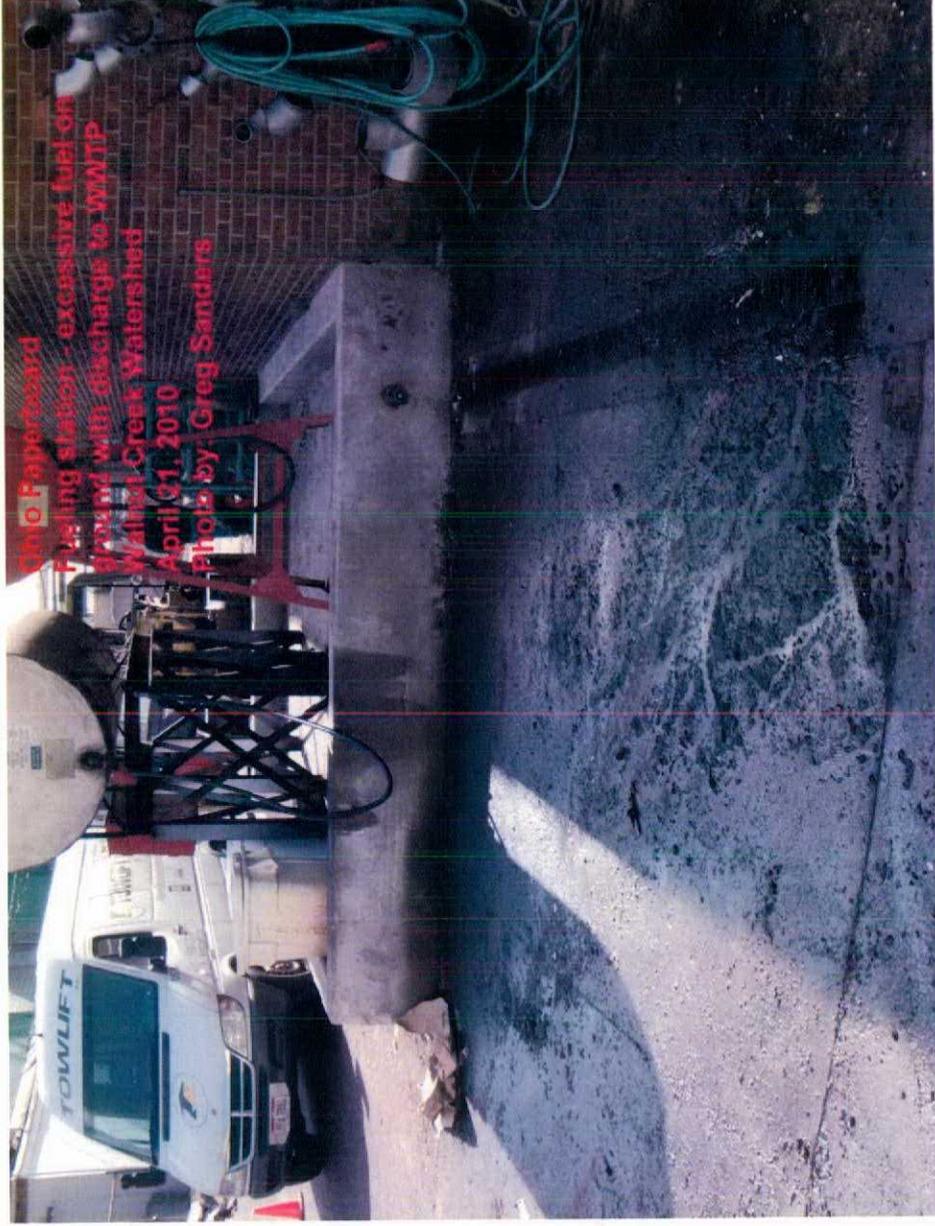
7. Housekeeping in the fueling area was poor. A lot of fuel was spilled on the ground and could discharge to drains which discharge to the WWTP. Excessive fuel could upset the WWTP and prevent it from properly treating its wastewater. It is requested that the fueling area be in a secondary containment area and the captured wastewater be discharged to an oil-water separator before discharging to the WWTP. This area should be put under roof to prevent excessive storm water to the oil-water separator. Also, the SWP3 and spill prevention plan should be revised to include this secondary containment. Please see attached picture.

Ohio Paperboard
Fusling station - excessive fuel oil
found with discharge to WWTP
Walnut Creek Watershed
April 01, 2010
Photo by Greg Sanders

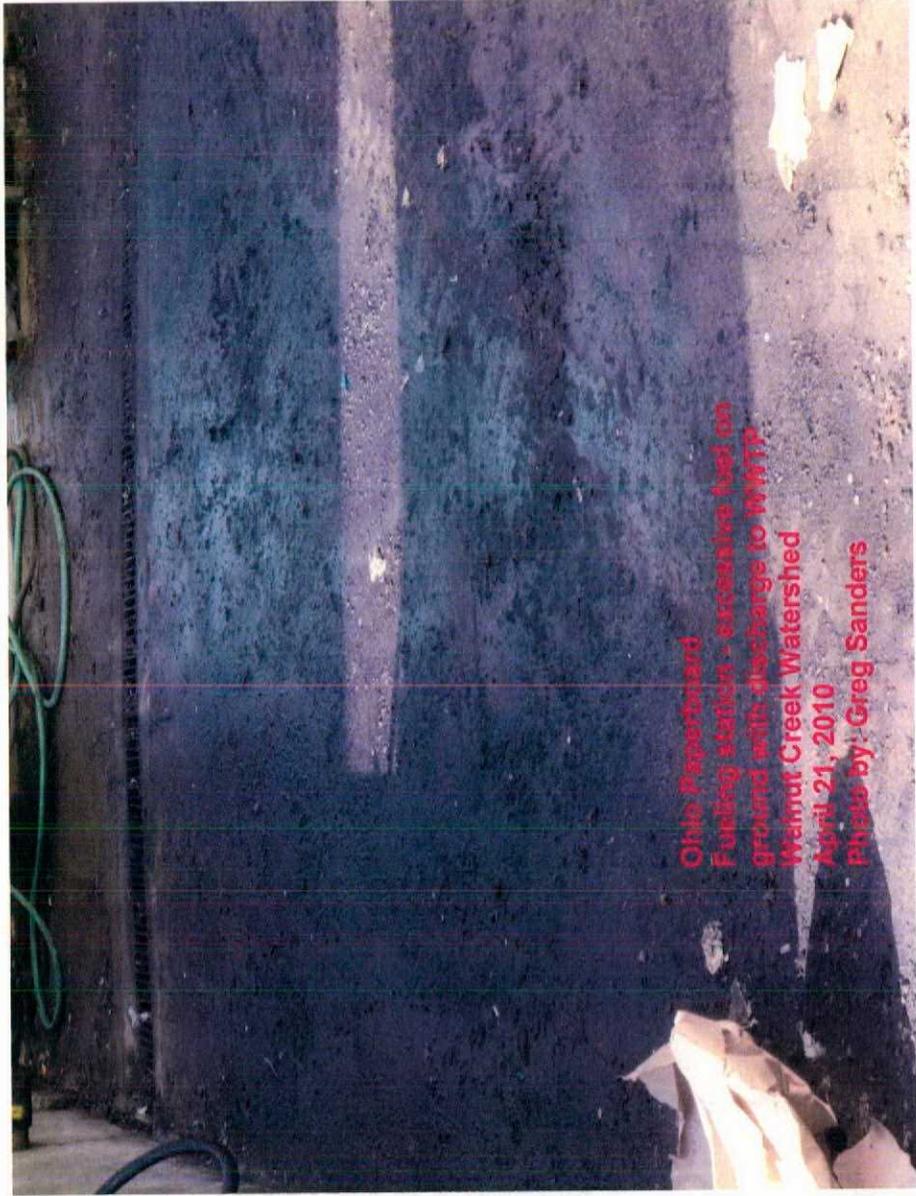
Ohio Paperboard
Fueling station - excessive fuel on
ground with discharge to WATP
Walnut Creek Watershed
April 21, 2010
Photo by: Greg Sanders

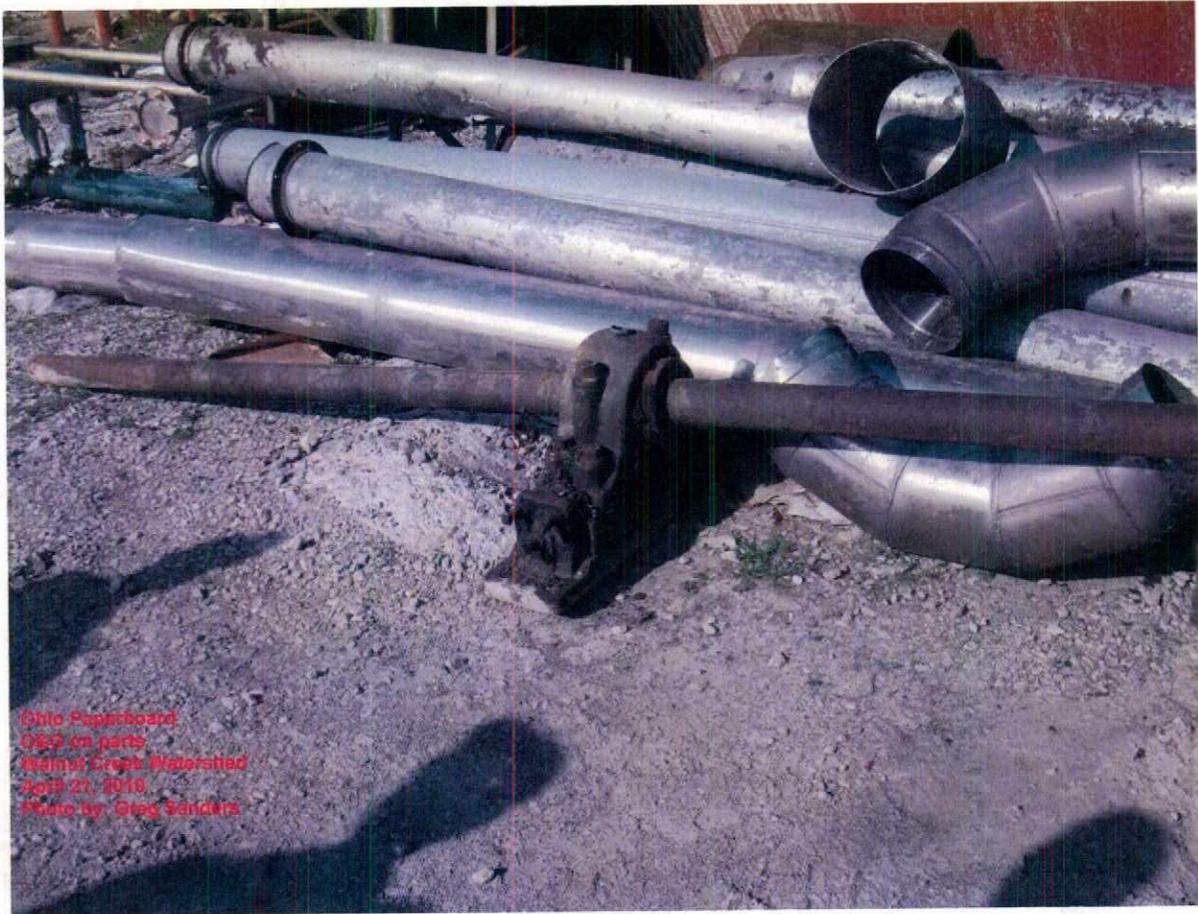
8. Old parts that had excessive oil and grease on them were stored outside on the ground. These parts should be stored inside or at least covered to protect rain and snow from washing the oil and grease to waters of the state. Please see attached picture.

Ohio Paperboard
D&S on parts
Walton Creek Watershed
April 27, 2018
Photo by Greg Sanders

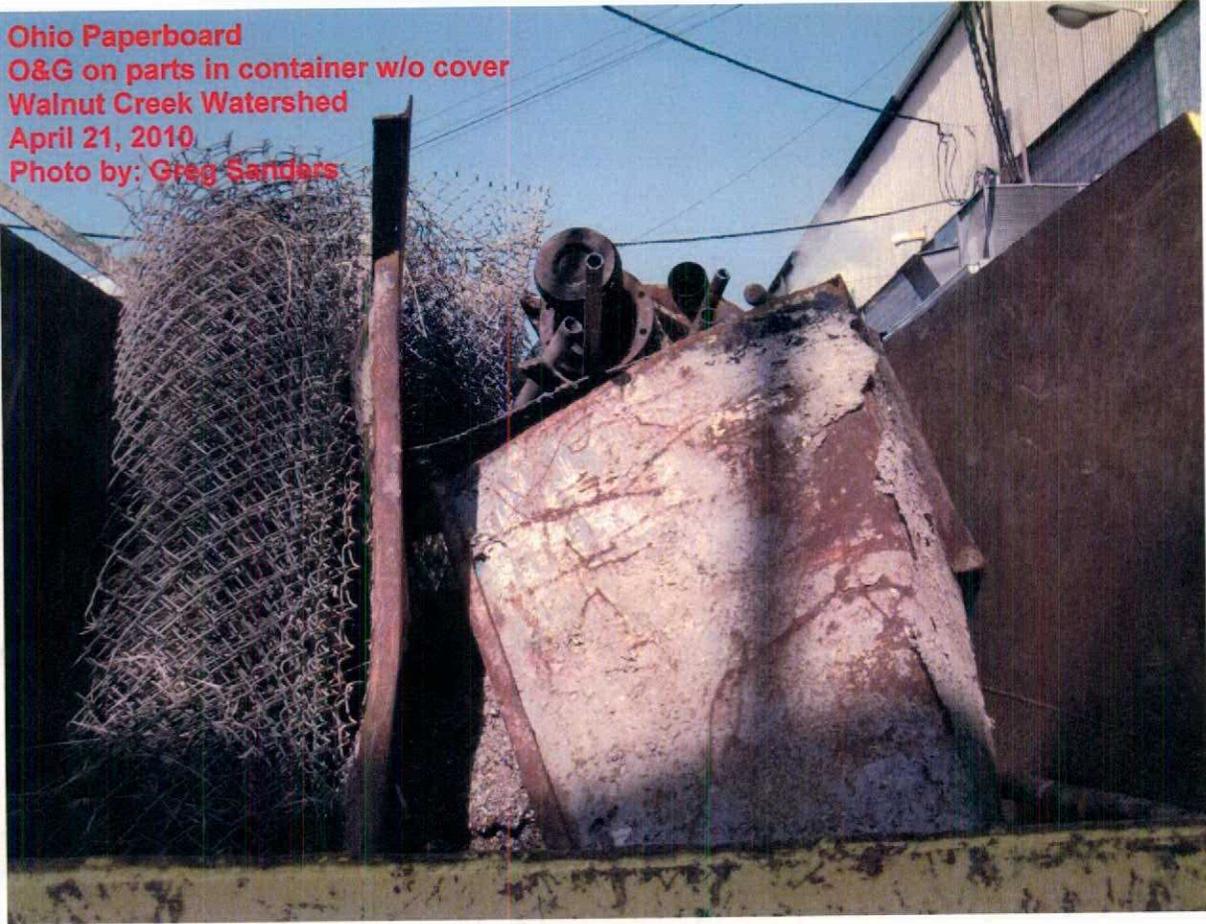
9. Oily and greasy parts were disposed in a dumpster that did not have a cover. Please install a cover on the dumpster or keep the dumpster under roof. Please see attached picture.

Ohio Paperboard
O&G on parts in container w/o cover
Walnut Creek Watershed
April 21, 2010
Photo by: Greg Sanders
