**Environmental
Protection Agency**

SUBJECT: June 2, 2011, Site Visit Documentation

**ATHENS COUNTY
FAC – COZART LANDFILL**

Closed Cozart Sanitary Waste Landfill Facility Inspection Checklist

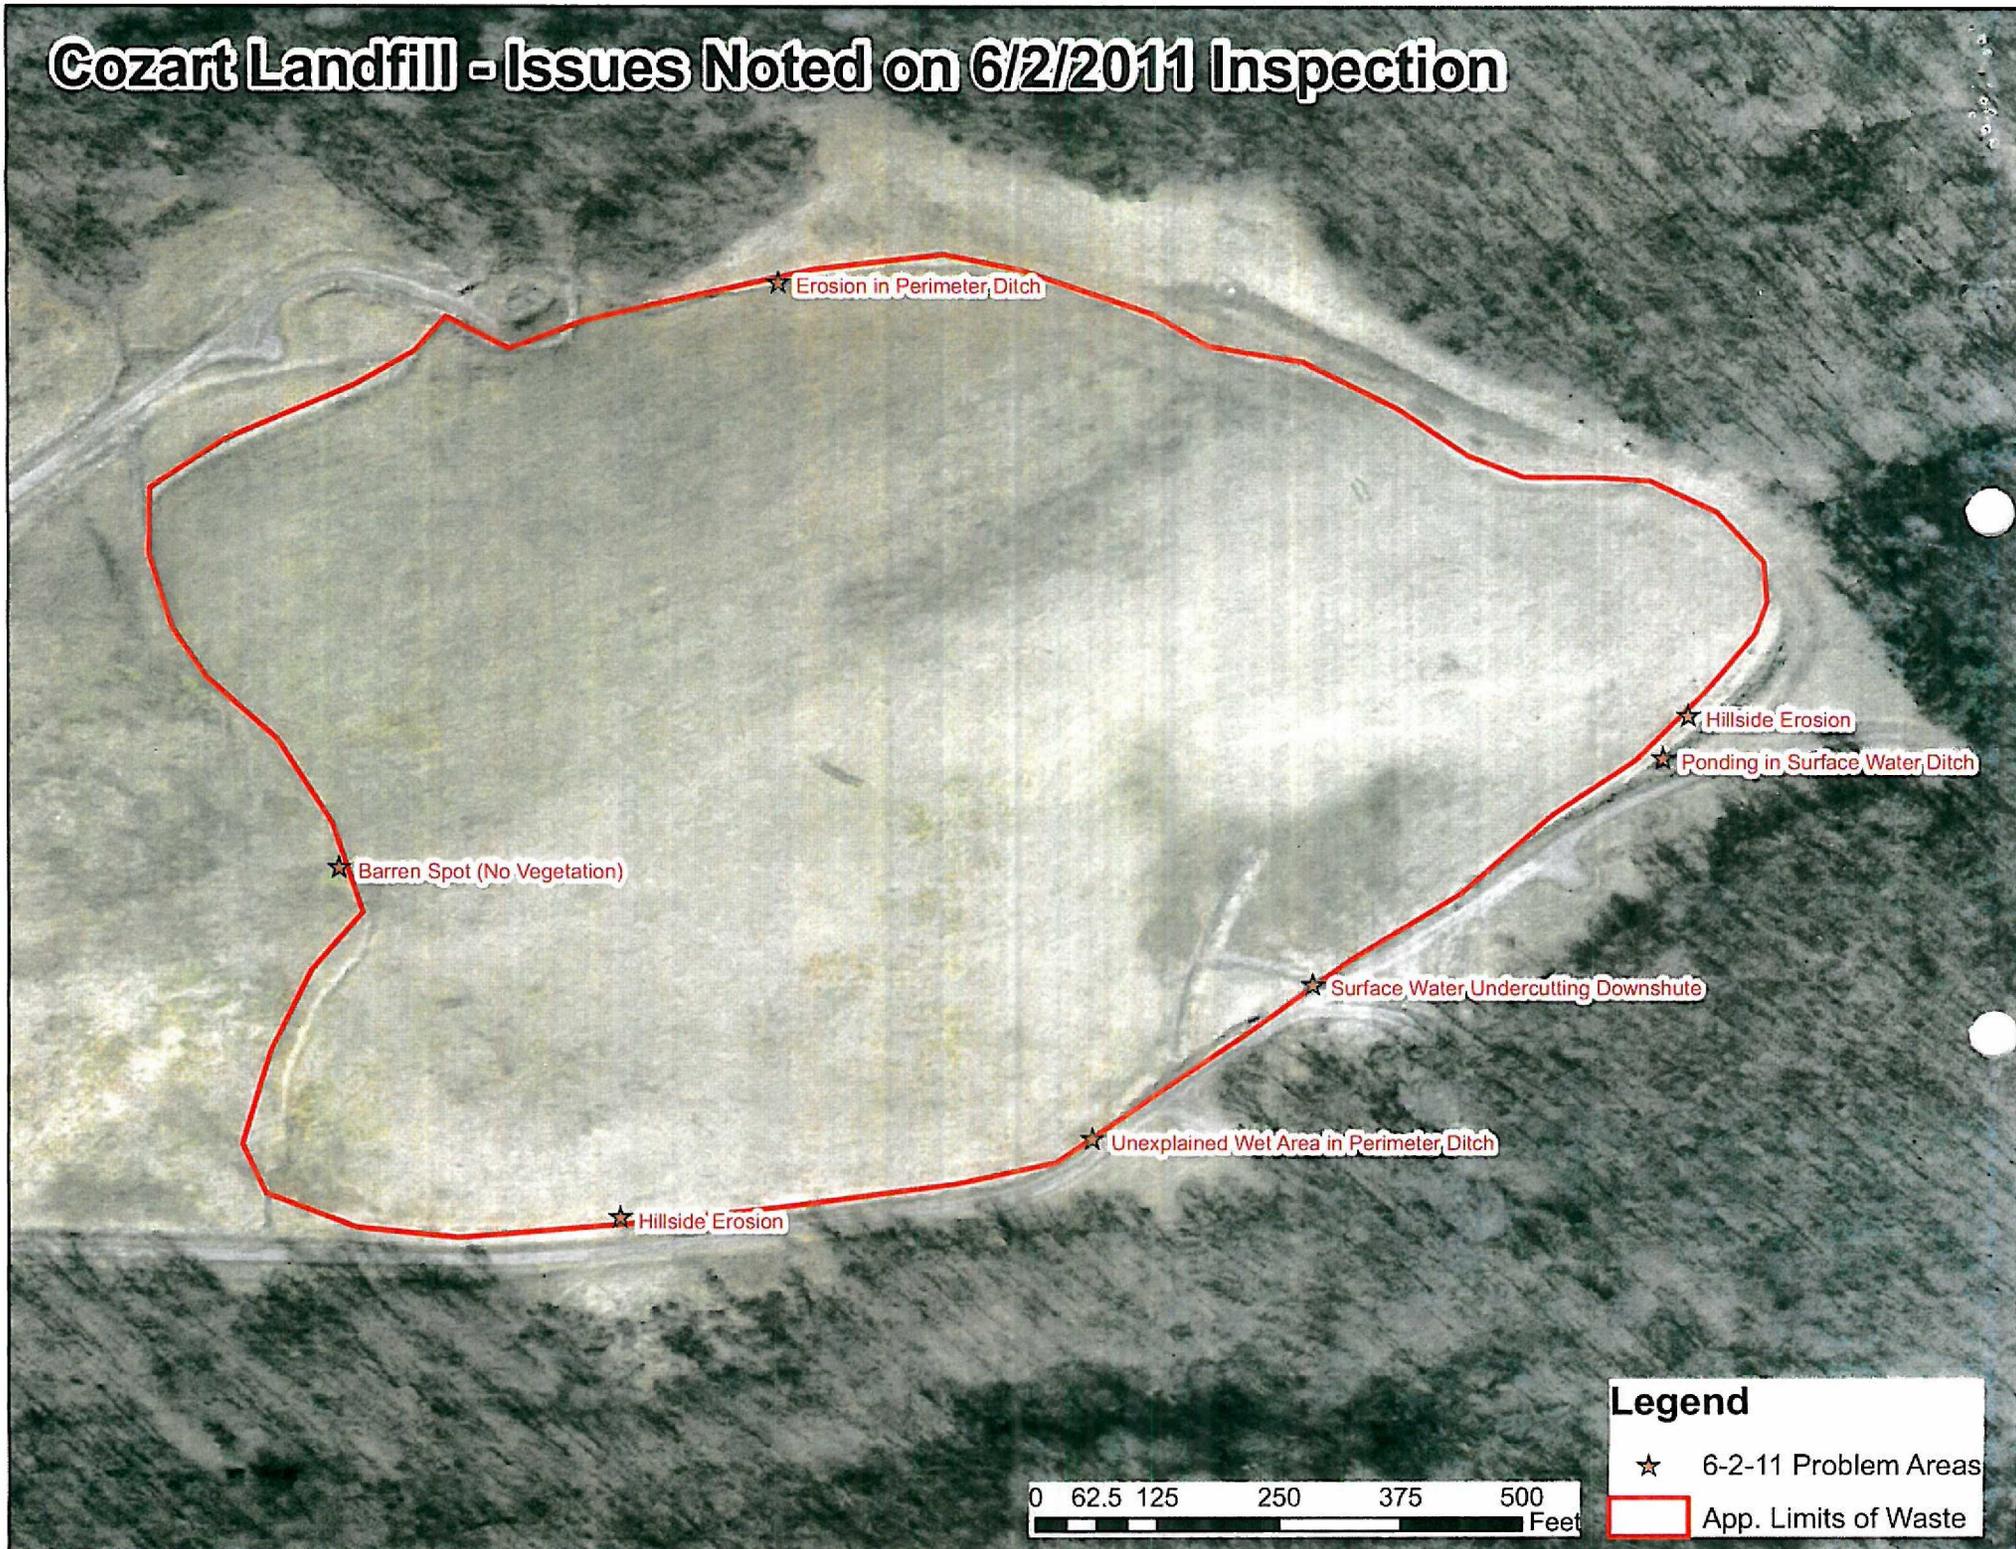
Cozart Landfill - Issues Noted on 6/2/2011 Inspection

Area	Latitude	Longitude	Comment
1	39.22894	-81.84703	Hillside Erosion
2	39.22916	-81.84570	Unexplained Wet Area in Perimeter Ditch
3	39.22960	-81.84508	Surface Water Undercutting Downshute
4	39.23024	-81.84409	Ponding in Surface Water Ditch
5	39.23036	-81.84402	Hillside Erosion
6	39.23157	-81.84658	Erosion in Perimeter Ditch
7	39.22993	-81.84782	Barren Spot (No Vegetation)

4) Are there any noticeable indications of settlement or slumping of the cap? If so, note the location(s) and describe the condition. Is corrective action necessary? No, settling or slumping of the cap was noted. There were, however, two areas of hillside erosion and one area of surface water undercutting a down chute that should be addressed. See the attached aerial photo with locations noted on it.

Additionally, many of the cap drain outlets were partially blocked by soil and/or moss. These outlets should be repaired such that free flow of water out of the cap drainage layer is maximized. Also, a few of the metal gas vent cap/spinners were rusted or not free spinning. Our survey specifically noted GV3, GV4, and GV10. It was also noted that GV6 was missing its side cap.
