July 21, 2010

**Re: Construction Storm Water Inspection at Springhill Suites by Marriott / Franklin County
Permit Number 4GC03232*AG**

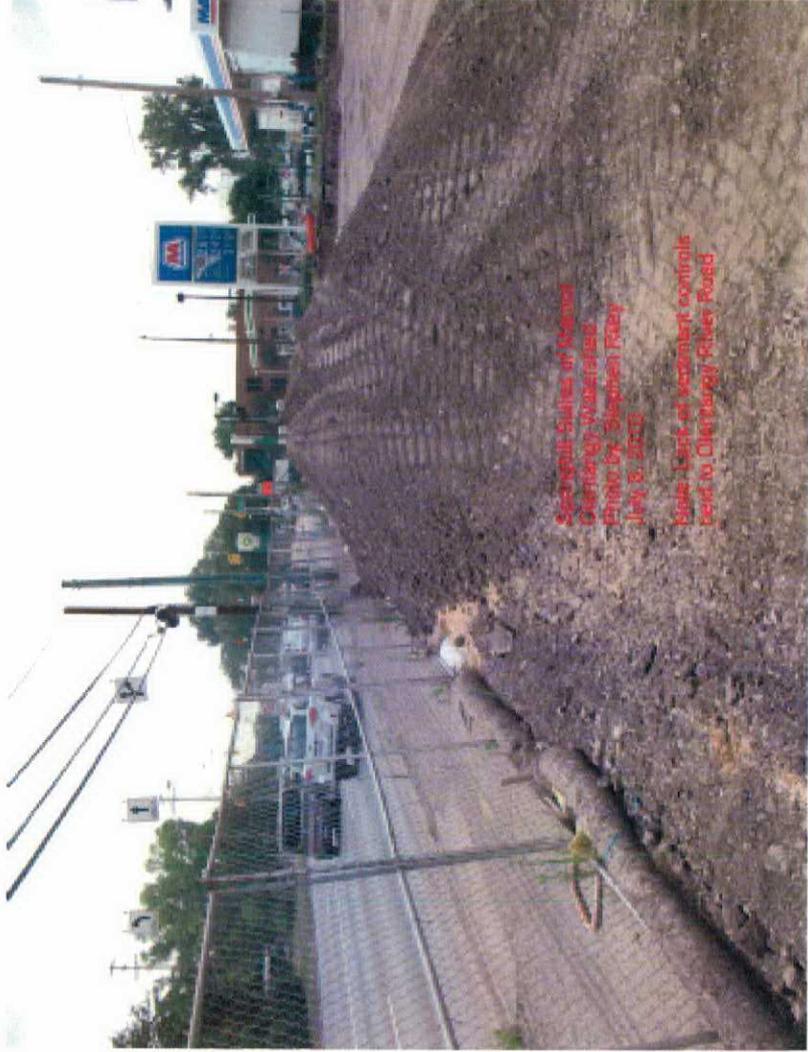
- The stockpile along the eastern most side of the project area lacks appropriate sediment and erosion control. Corrective measures to install silt fencing and cover is expected within three days upon receipt of this letter. (Figure 1)
- There are no sediment controls around the storm drain access point shown in figure 2. It is evident that sediment could bypass the manhole cover through the open point shown in the photo. Corrective measures are expected to eliminate this by-pass with three days upon receipt of this letter.

Figure 1: Stockpile along fence line

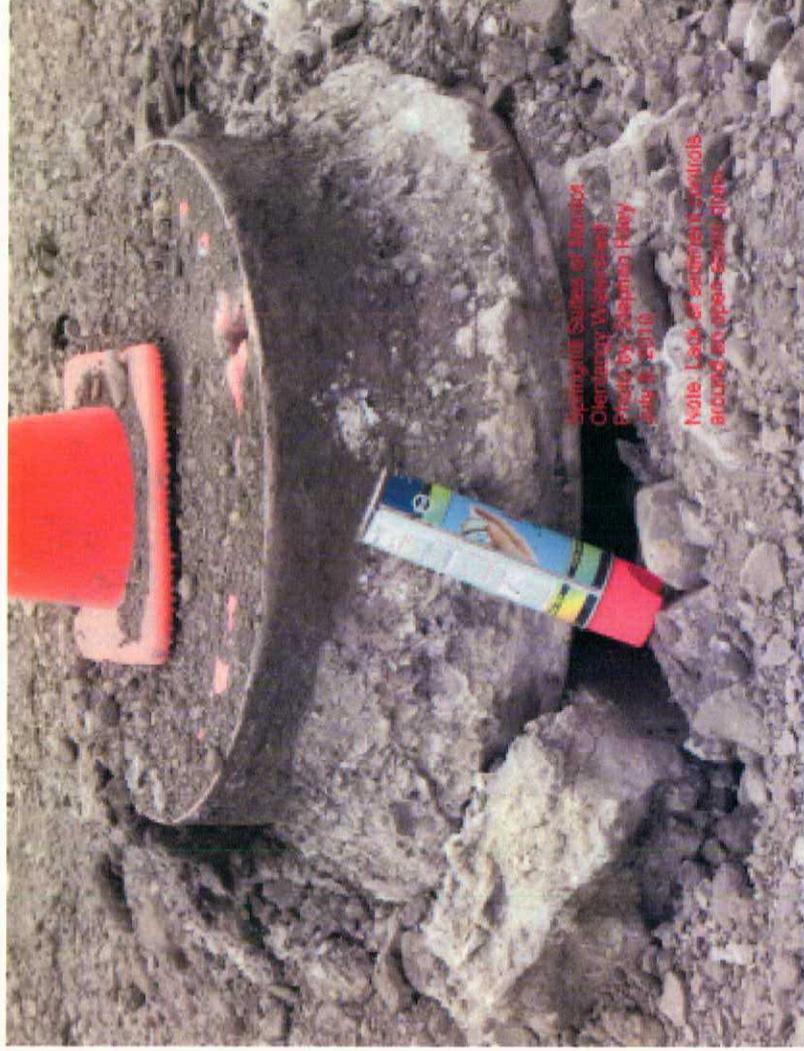
Figure 2: Sediment Bypass point noted by spray can top
