AMBERLEIGH COMMUNITY PARK

August 4, 2011

**Re: Construction Storm Water Inspection at Amberleigh Community Park  
Franklin County  
Permit Number: 4GC03437 \*AG**

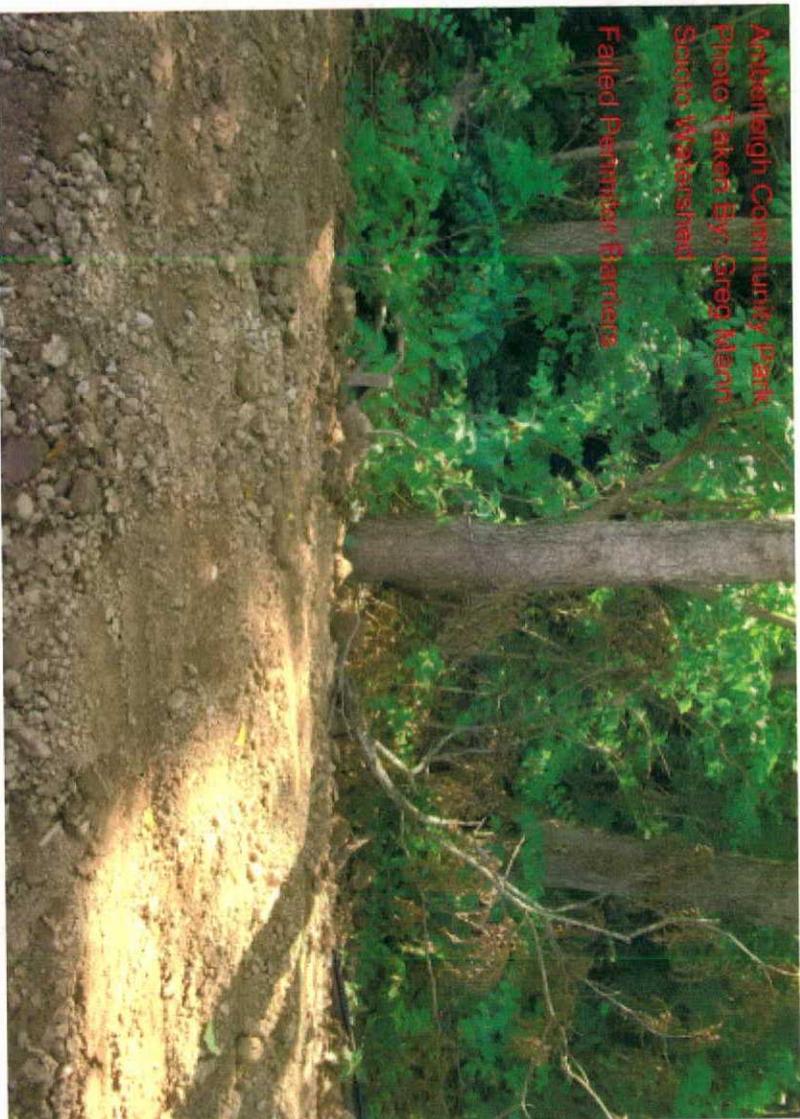
Figure 1

- Our staff noted that perimeter silt fence has failed along the lower (eastern) side of the site. Please perform the necessary maintenance to ensure the silt fences are functioning as intended and offsite sediment transport is minimized (See Figure 1).
- During the inspection our staff noticed improper concrete disposal near the entrance of the site. Please employ corrective measures to implement a proper concrete disposal area (See Figure 2).

Amherstleigh Community Park  
Photo Taken By: Greg Mann  
Santo Watershed  
Failed Perimeter Barrels

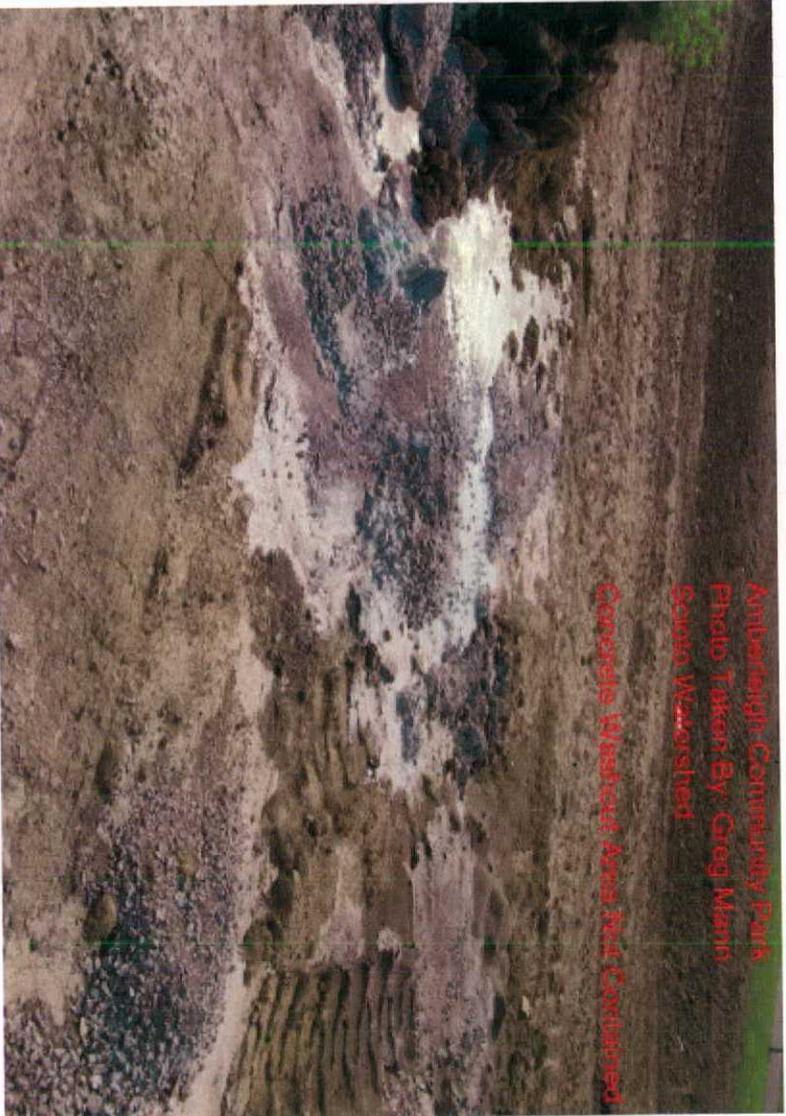
Figure 2

Concrete Washout Area Not Contained
