CITY OF COLUMBUS UPLAND RESERVOIR - SITE #2

August 1, 2011

**Re: Construction Storm Water Inspection at City of Columbus Upland Reservoir –
Site #2 / Delaware County
Permit Number: 4GC03524 *AG**

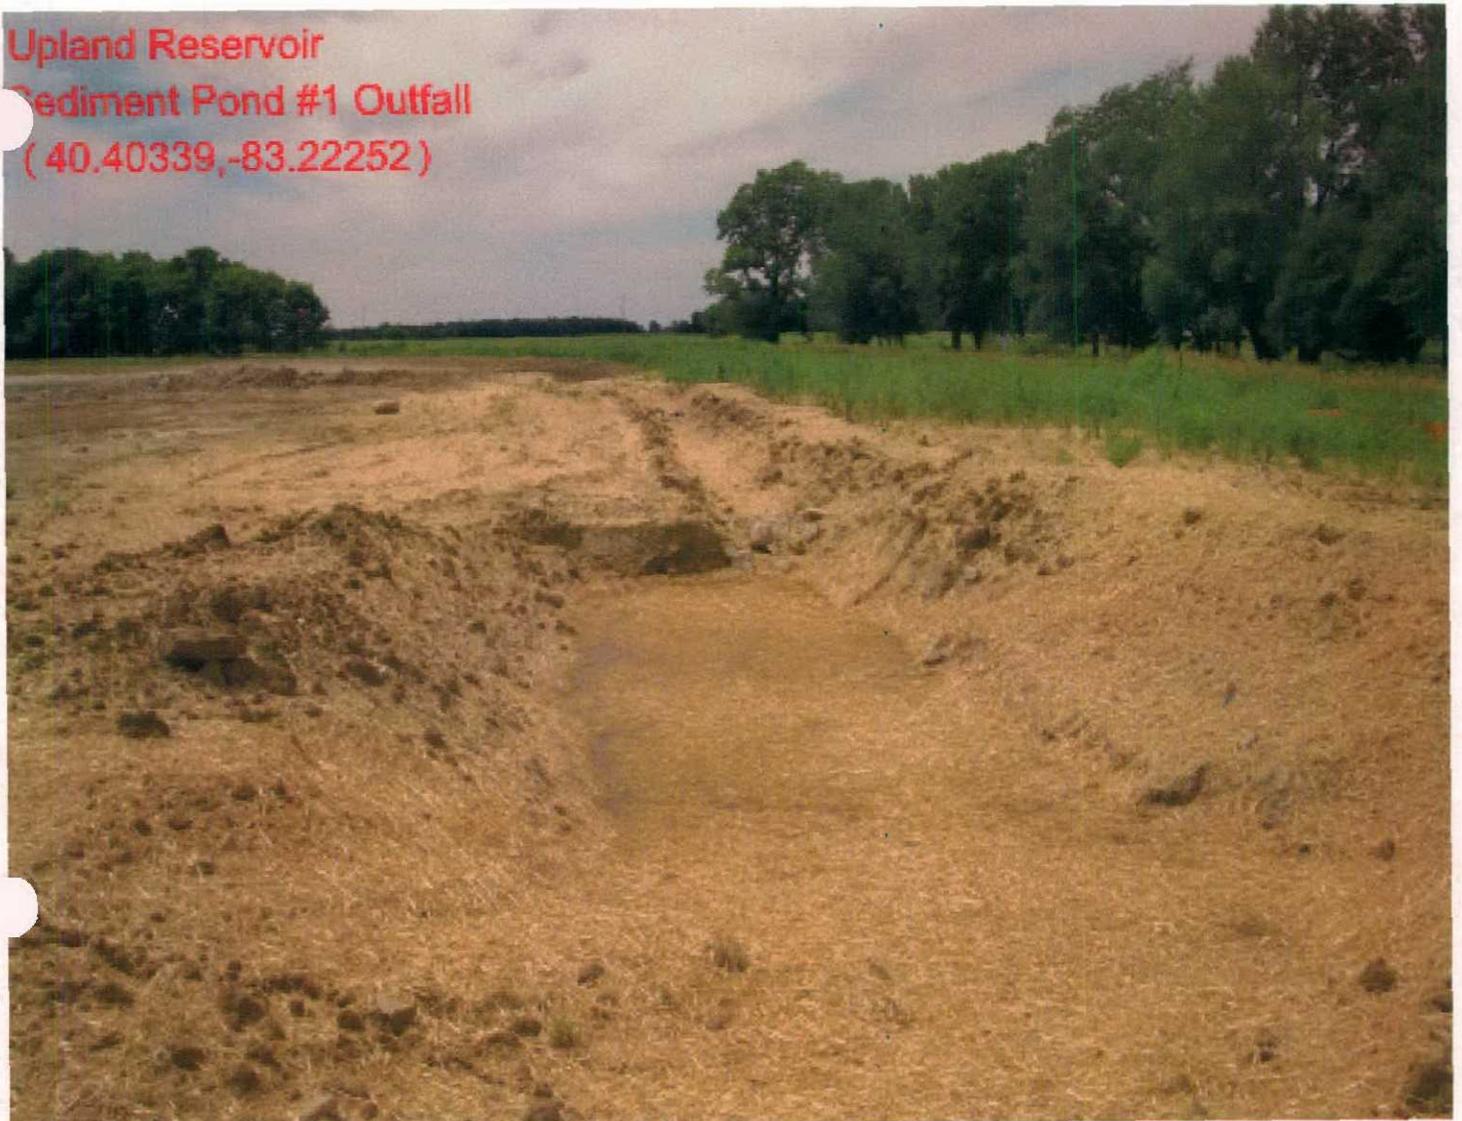
Upland Reservoir
Sediment Pond #1 Outfall
(40.40339, -83.22252)

Figure 2: Sediment Pond #1 Outfall to Ottawa Creek

- Begin modifications to the outlet channel of sediment pond number one to further decrease energy by widening the existing channel and incorporating a level spreader prior to the final discharge to Ottawa Creek. During the inspection we agreed on a skimmer device to further enhance sediment control during construction.
