GEORGES CORNER II

July 26, 2011

**Re: Construction Storm Water Inspection at Georges Corner II / Franklin County  
Permit Number: 4GC03420\*AG**

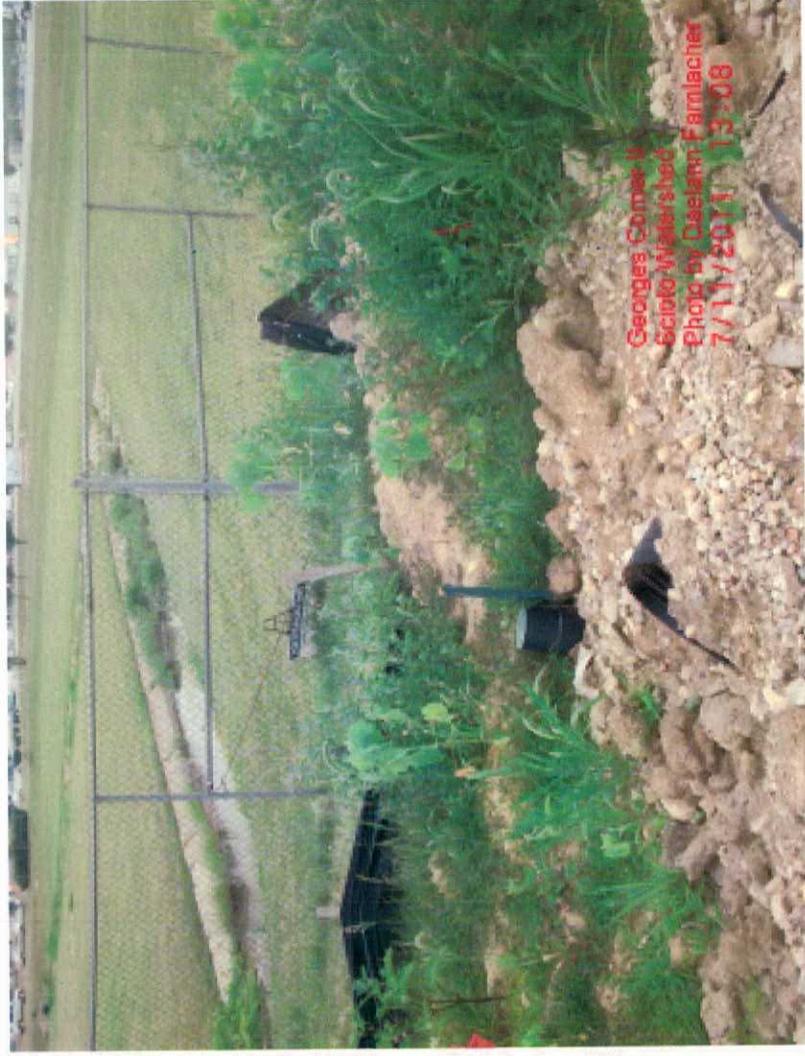
- Our staff noted failed silt fence along the north side of the perimeter which requires reinstallation (See Figure 1).
- Our staff observed a bypass on one of the storm sewer drains which must be maintained to minimize the discharge of sediment into waters of the state (See Figure 2).
- Please advise in your response the intended function of the pipe noted in Figure 3.

Figure 1: Failed silt fence

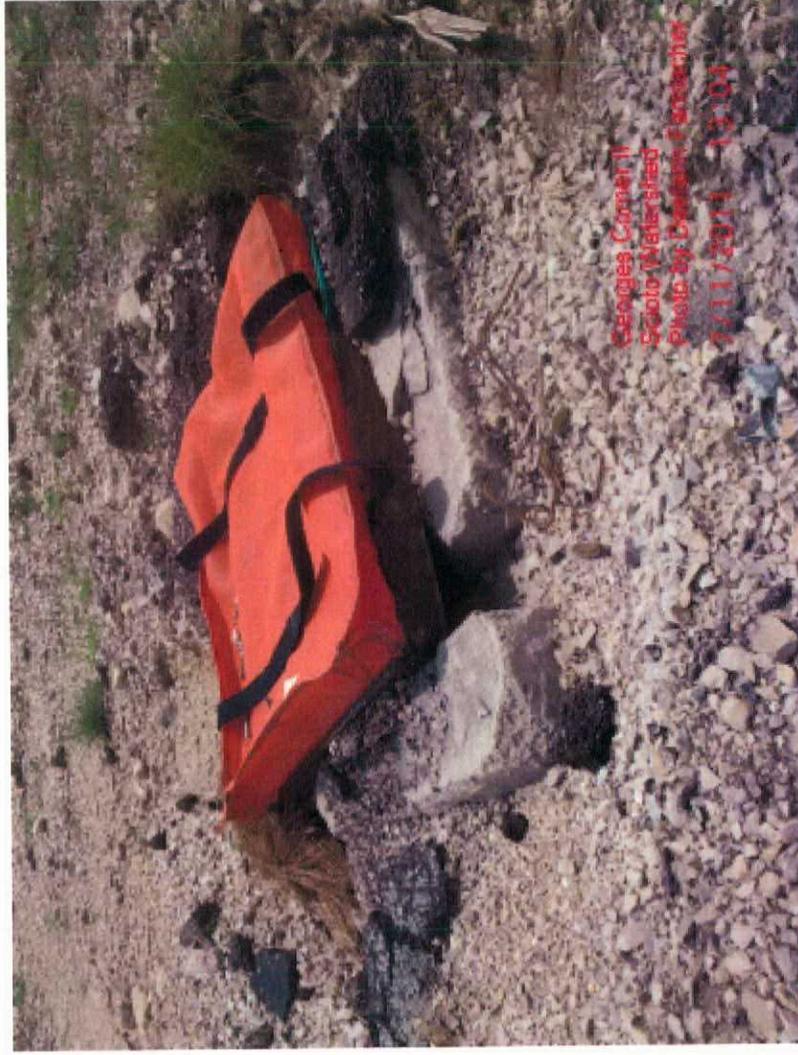
Figure 2: Bypass into storm sewer drain
