TURKEY HILL MINIT MARKET #707

July 12, 2011

**Re: Construction Storm Water Inspection at Turkey Hill Minit Market #707
Franklin County
Permit Number: 4GCO00053*AG**

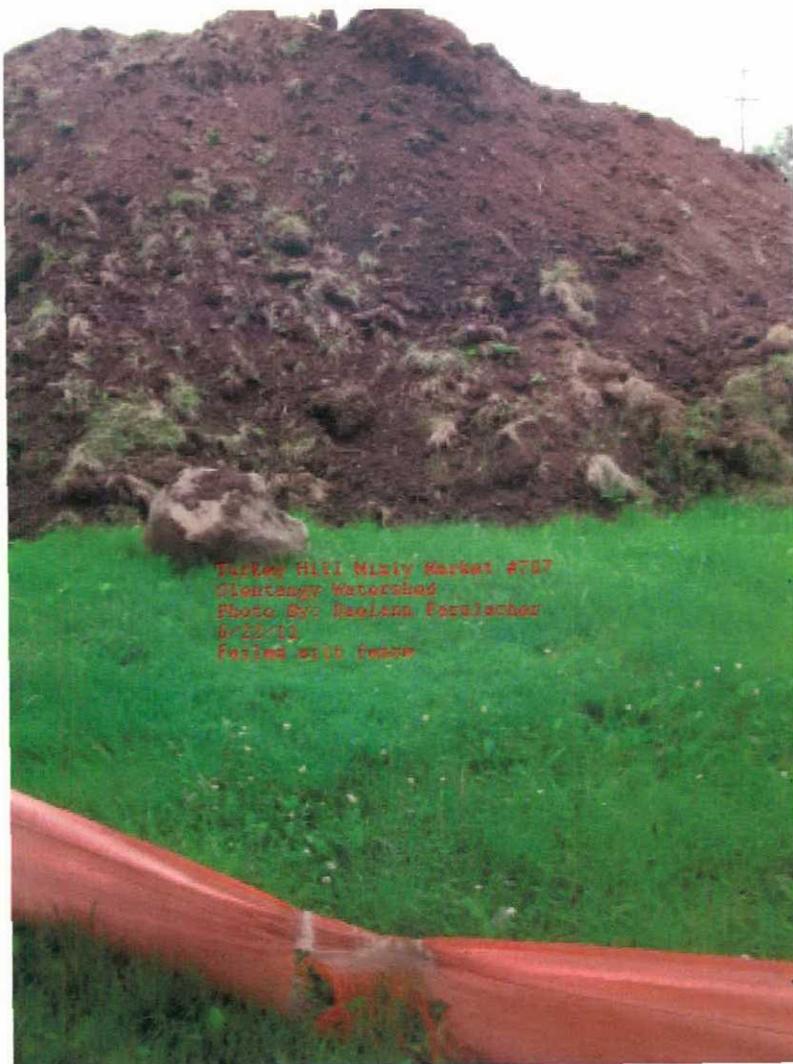
- Sediment controls for this project must be implemented in accordance with the General Storm Water Permit. Our staff noted failed silt fencing along the north end of the perimeter by State Route 62 which must be maintained (See Figure 1).
- According to the Storm Water Pollution Prevention Plan, the sediment basin was required first in the construction sequence. Please install the sediment basin and ensure all barren areas are routed to the impoundment intended for sediment control within seven days of receipt of this letter.
- A stabilized construction entrance must be provided to minimize the vehicle tracking of mud onto public roads (See Figure 2).

Figure 1: Failed silt fence

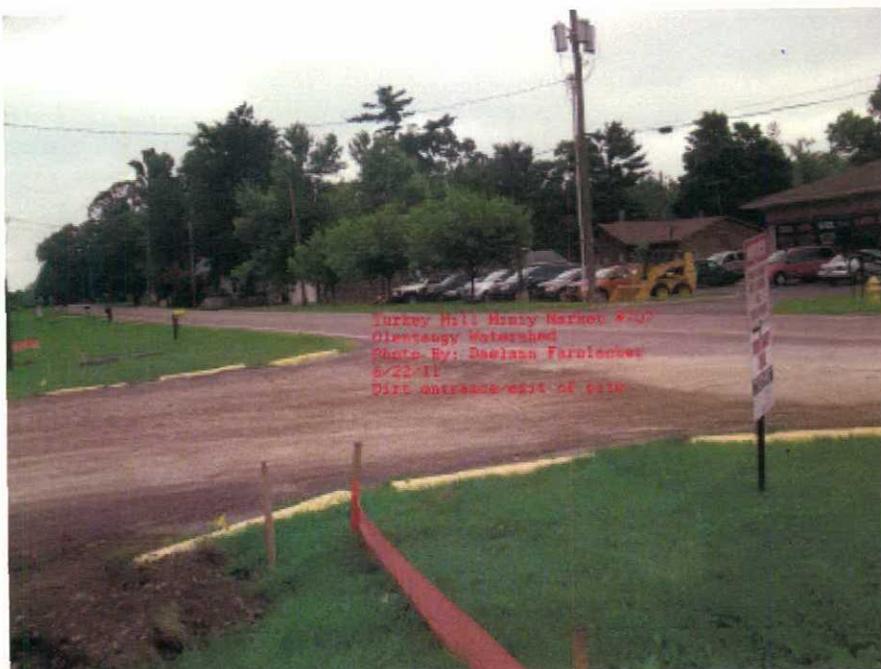
Figure 2: Entrance to site
