**Environmental
Protection Agency**

March 14, 2012

**RE: Notice of Violation
Rumpke Sanitary Landfill, Hamilton County**

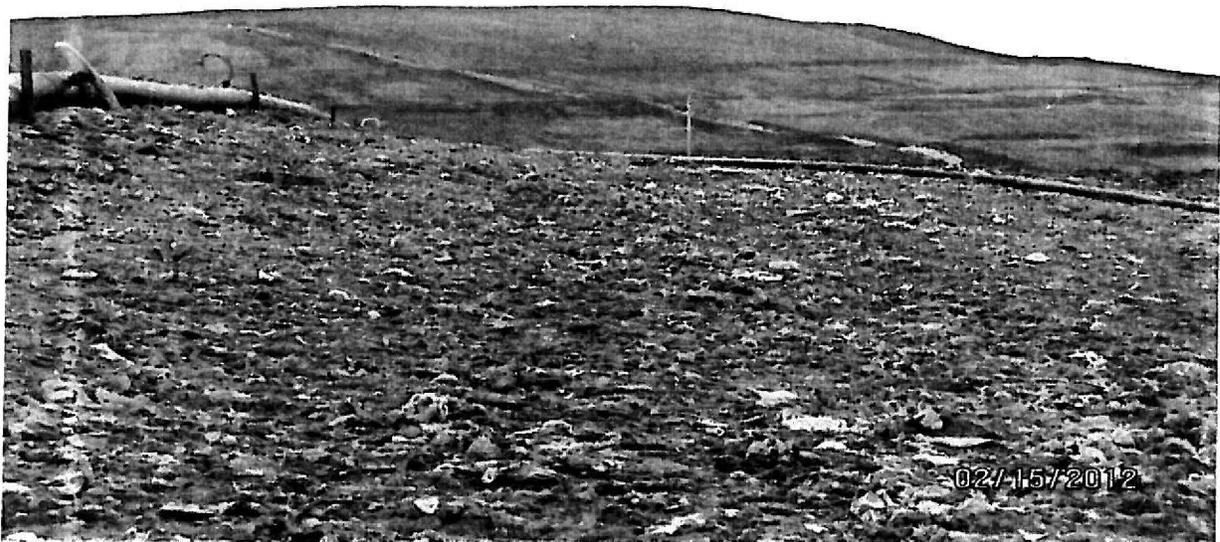
Picture 1 Exposed waste in west buttress area

Waste was flagging in the cover soil and soil pile of the west buttress construction area. (Picture 1)

Ohio Administrative Code (OAC) Rule 3745-27-19(G)(2) states in pertinent part, "Intermediate cover material shall be... (a) soil layer, a minimum of twelve inches thick, consisting of well-compacted loam, silt loam, clay loam, silty clay loam, silty clay or some combination thereof, shall be used."

The west buttress construction area has intermediate cover material. The material found in this location was comprised of waste along with cover soil. This material may not be comprised of any material other than what is outlined in 19(G)(2).

Therefore, Rumpke is in violation of (G)(2) for failing to maintain intermediate cover as outlined in OAC Rule 3745-27-19(G)(2).

Please respond in writing within fourteen (14) days from receipt of this correspondence regarding a plan to ensure that intermediate cover areas comply with OAC Rule 3745-27-19(G)(2).

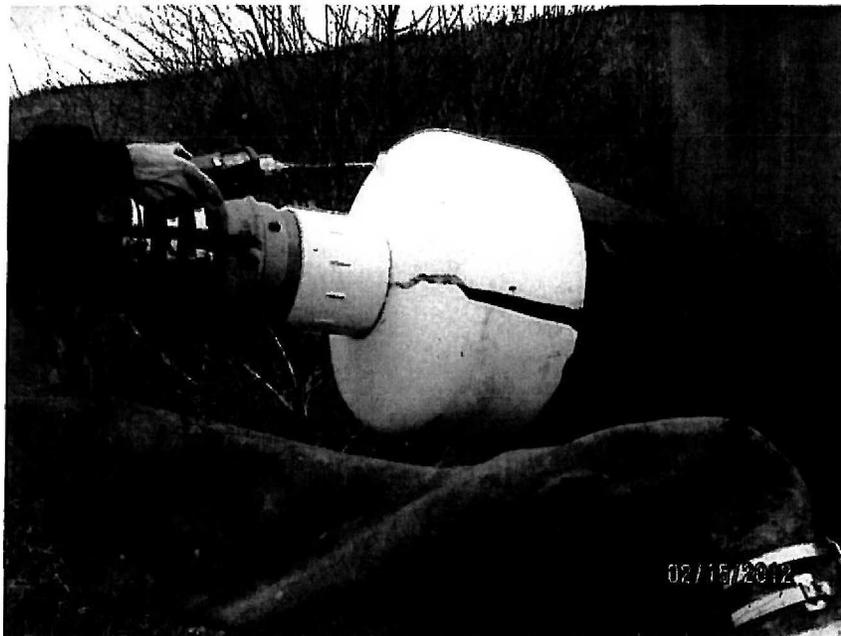
Picture 2 - Phase II underdrain side slope riser

During the February 15, 2012 inspection, odors were again observed in this area. The group noted that the white cap on the 18 inch side slope riser was cracked, which allowed both odors and visible vapors to escape from the riser. Brian Huffman was not aware of the damage to the cap and made a call to have the cap fixed. (Picture 2)

On February 17, 2012 Joleen Cook from Ohio EPA was on site and observed that the cracked cap had been caulked.

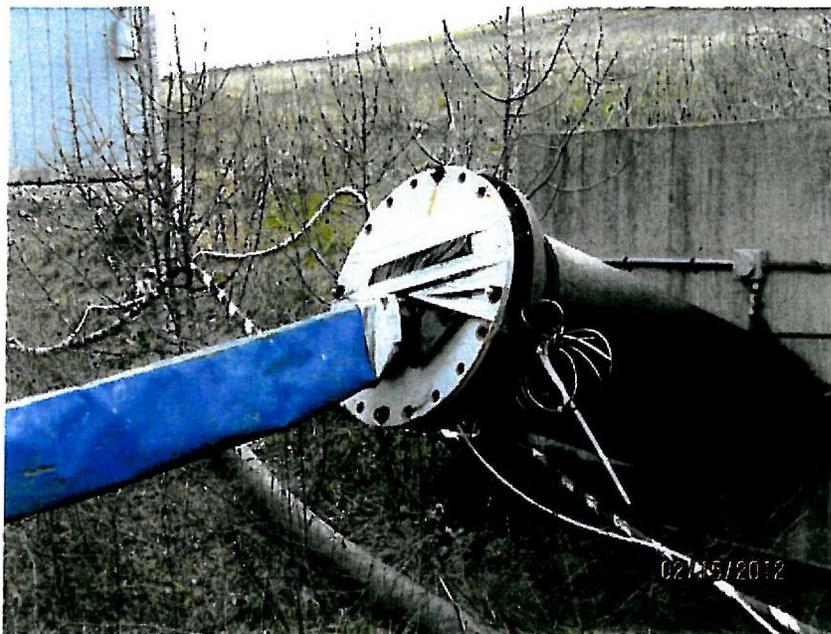
Picture 3 - Phase II side slope riser

During the February 15, 2012 inspection, the east lift station was being cleaned. Black material, which Rumpke has indicated may clog the pump, was being removed. Additionally, the tarp covering the east lift station had not been replaced. One of the 18 inch leachate riser caps had been repaired with duct tape and plastic. (Picture 3)

On February 17, 2012, Joleen Cook from Ohio EPA was on site and observed that the tarp was in place and stabilized with sandbags.

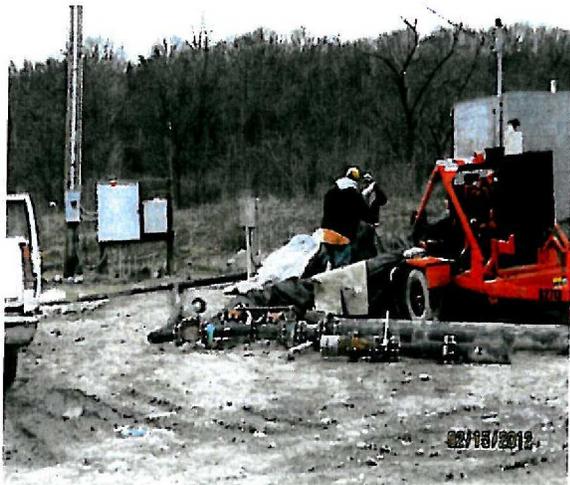
Picture 5 – Northwest lift station

During the February 15, 2012 inspection, odors were again identified at this area. The lift station was still covered only by tarps, which were still torn, and vapors were visibly escaping from underneath the tarps. The damaged tarps seemed to be the source of the odors. Neither Mr. Huffman nor Mr. Butler seemed to be aware that new tarps were to have been deployed at the Northwest lift station. Mr. Huffman stated that an odor control mister was operating inside the lift station under the tarps at that time. He called to have the new tarps deployed at the lift station, which occurred while the group was present. (Pictures 4 & 5)

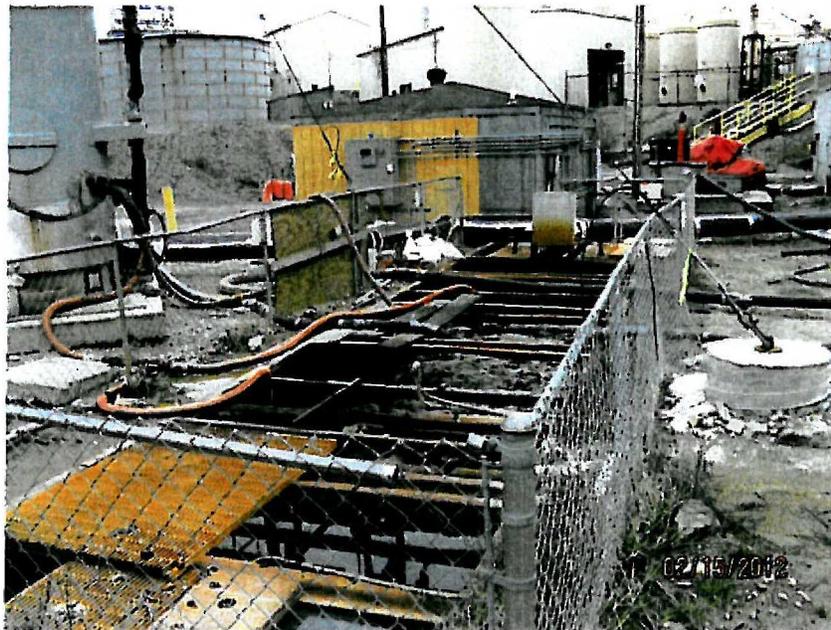
Picture 6 - Leachate pumping area tanks

During the February 15, 2012 inspection, HCPH, SWOQA, Ohio EPA and Mr. Huffman inspected the leachate storage tank and associated pumping area. The group observed landfill leachate being pumped from two large open metal in-ground tanks to the leachate storage tank. This area was another source of odors. This area's odor was noted at the adjacent frac tank/tanker truck loading station approximately twenty feet above. (Picture 6)
