State of Ohio Environmental Protection Agency

January 20, 2010

**Re: Allen Milk Company, A Division of T. Marzetti Company / Franklin County
Industrial Storm Water Permit 4GR00065*DG**

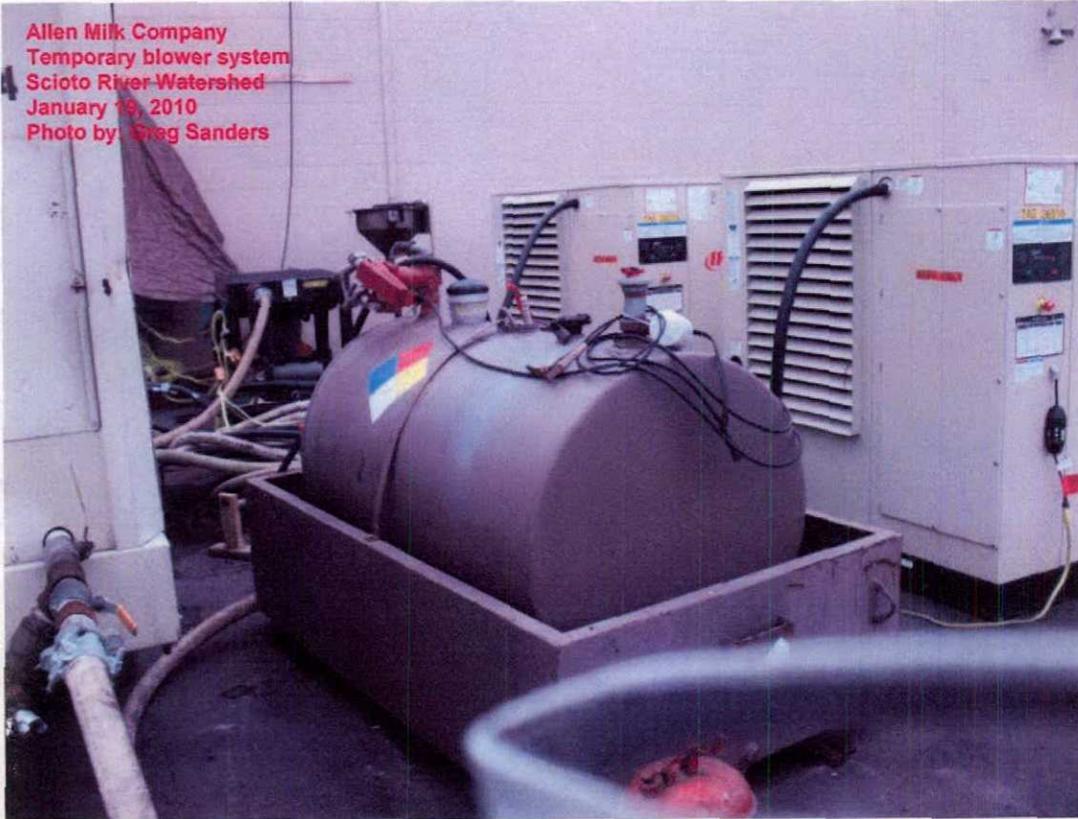
1. The property had a fire that caused damage to the blower room. Temporary blowers were being used and located outside. Secondary containment was being used for the fuel tank of the blowers. However, a small amount of fuel had spilled on to the parking lot near the temporary blowers. There was an oily sheen in a small puddle in the parking lot. You stated that the new blower building would be ready in approximately a week and the temporary blowers would then be removed from the parking lot. You also stated that the parking lot would be steam cleaned.
2. The facility had all outside tanks in either secondary containment or used double-walled tanks. No evidence of product staining the parking lot or storage areas.
3. The facility had a storm water pollution prevent plan and a spill prevention plan.

Allen Milk Company
Temporary blower system
Scioto River Watershed
January 18, 2010
Photo by: Greg Sanders

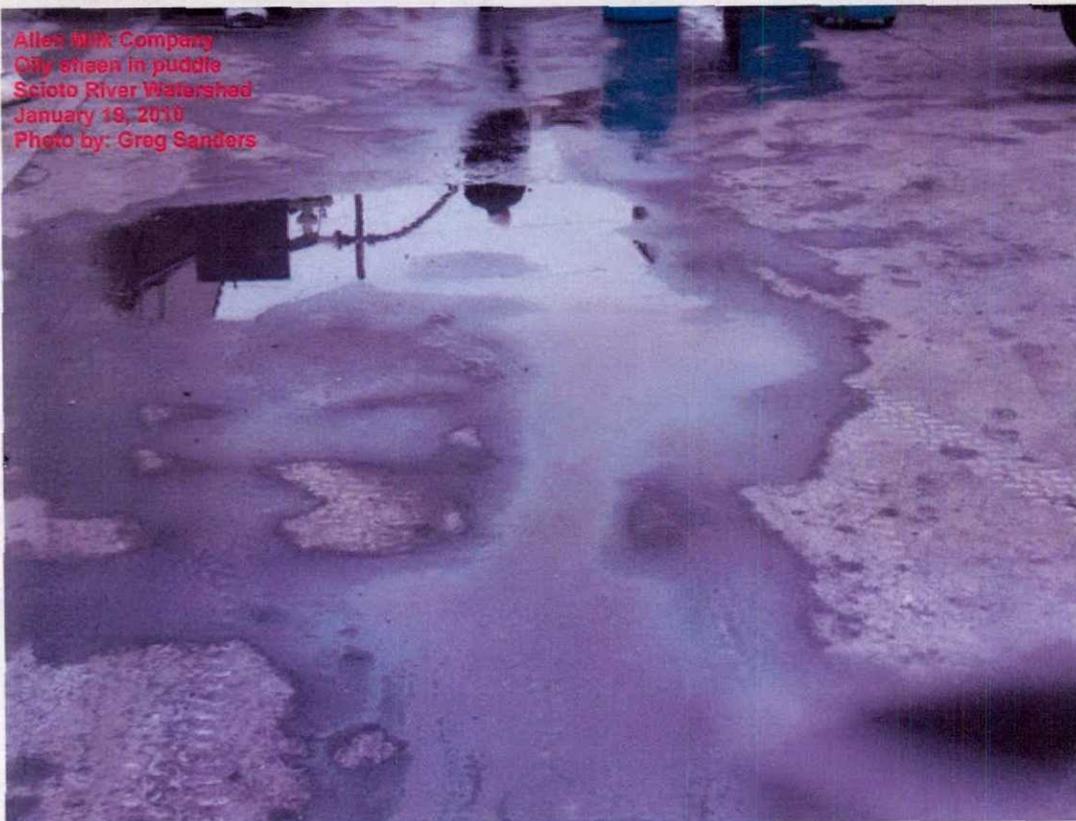
Allen Milk Company
Oily sheen in puddle
Scioto River Watershed
January 18, 2010
Photo by: Greg Sanders

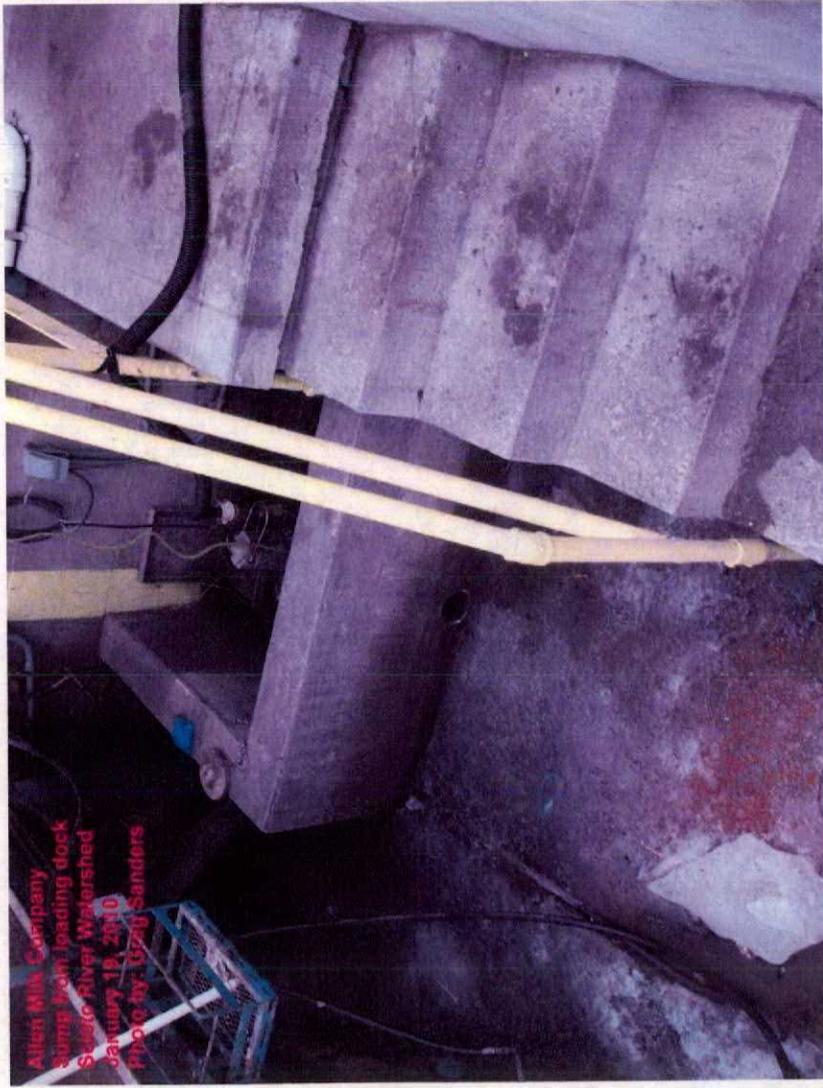
4. A sump pit was located near the loading dock located on the west side of the building. The sump pit had the drain plugs removed due to freezing of the sump pit. The sump pit was manually operated. No evidence of pollutants discharging to the storm water drain.

Allen Milk Company
Sump from Loading Dock
Saguaro River Watershed
January 19, 2010
Photo by: Craig Sanders
