**Environmental  
Protection Agency**

RE: VILLAGE OF SALINEVILLE  
COMPLIANCE EVALUATION INSPECTION  
NPDES PERMIT NO. 3PB00026

**INSPECTION PHOTOS**

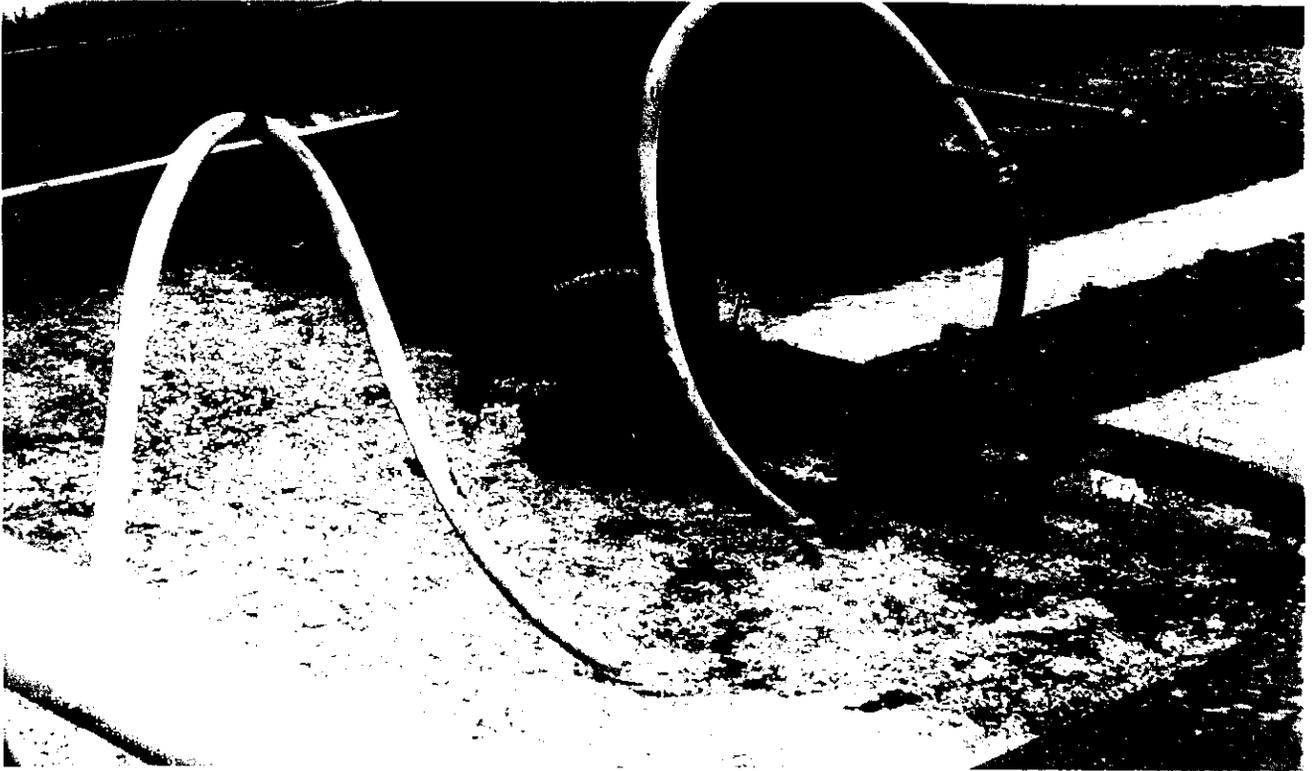
- 4) A great deal of solids and debris are passing through to the aeration tank and clarifiers. The Village must evaluate alternative equipment to remove these materials at the head of the system.

**THE BAR SCREEN IS NOT REMOVING FINE PARTICLES AT HEAD OF PLANT.**
