**Environmental  
Protection Agency**

RE: MEDINA COUNTY  
BLEACH TECH LLC  
NPDES PERMIT NO. OHR000004  
OHIO EPA PERMIT NO. 3GR01348\*DG  
INDUSTRIAL STORM WATER INSPECTION

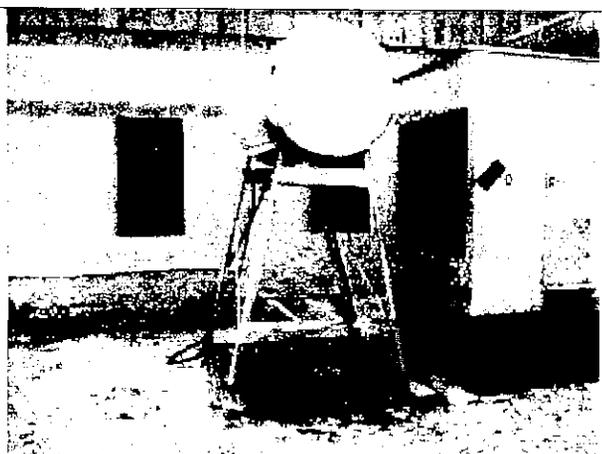
- Section III of the SWP3, page four, details the BMPs that will be implemented to minimize or eliminate the discharge of pollutants associated with the diesel fuel tank. The BMPs for the diesel fuel tank are detailed as containment, inspection, and maintenance. Currently, the diesel fuel tank does not have any containment installed (Figure 2). In addition, a spill kit must be installed near the diesel fuel tank to address the potential for spills and overfills.

**Figure 2** - The diesel fuel tank does not have any containment installed.
