Environmental
Protection Agency

June 23, 2011

RE: CLIFTON STEEL CO
3GR01205*DG
STORMWATER
CUYAHOGA

On June 20, 2011 this writer conducted an inspection of your facility, located at 16500 Rockside Road, Maple Heights, Ohio to determine compliance with your Industrial General Storm Water NPDES permit referenced above. Along with my observations from the inspection I have provided comments concerning your permit below:

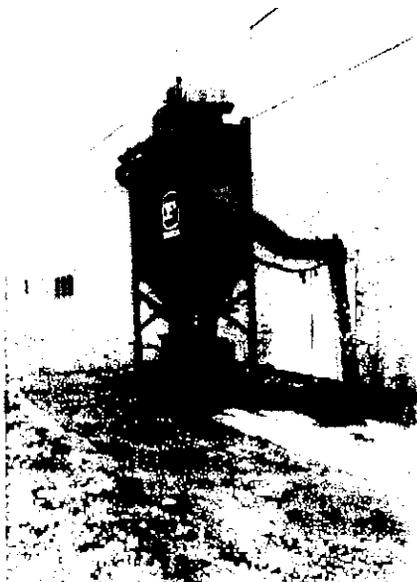
4. Two totes containing oil mixtures were located just outside of the south door. These totes should be properly labeled and kept indoors.
5. Dust and particulate matter was scattered on the pavement around the bag house (Figure 2). This area should be swept and inspected regularly and methods of containment should be considered to prevent this debris from washing into the storm drainage system.

Figure 2b: Bag house cement showing significant particulate buildup and staining.
