Environmental  
Protection Agency

June 20, 2011

RE: KOKOSING MATERIALS PLANT 519  
PERMIT# 3GR01082\*DG  
INDUSTRIAL STORMWATER  
CUYAHOGA COUNTY

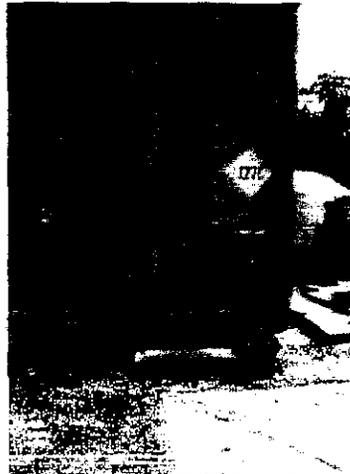
3. The dike around the asphalt tanks needs repair. It had large cracks and there was evidence that leaks have occurred (Figure 7).
4. A trailer containing automotive fluids on the south side of the Maintenance Building appeared to be leaking. Spills from this trailer can enter the storm drain a few feet away (Figure 3). This trailer should be inspected regularly and measures taken to clean up spills if they occur. Containers within the trailer that are leaking should be kept on containment trays.

**Figure 3:** Trailer with signs of oil leakage

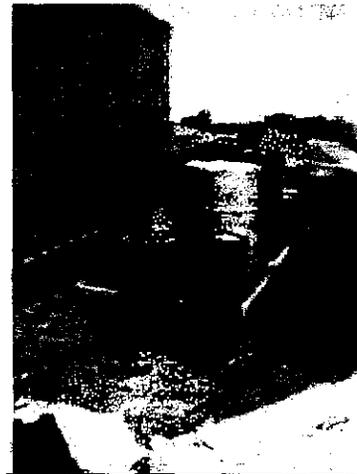
5. Several 55-gallon drums are stored on the south side of the maintenance building (Figure 4). Although most of these drums are stored on a containment tray, two full drums were not. These should be moved onto the containment tray or stored inside.

**Figure 4:** Two drums located off of containment tray

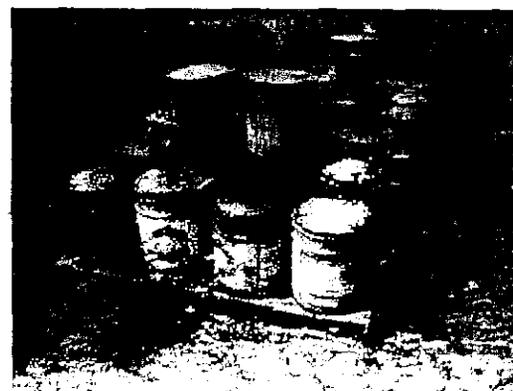
9. There were about 20 buckets of Epoxy on the north side of the facility which should be stored inside (Figure 6).

**Figure 6:** Buckets of Epoxy exposed
