**Environmental
Protection Agency**

July 6, 2011

RE: PEARL ROAD AUTO WRECKING
3GR00732*DG
STORMWATER
CUYAHOGA

On July 5, 2011 this writer conducted an inspection of your facility, located at 5000 Pearl Road, Cleveland, Ohio, to determine compliance with the Ohio EPA General Storm Water National Pollutant Discharge Elimination System (NPDES) Permit for Industrial Activities #OHR000004 referenced above. Along with my observations from the inspection I have provided comments concerning your permit below:

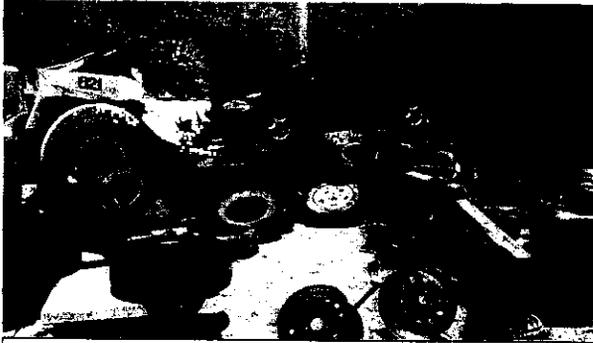
1. While walking around the outside of the building I noticed a few areas of concern. I was told tires were to be stored in a dumpster near the west side of the main building and that they were picked up about once every month. However, many tires were piled up on the ground around this area (Figure 1). Tires should be stored indoors on tire racks or in a covered container, such as the dumpster covered with a lid or tarp. The tires should be picked up as soon as the dumpster is full so they are not sitting for extensive periods of time. Stockpiling tires is not suggested as they create both a fire hazard and a breeding ground for mosquitos and rodents.

Figure 1: Tires piled outside.

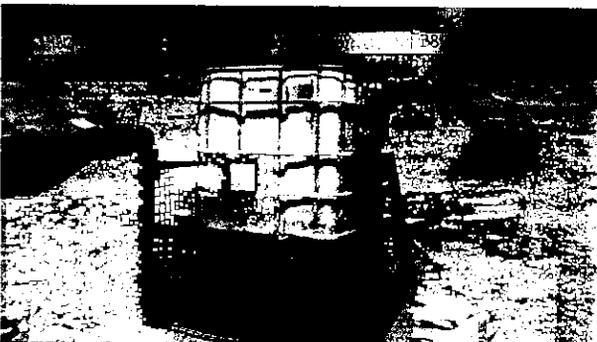
6. A couple of unused totes (Figure 5) and dumpsters were sitting in the yard. These unused containers should be rid of if they are not going to be used to minimize your exposure.

Figure 5: An unused tote sitting in the yard.
