**Environmental
Protection Agency**

July 12, 2011

RE: SIMA MARINE SALES INC
3GRM00002*AG
STORMWATER
LAKE

On June 6, 2011 this writer conducted an inspection of your facility, located at 200 Forest Drive, to determine compliance with the Ohio EPA General Storm Water National Pollutant Discharge Elimination System (NPDES) Permit for Marinas #OHRM00001 referenced above. Dan Bogoevski, of the Ohio EPA Division of Surface Water, was also present at this inspection. Along with our observations from the inspection I have provided comments concerning your permit below:

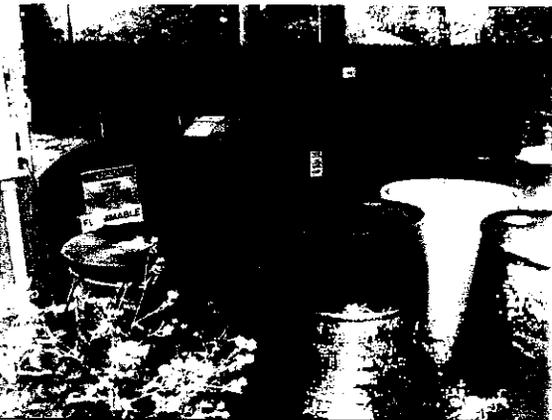
7. Lots of staining and signs of spills were seen in the gas pump area, especially around the used oil tank (Figure 4). A spill kit was moved to this area. Good housekeeping methods should be implemented to clean any spilled materials in the future and to clean up the current spills. Furthermore, drums of antifreeze were open and outside of the covered area. Drums should be kept closed and stored under the roofed area on containment trays or indoors. Also, drums should have labels indicating their contents.

Figure 4a: Gas pump area. Staining and open drum are visible.

9. Make adjustments to the outboard test tank so polluted water is no longer discharged out of the building.
10. Label drums and keep them, along with any other containers with liquids, on a containment tray or within some other means of secondary confinement.
11. Clean up spills in the gas pump area.

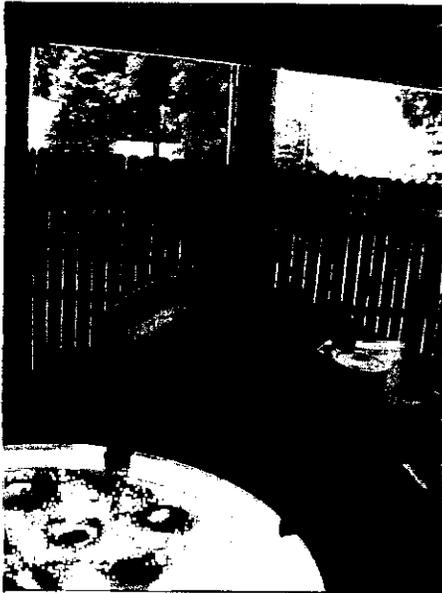
Figure 4b: Used oil tank. All tanks and drums should be labeled.

4. Conduct a comprehensive site compliance evaluation by December 31, 2011.
5. The tank containing used oil was labeled "Waste Oil". This tank must be label "Used Oil".
