**Environmental
Protection Agency**

August 3, 2011

RE: GEAUGA COUNTY
SCARSDALE WWTP
NPDES #3PG00000
NPDES PRE-PERMIT INSPECTIONS
COMPLIANCE INSPECTION EVALUATION

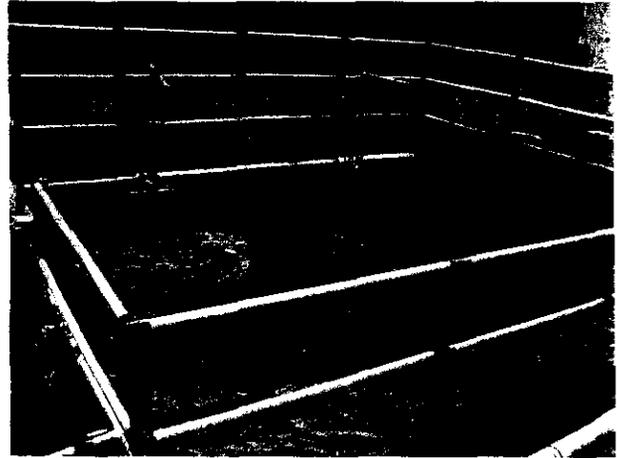
Figure 2: Aeration tank with only one blower online.
