**Environmental  
Protection Agency**

May 13, 2010

RE: STARK COUNTY  
VILLAGE GREEN ALLOTMENT WWTP  
NPDES #3PG00087

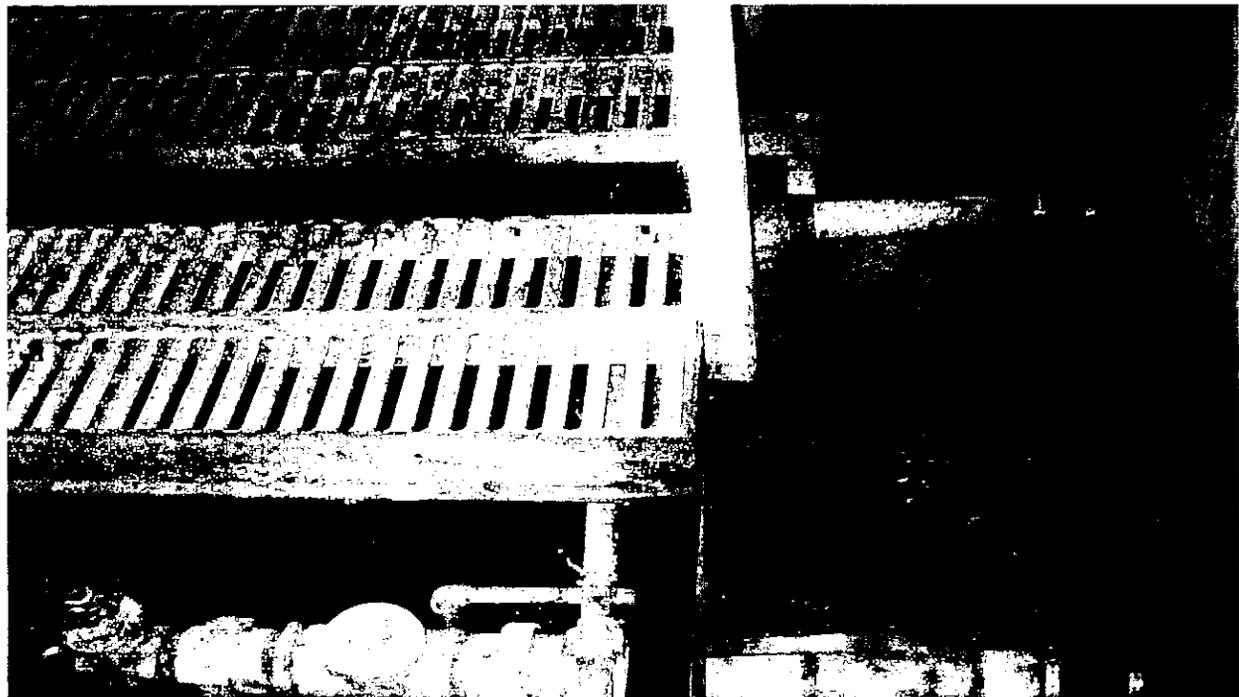
Photo 2 shows solids floating on top of the clarifier.

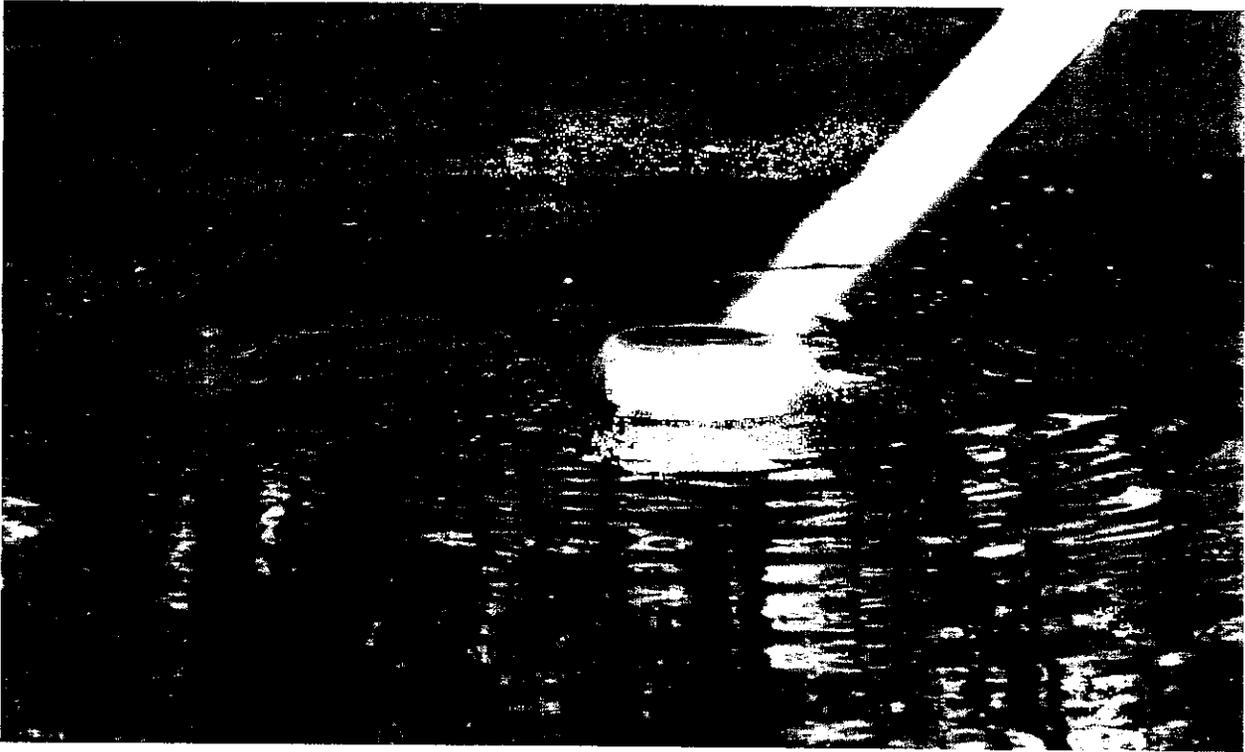
Photo 3 shows water being discharged from dosing station onto sand filter bed.

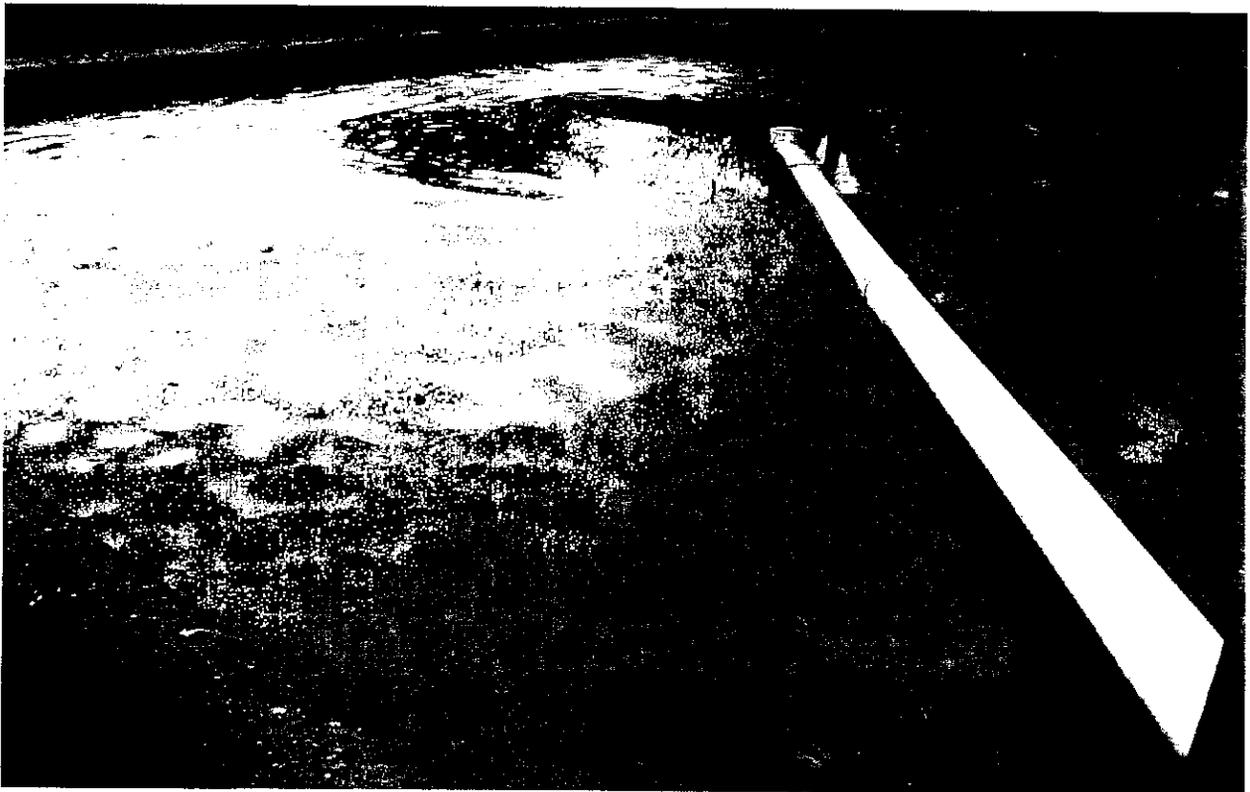
Photo 4 shows significant amount of solids covering sand filter bed.

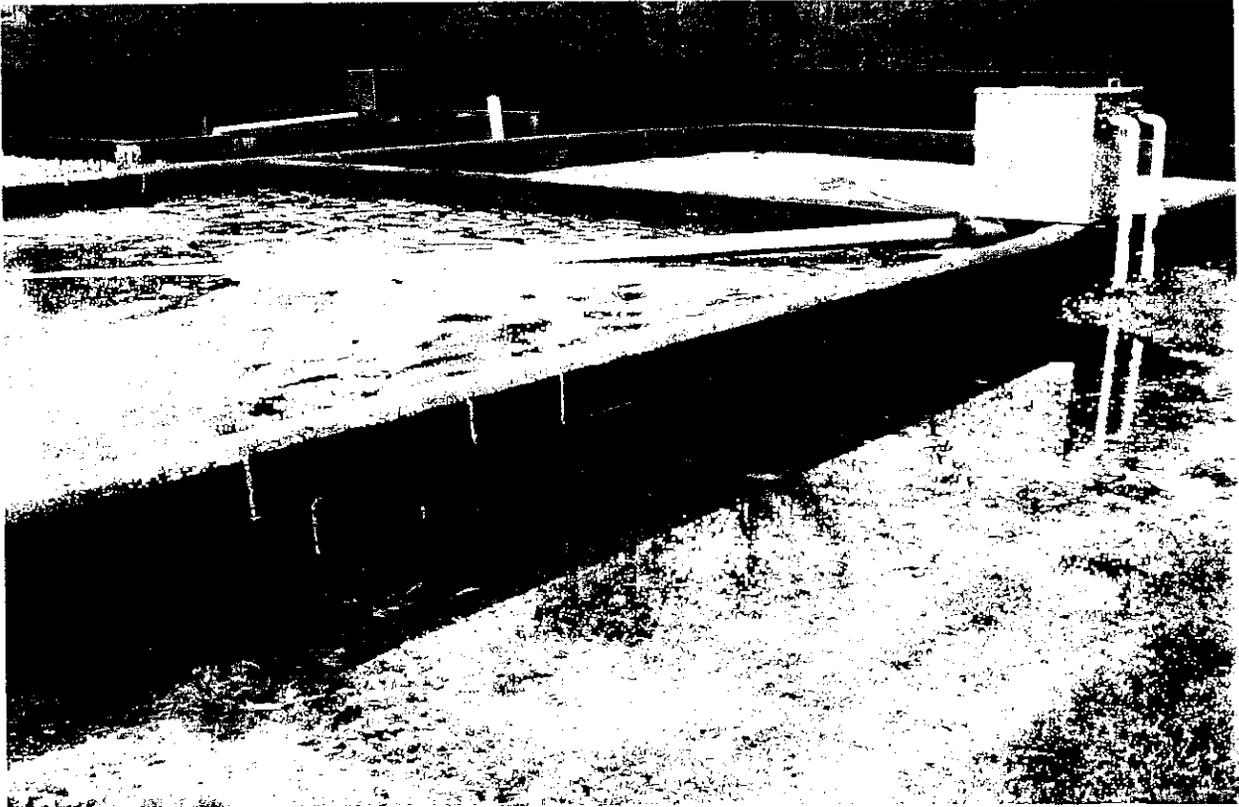
Photo 5 shows wastewater leaking from cracks in concrete wall of sand filter bed.

The surface sand filter bed walls must be repaired immediately. Bypassing around any portion of your treatment system violates the conditions of your NPDES permit, specifically Part III, item 11.

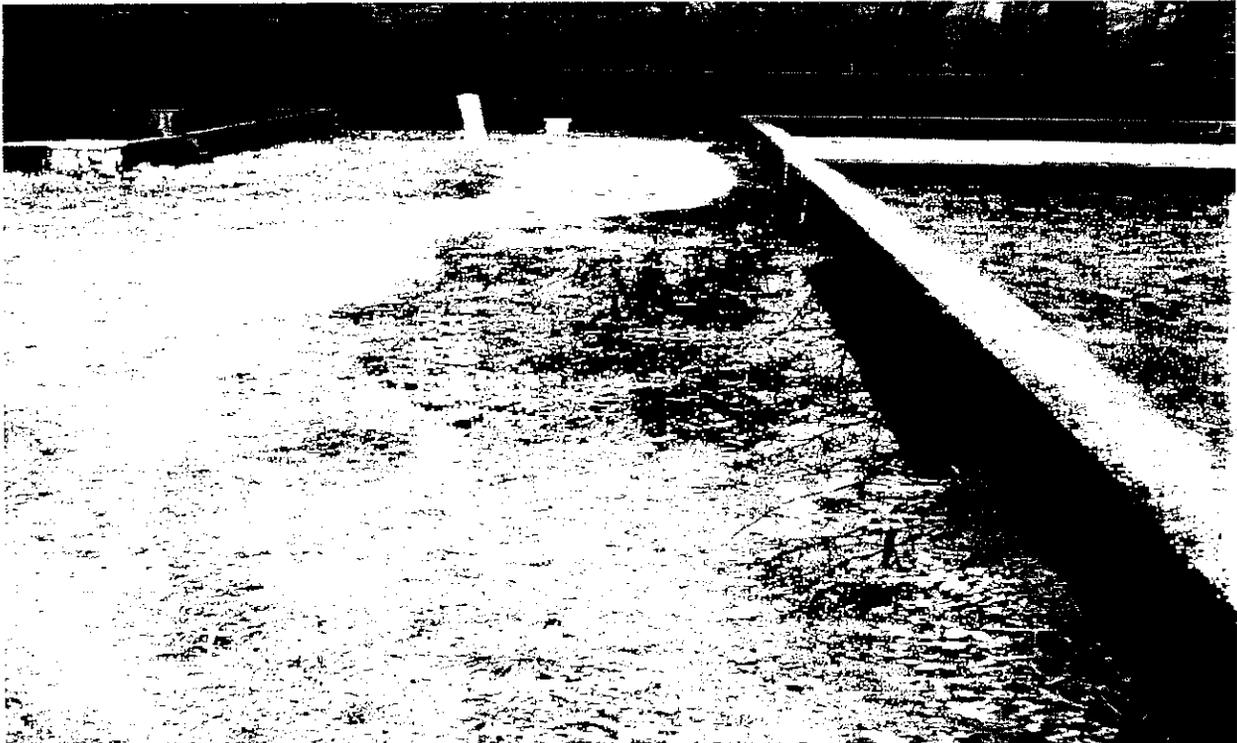
Photo 6 shows wastewater leaking from cracks in concrete wall of sand filter bed.
