Environmental
Protection Agency

June 27, 2011

RE: ASHTABULA COUNTY
HARPERSFIELD TOWNSHIP
CORK ELEMENTARY
NPDES PERMIT NO. OHC000003
OHIO EPA PERMIT NO. 3GC04767*AG
CONSTRUCTION STORM WATER

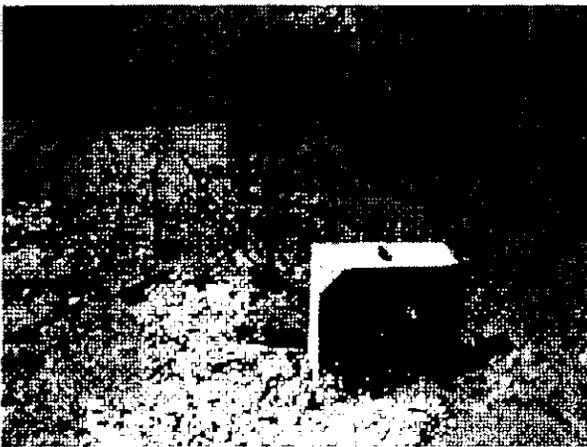
- The sediment pond has not been constructed per requirements (see enclosed specifications from *Rainwater and Land Development, Ohio's Standards for Stormwater Management, Land Development and Urban Stream Protection* and refer to the detail drawing contained in the SWPPP). This has resulted in a significant discharge of sediment to the wetlands located downstream of the pond. The sediment pond must provide a sediment storage volume of at least 1,000 cubic feet per acre of disturbed area, a dewatering volume of at least 1800 cubic feet per acre of total contributing drainage area, and an outlet structure that drains down the dewatering volume in no less than 48 hours. Please complete construction of the sediment pond and install the appropriate sediment control structure, i.e. riser pipe or skimmer, before allowing any more water to discharge into the wetland (See Figures 5 & 6).

Figure 5. The sediment pond is discharging sediment laden water into the wetland area.

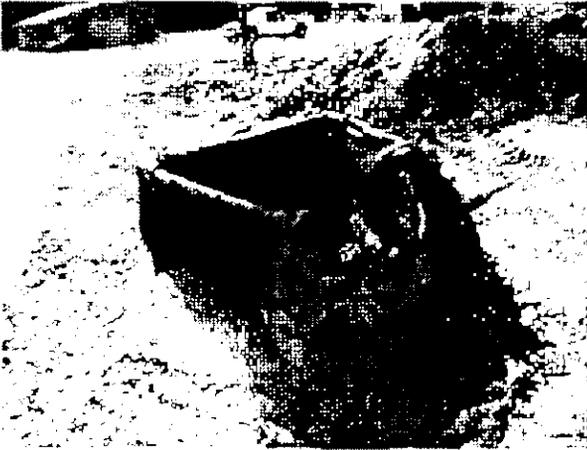
- The storm drain inlet protections were not properly installed, and even missing on some of the inlets. The wrong type of geotextile material was used as well. Please be sure to follow the specifications in the SWPPP very closely, and install new inlet protections promptly (See Figures 7 & 8).

Figure 7. Inlet protection is damaged and made from the wrong type of geotextile material.
