State of Ohio Environmental Protection Agency

RE: CUYAHOGA COUNTY  
ROCKY RIVER WATERSHED  
CITY OF BEREA  
SANDSTONE RIDGE SOUTH

**NOTICE OF VIOLATION**

**SANDSTONE RIDGE SOUTH PH 3A & 3B**  
City of Berea Cuyahoga County  
Operator: Lopat LLC

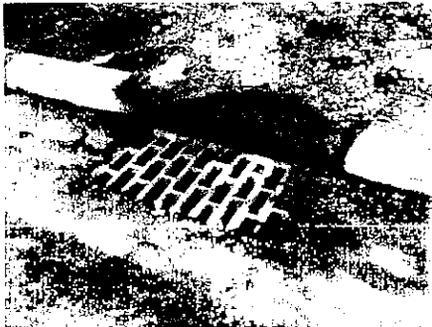
Fig 7-9. Storm drain inlet protection is not being maintained, has not been installed or is the wrong type for the kind of inlet you are protecting. Inlet protection must be capable of ponding runoff in order to be effective. It cannot pond runoff if it is not installed, is torn or does not protect the curb window.

- **Failure to install storm drain inlet protection on curb, street and yard inlets. This is a violation of Part III.G.2.d.iv of the NPDES permit and ORC 6111.04 and 6111.07. Failure to maintain storm drain inlet protection where it has been installed. This is a violation of Part III.G.2.i of the NPDES permit and ORC 6111.04 and 6111.07.** The approved SWP3 indicates that inlet protection is to be provided on all curb, street and yard inlets. It was missing from a number of storm drain inlets. Where it was installed, it was not constructed per the specifications contained in the approved SWP3 and is not being maintained to function as intended. Storm drain inlet protection must be able to pond runoff in order to function as intended. The filter fabric has been pulled back, is torn or sagging, making it unable to pond runoff. Please install storm drain inlet protection where it is missing and replace or repair it as necessary to achieve functional storm drain inlet protection.

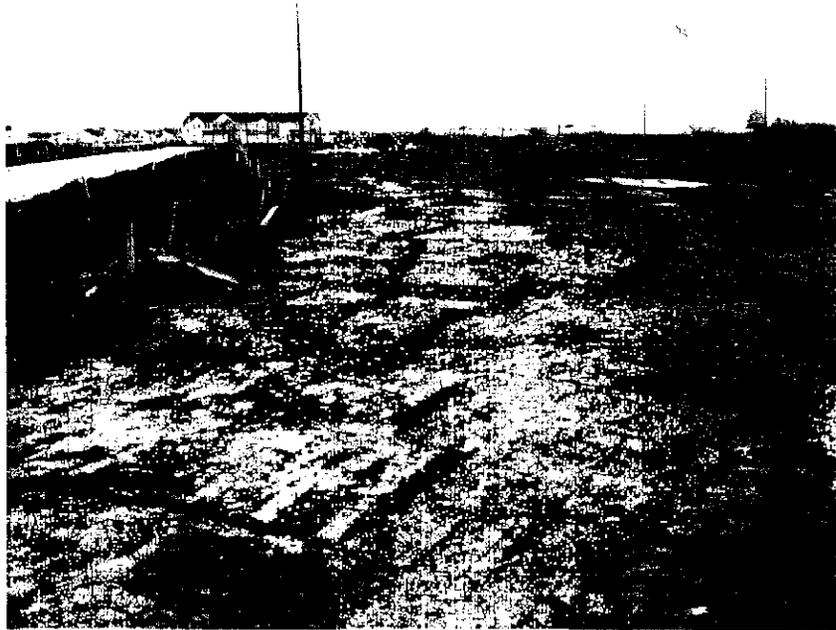
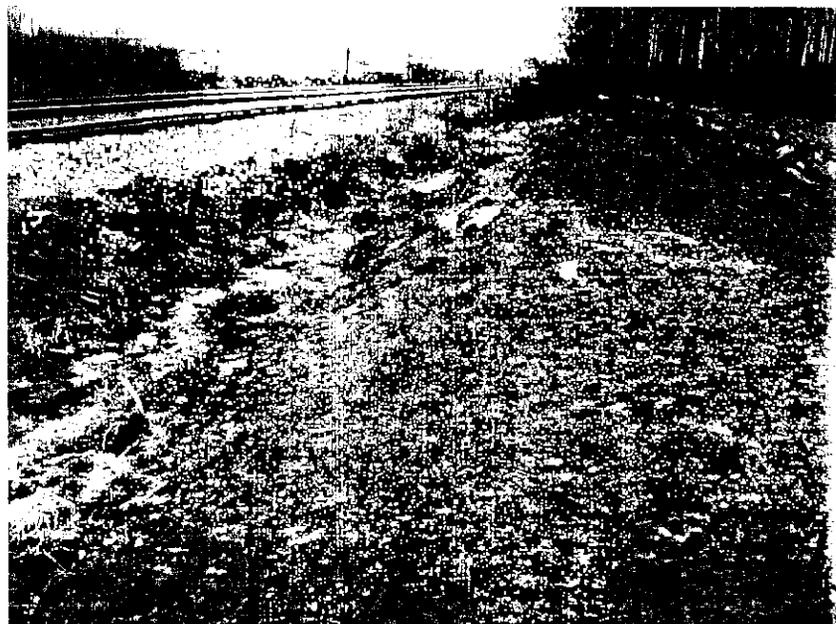
**Fig 10 & 11.** Disturbed areas outside the road and utility right-of-ways and the privacy mound along the railroad tracks have not been stabilized. These areas will remain idle 21 days or longer and are required to be temporarily stabilized between construction operations. Note that runoff from the privacy mound enters the drainage channel along the tracks. Silt fence should be installed at the base of the mound to prevent the migration of sediment into the drainage channel.

- **Failure to initiate temporary stabilization of disturbed areas within 7 days of last disturbance if they are to remain idle for 21 days or longer. This is a violation of Part III.G.2.b.i of the NPDES permit and ORC 6111.04 and 6111.07.** The soil stockpile, berm along the railroad tracks and disturbed areas that lie beyond the road and utility right-of-ways have been idle all winter long. No attempt to temporarily stabilize these areas was evident. Please seed and mulch these areas and any other areas disturbed by construction activity that will remain idle 21 days or longer.
