RE: CUYAHOGA COUNTY  
CHAGRIN RIVER WATERSHED  
VILLAGE OF CHAGRIN FALLS  
FALLS WALK SUBDIVISION

On August 26, 2009, I inspected storm water best management practices (BMPs) at the above referenced site. This was a routine inspection to assure that the control measures previously installed are being maintained in functional condition. Our records indicate that Falls Walk Developers has obtained coverage under the Ohio EPA General Storm Water National Pollutant Discharge Elimination System (NPDES) Permit for Construction Activities #3GC04297\*AG.

**FALLS WALK SUBDIVISION**  
Village of Chagrin Falls Cuyahoga County  
**Operator:** Falls Walk Developers LLC

**Photos Taken:** August 26, 2009  
**By:** Dan Bogoevski, DSW-NEDO

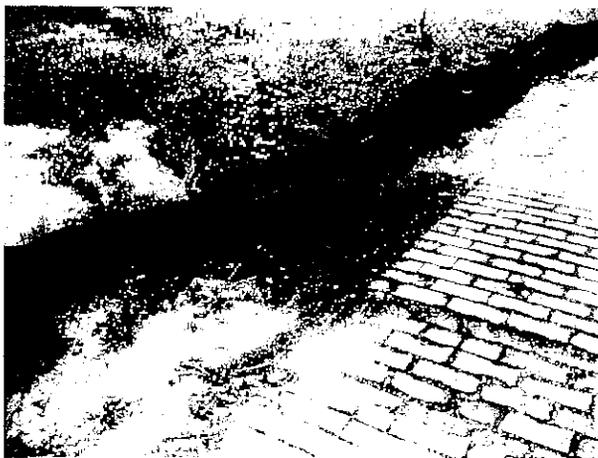
- Silt fence along Summit Street must be trenched in and anchored with backfill to assure that it is capable of ponding runoff. Several sections were not trenched and allow runoff to flow underneath the fence. Please repair.

**Fig 2 & 3.** Silt fence along Summit Street needs maintenance. Be sure it is trench in 6-8 inches, pulled tight and backfilled so that runoff ponds behind the fence and does not flow underneath.
