Environmental  
Protection Agency

August 17, 2011

RE: CUYAHOGA COUNTY  
CITY OF CLEVELAND  
I-90 INNERBELT PROJECT  
NPDES PERMIT NO. OHC000003  
OHIO EPA PERMIT NO. 3GC04733\*AG  
CONSTRUCTION STORM WATER

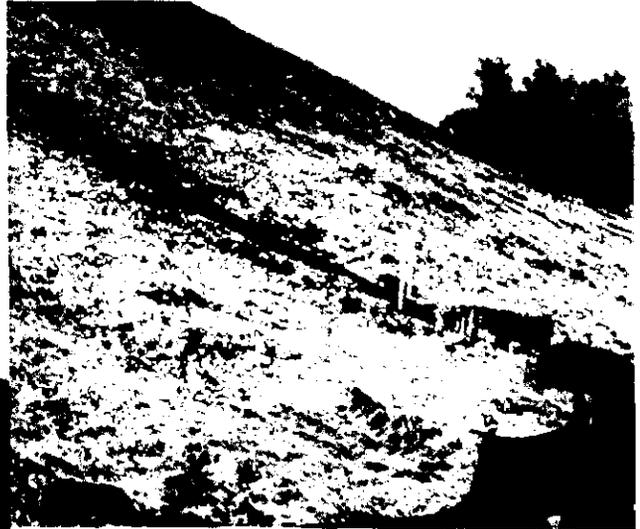
- ***Silt fence is not an appropriate sediment control.*** Due to the size and excessive slope of the site, silt fence is not a sufficient sediment control. Rather, runoff should be collected through a series of diversion channels and/or berms and be directed to a sediment pond. This comment applies to construction areas on **both sides** of Fairfield Avenue. We suggested the installation of a sediment pond in the NW corner of the active area south of Fairfield Avenue and in the SW corner of the active area north of Fairfield Avenue. Please amend the Storm Water Pollution Prevention Plan (SWP3) accordingly and be sure that the sediment ponds are sized per NPDES permit requirements (See Figure 2 and Enclosures).

Figure 2. The silt fence is not appropriate. Runoff should be conveyed to a sediment pond via a diversion at the base of the slope.

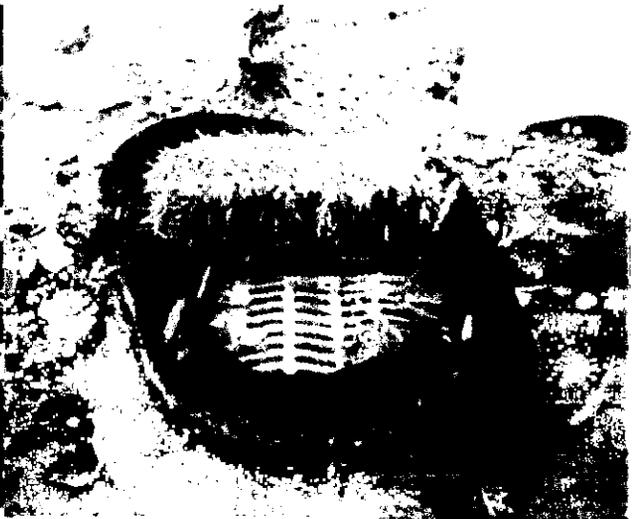
- ***There are storm sewer catch basins with inadequate inlet protection or no inlet protection at all.*** The catch basin by Pier 8 had a compost filter sock wrapped around it. The filter sock is not an appropriate form of inlet protection, and must be replaced by acceptable inlet protection as specified in the SWP3 (i.e. Dandy Bags, Silt Sacks, etc.). In addition, inlet protection #IP-11 was not installed at all. Please install inlet protection as specified in the SWP3 immediately (See Figure 6 & 7).

Figure 6. Compost filter socks are not approved as an inlet protection measure.

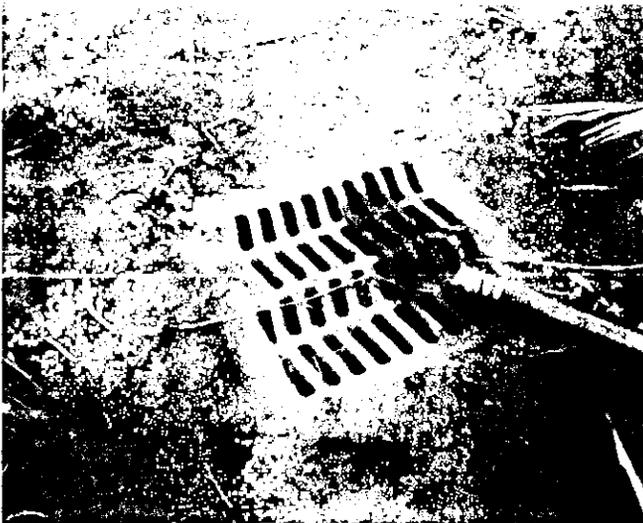
- ***Controls must be installed to prevent sediment-laden discharges from dewatering activities at pier excavations.*** During the visit, ground water from the Pier 7 pit excavation was being pumped to an unprotected catch basin. The discharge appeared clear at the time of inspection; however, it was apparent that water that collects within pier excavations can be sediment-laden after a rain event. Although we noted the presence of a dewatering bag on site, it was not in use nor situated correctly at the time of inspection. Dewatering bags must be located on stabilized ground with no potential for treated water to re-accumulate sediment after discharging from the bag and before entering the catch basin (See Figure 7). Other acceptable methods for dewatering include pumping to a sediment pond or dewatering through a sump consisting of a perforated standpipe wrapped in geotextile and embedded in stone after allowing at least 24 hours for sediment to settle (see Enclosure). We noted the presence of sumps within the pier excavations, but it was not evident that they had been wrapped in geotextile.

Figure 7. Unprotected catch basin with Pier 7 dewatering directly into it.

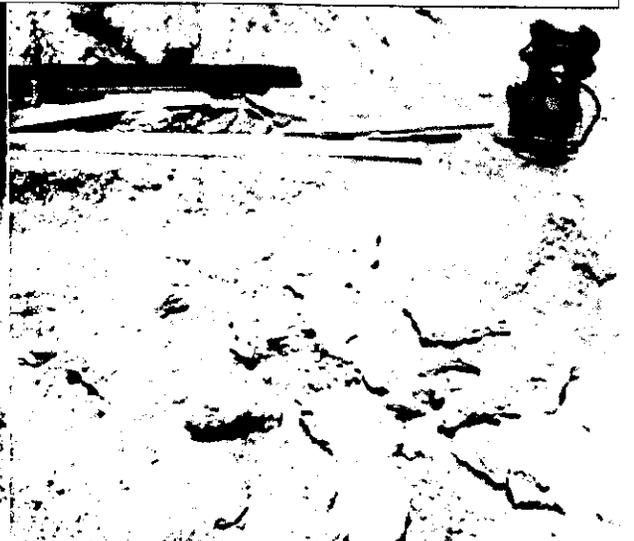
- ***The concrete washout pit shown on Sheet 13 of 26 of the SWP3 has not been installed.*** There were signs of concrete washout on disturbed earth. A concrete wash out pit needs to be constructed to serve this portion of the project and all concrete wash water must be conveyed into this pit. Concrete wash water is wastewater and must be treated as such (See Figure 12).

Figure 12. Concrete wash out must be done in a concrete wash pit.
