**Environmental  
Protection Agency**

July 13, 2010

RE: CUYAHOGA COUNTY  
TINKERS CREEK BASIN  
CITY OF MAPLE HEIGHTS  
NEW STAFFORD MIDDLE SCHOOL

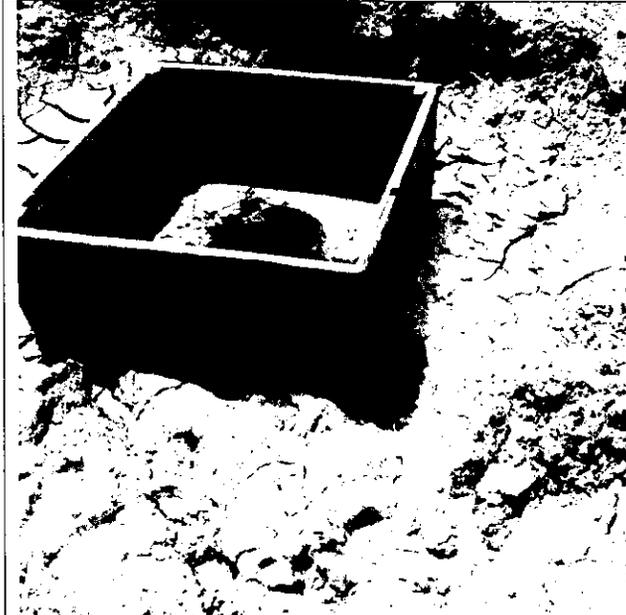
- Sediment basin #1 (SB1) was being installed at the time of inspection. Ensure the outlet structure and skimmer are installed in accordance with the site's storm water pollution prevention plan (SWP3).
- Inlet protection around inlet #2 (IP2) appears to have been breached (Figure 1). Ensure the inlet protection has been installed properly. Repair or reinstall inlet protection in accordance with the site's SWP3.
- The rock check dam in TD3 as it enters into sediment trap #2 (ST2) was observed to be in need of repair (Figure 2). Repair or reinstall the rock check dam in accordance with the site's SWP3.
- There were issues with the installation of the silt fence along the east end of the site. Observations showed the backfill material to be unsuitable, wet or dry. Mr. Jensen stated that he would discuss the issue with Christopher Hartman of Chagrin Valley Engineering.

Figure 1. Water appears to have found its way underneath the inlet protection.
