**Environmental  
Protection Agency**

July 19, 2011

RE: CUYAHOGA COUNTY  
CITY OF MIDDLEBURG HEIGHTS  
MCDONALD'S RESTAURANT  
NPDES PERMIT NO. OHC000003  
OHIO EPA PERMIT NO. 3GC05329\*AG  
CONSTRUCTION STORM WATER

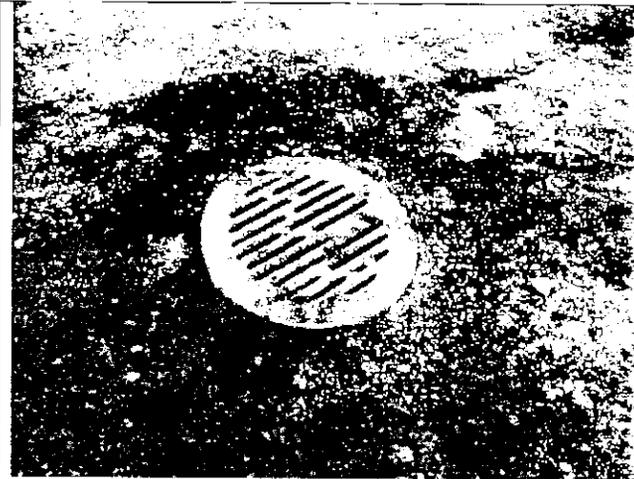
- There appeared to be several unprotected preexisting catch basins throughout the site, specifically along the construction drive near the construction trailer, and near the soil piles on the side opposite Bagley Road. Please be sure to install proper inlet protection as specified in the Storm Water Pollution Prevention Plan (SWP3) to prevent sediment laden water from discharging to surface waters of the state (See Figures 1 & 2).

Figure 1. Preexisting catch basin along the construction drive with no inlet protection.

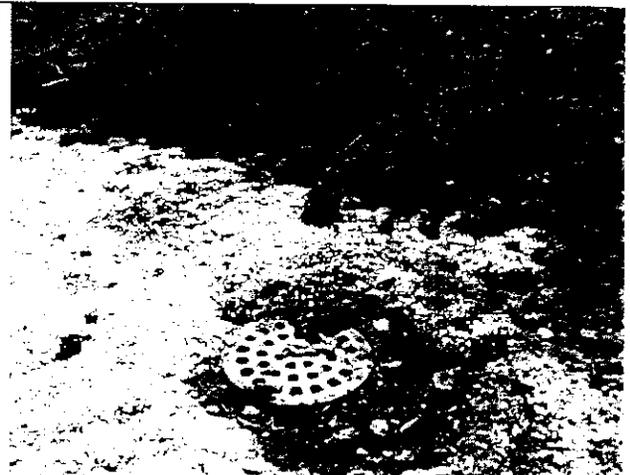
Figure 2. Preexisting catch basin located near the soil piles opposite Bagley Road with no inlet protection.

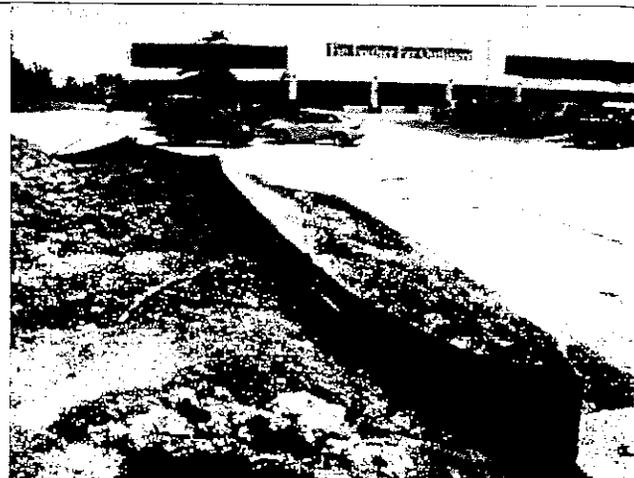
- There appeared to be areas where the silt fence was in need of maintenance, or improperly installed. Silt fence must be trenched and backfilled, with the ends of each section twisted together in order to pond runoff correctly. Please refer to the details for silt fence in the SWP3 and reinstall or replace the silt fence as necessary (See Figures 3 & 4).

Figure 3. Silt fence in need of maintenance.

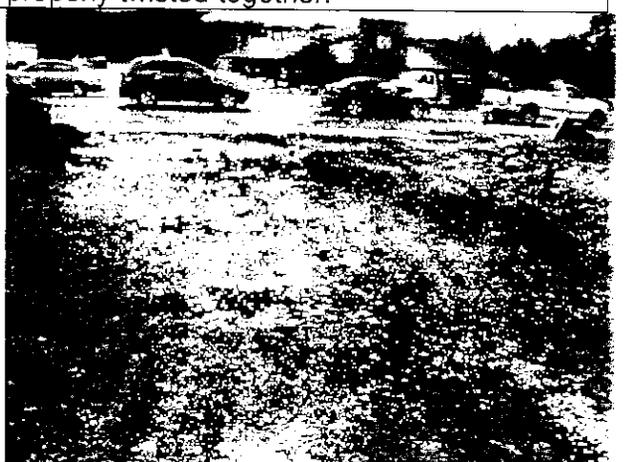
- There were signs of tracking of sediment onto Bagley Road. Please add more clean stone to the construction drive to help prevent sediment from being tracked by vehicles entering and exiting the construction site (See Figure 6).

Figure 6. The construction drive could use more stone.
