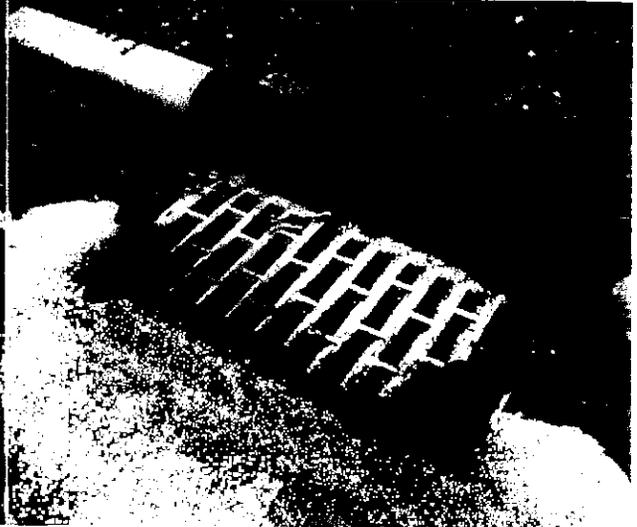
Figure 2. inadequate inlet protections have still not been replaced.

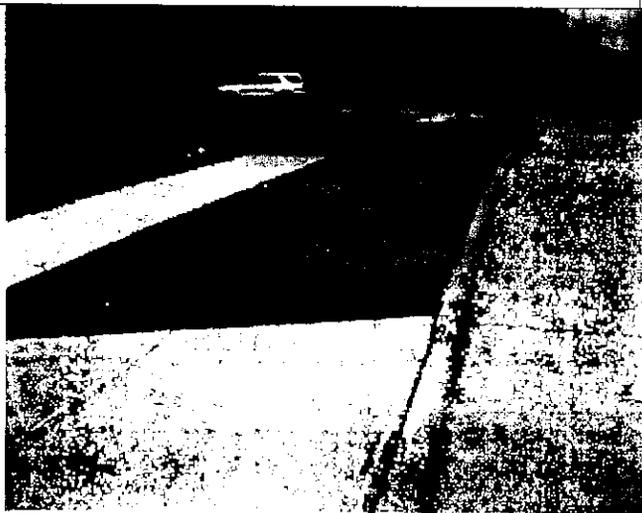
Figure 5. Tree lawns still aren't stabilized.
