State of Ohio Environmental Protection Agency

July 24, 2009

RE: CUYAHOGA COUNTY
CITY OF SOUTH EUCLID
EUCLID CREEK WATERSHED
FRANCIS COURT GABLES

NOTICE OF VIOLATION

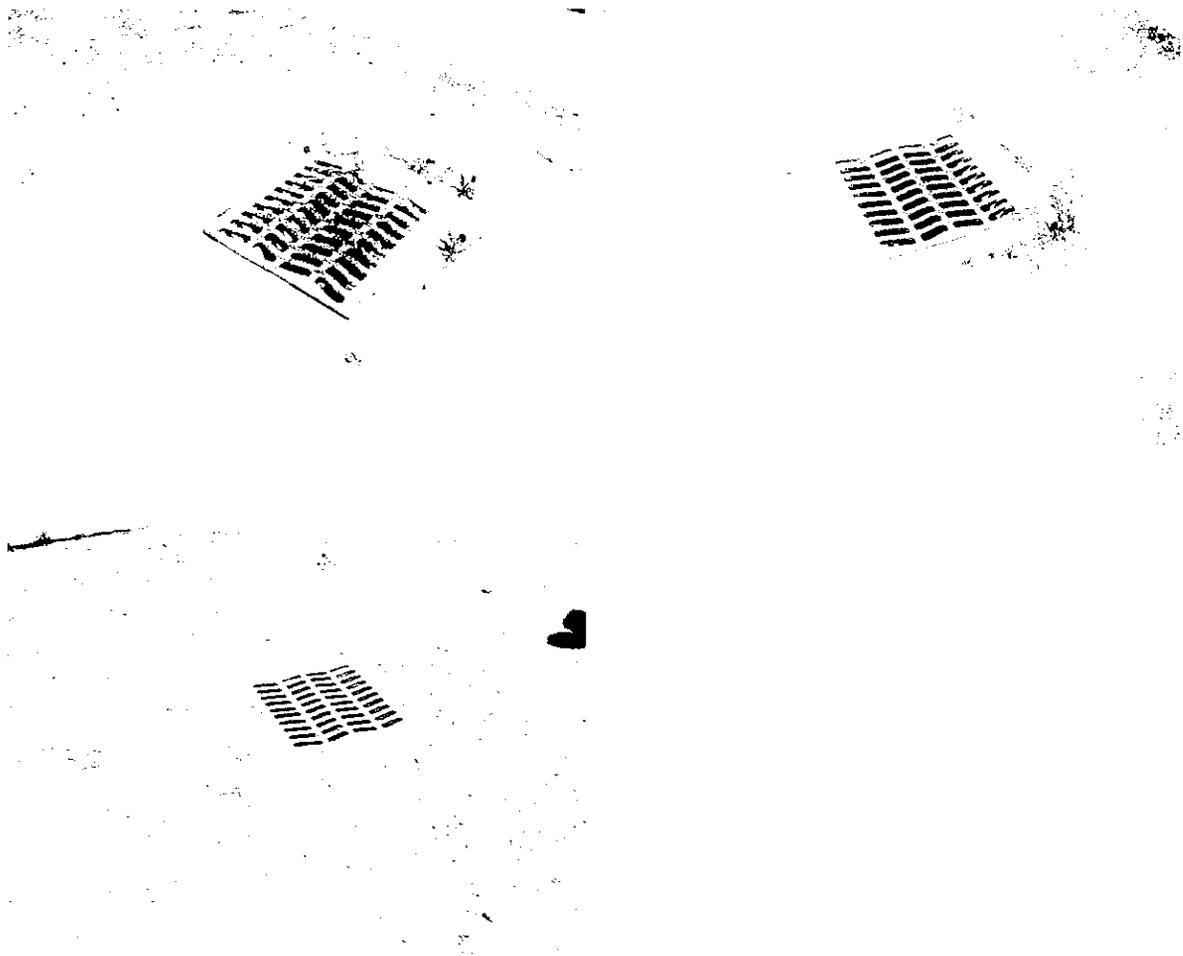
Failure to install inlet protection on storm sewer grates, unless those sewers discharge to a sediment pond. This is a violation of Part III.G.2.d.iv of the NPDES permit and ORC 6111.04 and 6111.07.

There are many storm sewers on site which have no protection. Are all of these storm sewers routed to the detention basin? Please refer to the pictures attached.

Sediment laden runoff is entering the storm drains. All storm drains that do not divert water to a sediment basin must be protected with an appropriate BMP.

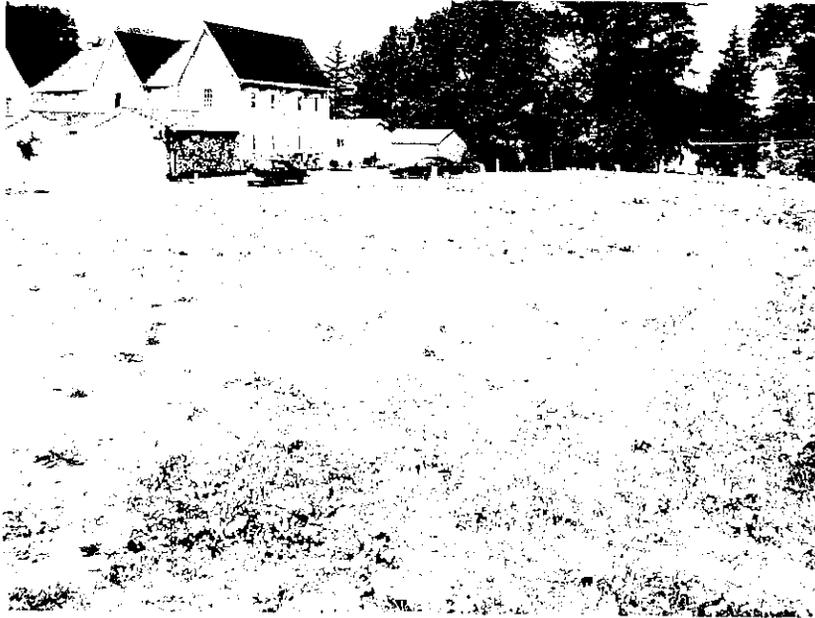
Failure to initiate the temporary stabilization of disturbed areas within 7 days of the last disturbance if they are to remain dormant for 21 days or longer. This is a violation of Part III.G.2.b.i of the National Pollution Discharge Elimination System (NPDES) Permit and Ohio Revised Code (ORC) 6111.04 and 6111.07.

The majority of the site was observed to consist of soil which has not been worked for several months. All areas of bare soil must be stabilized with grass seeding and mulching immediately.

Natural vegetation has started to grow throughout the site. This is a sign that the land has not been disturbed in several months. All areas of bare soil must be stabilized with grass seeding and mulching immediately.

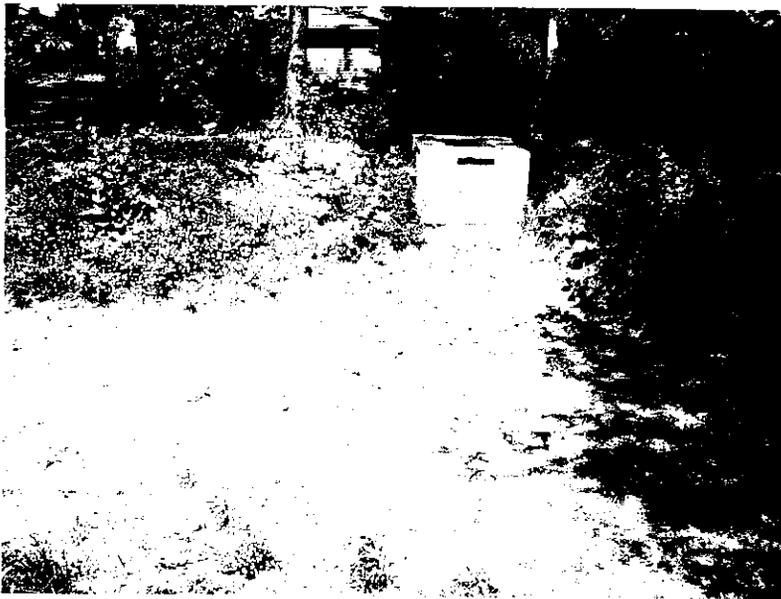
Failure to maintain the working order of sediment basins and perimeter sediment barriers until the up slope development area has been re-stabilized. This is a violation of Part III.G.2.d.i of the NPDES permit and ORC 6111.04 and 6111.07.

The outlet structure in your sediment basin has been improperly installed. Water is able to bypass the outlet structure due to lack of proper backfill. Also, the pipe inside the structure appears to be clogged; water is building up within the structure.

A sediment control structure must be installed in order for the sediment pond to work properly.
