Mr. Jerry Gruszewski  
Premier Development  
August 1, 2011  
Page 2

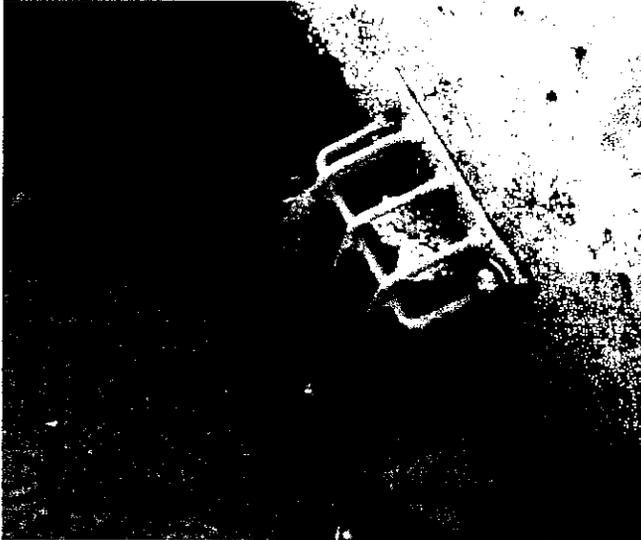
Figure 1. The orifice needs to be blocked off.
