**Environmental
Protection Agency**

July 6, 2011

RE: LAKE COUNTY
CITY OF MENTOR
S.R. 2 B/W S.R. 306 & FERN DRIVE
NPDES PERMIT NO. OHC000003
OHIO EPA PERMIT NO. 3GC04762*AG
CONSTRUCTION STORM WATER

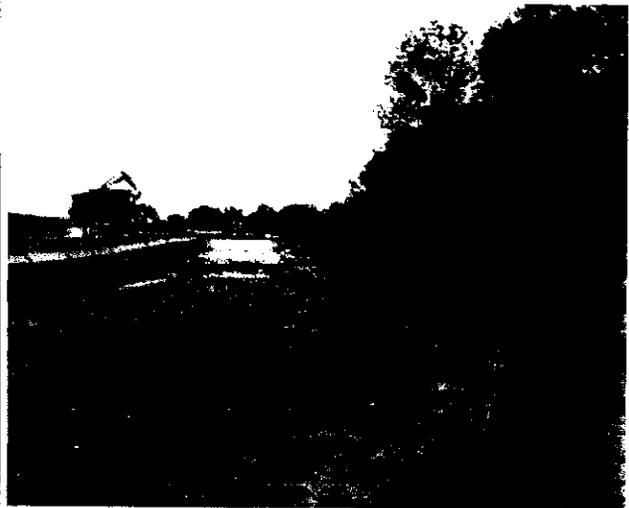
Figure 4. The sides of the exit ramps need to be stabilized if left idle for 21 days or greater.

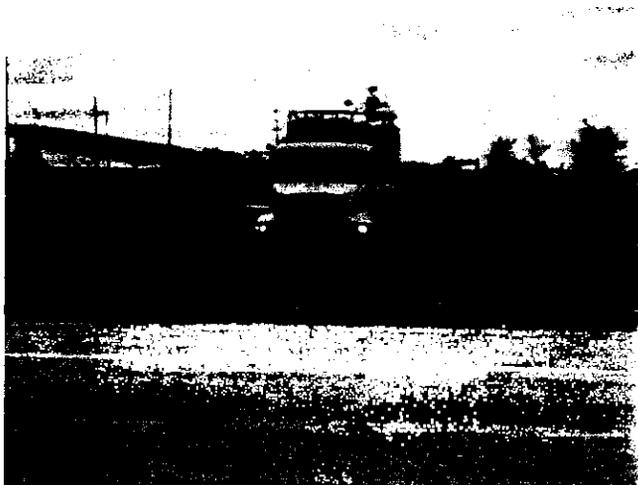
- There were signs of sediment tracking onto Center Street from the staging areas. Please be sure to construct rock entrances to these areas with the specifications detailed in the SWP3 to prevent mud from being tracked from vehicles onto Center Street (See Figure 5).

Figure 5. Off site tracking of sediment from vehicles is visible on Center Street.
