State of Ohio Environmental Protection Agency

July 6, 2010

RE: LORAIN COUNTY
HEIDER DITCH BASIN
CITY OF AVON LAKE
AVON LAKE HIGH SCHOOL STADIUM

On June 15, 2010, Ohio EPA conducted an inspection of the Avon Lake High School Stadium project located at 175 Avon Belden Road, City of Avon Lake, Lorain County (site). Ohio EPA records indicate that the site is covered by the General National Pollutant Discharge Elimination System (NPDES) Permit for Storm Water Associated with Construction Activity (General Storm Water Permit), permit No. 3GC04883*AG. I was accompanied by Chris Moody of Ohio EPA. The inspection documented the following:

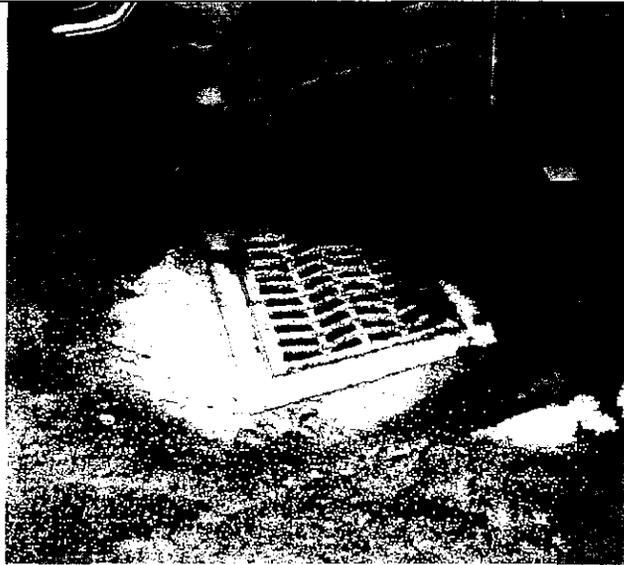
- No inlet protection has been installed (Figures 1 and 2). Heavy sediment deposition was observed in many of the site's storm sewer inlets. Install inlet protection according to the site's SWP3.

Figure 1. No inlet protection has been installed. Large amounts of sediment were observed in the storm sewer inlets.
