State of Ohio Environmental Protection Agency

July 7, 2010

RE: LORAIN COUNTY
EAST BRANCH BLACK RIVER BASIN
CITY OF ELYRIA
ELYRIA HIGH SCHOOL

On June 15, 2010, Ohio EPA conducted an inspection of the Elyria High School project located at 311 Vic Janowicz Drive (Sixth Street), City of Elyria, Lorain County (site). Ohio EPA records indicate that the site is covered by the General National Pollutant Discharge Elimination System (NPDES) Permit for Storm Water Associated with Construction Activity (General Storm Water Permit), permit No. 3GC03930*AG. I was accompanied by Chris Moody of Ohio EPA and Trever Haselberger of Marous Brothers Construction. The inspection documented the following:

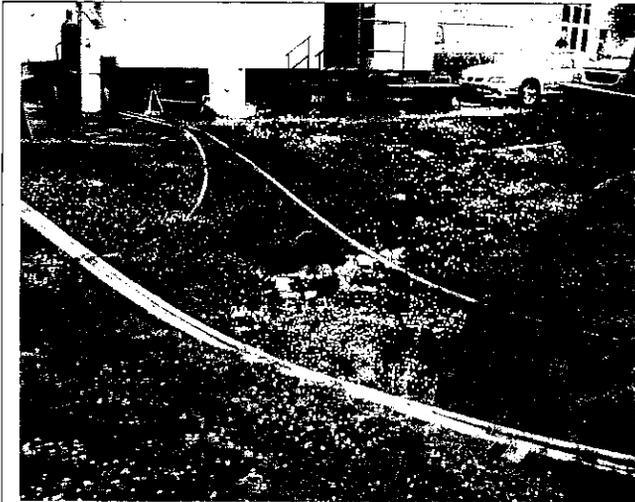
Figure 1. Bioswale to be completed.

- Bioswales and riser pipes were being installed as the site was inspected (Figures 1 and 2). Complete the installation of the bioswales and the riser pipes in accordance with the site's storm water pollution prevention plan (SWP3).

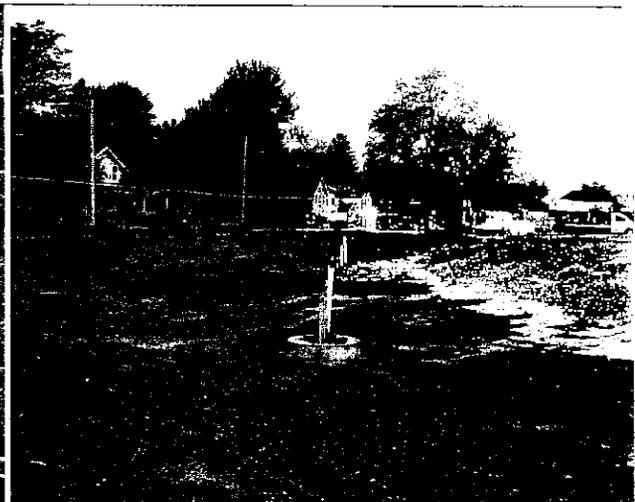
Figure 2. Completed bioswale.

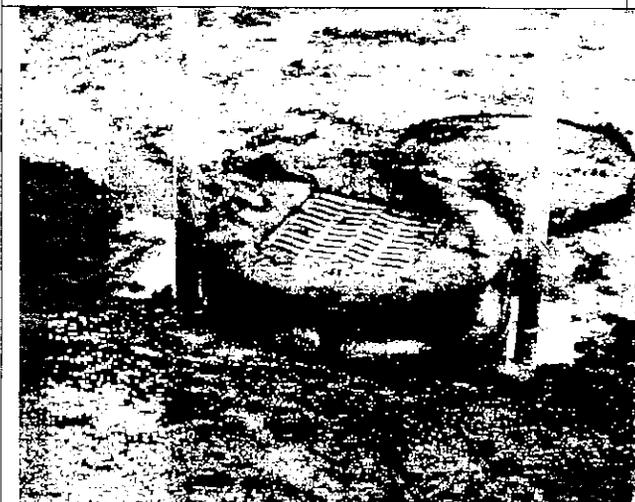
- No or improper inlet protection was installed on the site's storm sewer inlets (Figures 3 and 4). Install inlet protection in accordance with the site's SWP3.

Figure 3. Improper inlet protection must be removed and the proper inlet protection installed.

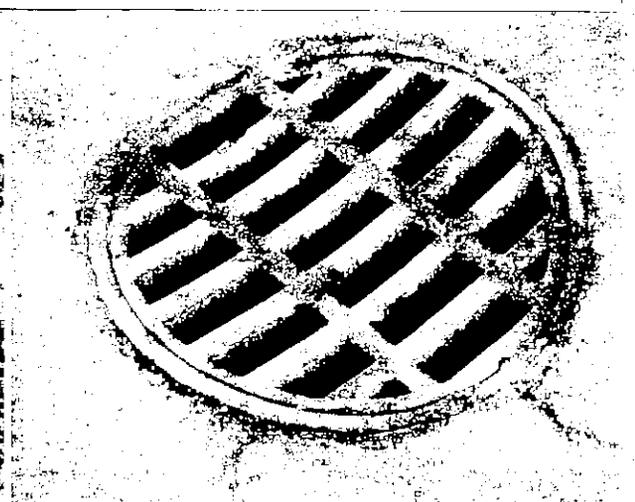
Figure 4. No inlet protection has been installed.

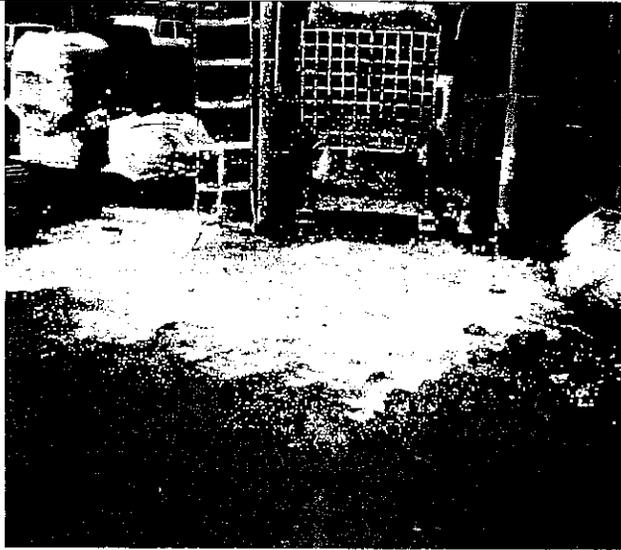
- Mortar/grout/concrete washout was observed to be spilled on-site (Figure 5). A sump or pit with no potential for discharge shall be constructed to prevent the discharge of pollutants to "waters of the state." The General Storm Water Permit does not authorize discharge of non-sediment pollutants to "waters of the state."

Figure 5. Spilled mortar/grout and mortar/grout washout was observed to be uncontained.
