**Environmental  
Protection Agency**

July 26, 2011

RE: LORAIN COUNTY  
VILLAGE OF GRAFTON  
MIDVIEW MIDDLE SCHOOL  
NPDES PERMIT NO. OHC000003  
OHIO EPA PERMIT NO. 3GC04797\*AG  
CONSTRUCTION STORM WATER

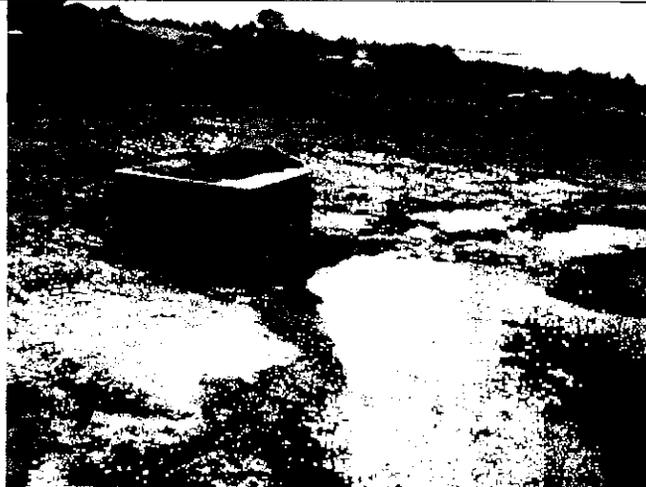
- **The sediment basins have not been equipped with an appropriate dewatering device for sediment control during construction activities.**
  - According to Jason, Titan Excavating is responsible for the installation of the dewatering devices for the outlet structures of the sediment basins. Please be sure Titan Excavating installs the riser pipe dewatering devices detailed in the Storm Water Pollution Prevention Plan (SWP3) **immediately** to prevent sediment laden water from discharging to surface waters of the State. Failure to do such is a **direct violation of the NPDES permit and punishable with fines up to \$25,000 per day of violation** (See Figures 1 & 2).

Figure 1. The outlet structure is missing a dewatering device.

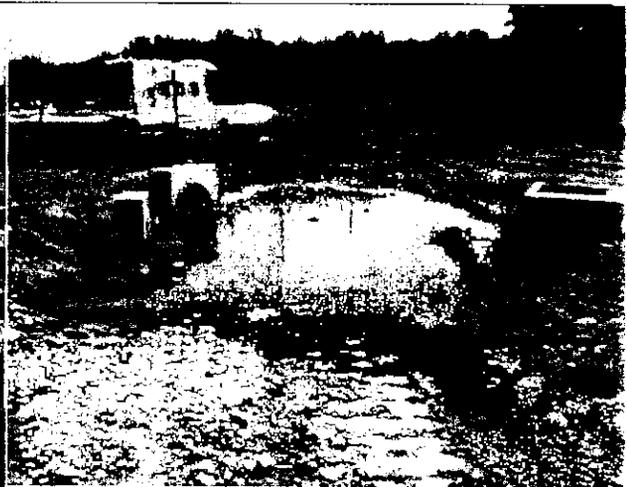
Figure 2. The outlet structure needs to be connected to a riser pipe.

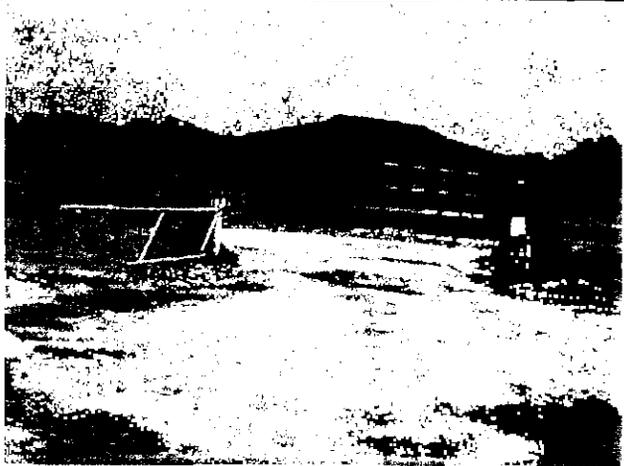
- **The construction drive is inadequate, resulting in offsite tracking of sediment from construction vehicles.**
  - The construction drive, as detailed in the SWP3, needs to consist of two (2) inch diameter stone, six (6) inches deep, and seventy (70) feet in length from the preexisting elementary school driveway. According to Rick, there is a Bobcat on site equipped with a broom device and the drive is swept free of sediment regularly (See Figure 3).

Figure 3. The construction drive is inadequate.
